Profile/Photo Observation Report

Street:	saint joesph pl	Flow Control:	Not Controlled
City:	Hobart, IN	Year Renewed:	
Location:	Other	Tape/Media #:	
Purpose:	Not Known	Dia/Height:	10"
Use:	Sanitary	Material:	PVC
Drain Area:	NA	Lining:	
Category:	NA		
Comment:

Location Details:		Direction of Survey:	Downstream
US MH:	M-902-078	DS MH:	M-902-046
		Total Length Surveyed (ft):	87.1

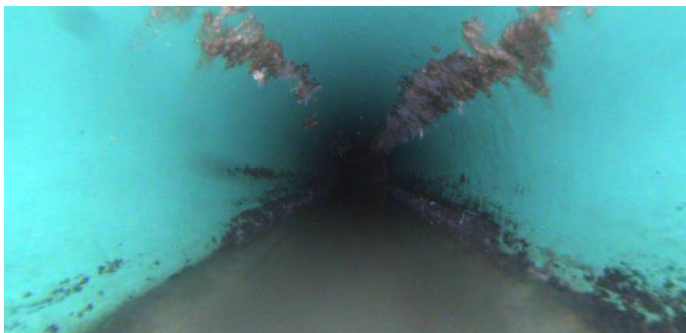
Code: **DAGS**
Description: **Deposits Attached Grease**

Distance (ft): **.0**
Structural Grade: **0**
O&M Grade: **2**
Clock Start/From: **8**
Clock To: **4**
1st Value:
2nd Value:
Value Percent: **5.000**
Continuous Index: **S02**
Within 8" of Joint: **NO**
Remarks:

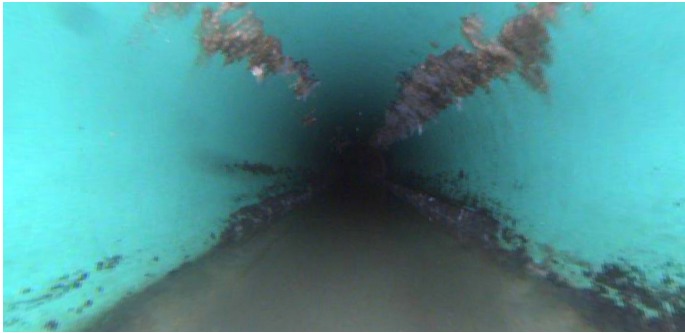
Code:	AMH
Description:	Manhole

Distance (ft):	.0
Structural Grade:	0
O&M Grade:	0
Clock Start/From:	
Clock To:	
1st Value:	
2nd Value:	
Value Percent:	
Continuous Index:	
Within 8" of Joint:	NO
Remarks:	M-902-078

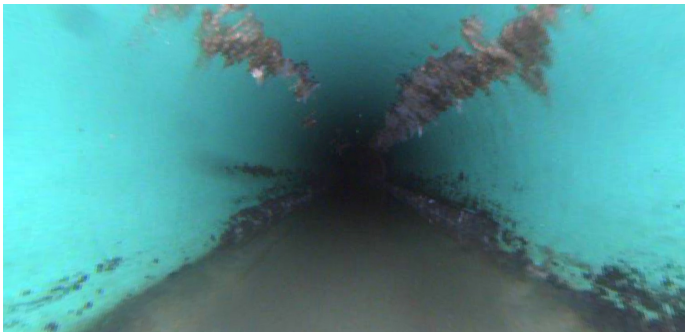
Code:	MWL
Description:	Water Level

Distance (ft):	.0
Structural Grade:	0
O&M Grade:	0
Clock Start/From:	
Clock To:	
1st Value:	
2nd Value:	
Value Percent:	10.000
Continuous Index:	
Within 8" of Joint:	NO
Remarks:

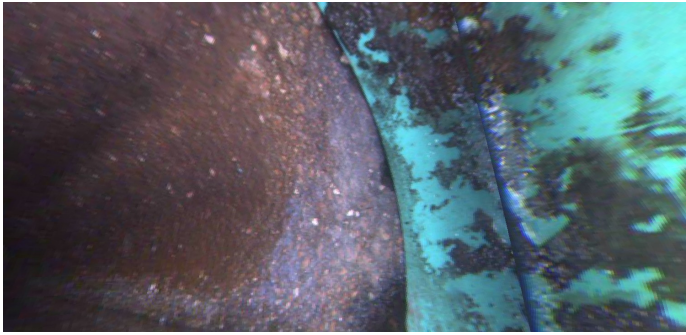
Code: **MMC**
Description: **Material Change**

Distance (ft): **5.8**
Structural Grade: **0**
O&M Grade: **0**
Clock Start/From:
Clock To:
1st Value:
2nd Value:
Value Percent:
Continuous Index:
Within 8" of Joint: **NO**
Remarks: **concrete?**

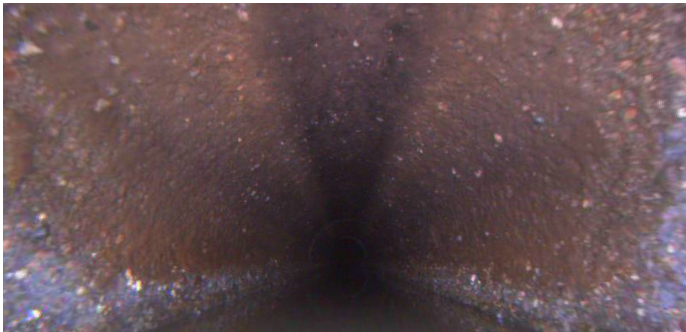
Code: **DAGS**
Description: **Deposits Attached Grease**

Distance (ft): **6.0**
Structural Grade: **0**
O&M Grade: **2**
Clock Start/From: **8**
Clock To: **4**
1st Value:
2nd Value:
Value Percent: **5.000**
Continuous Index: **F02**
Within 8" of Joint: **NO**
Remarks:

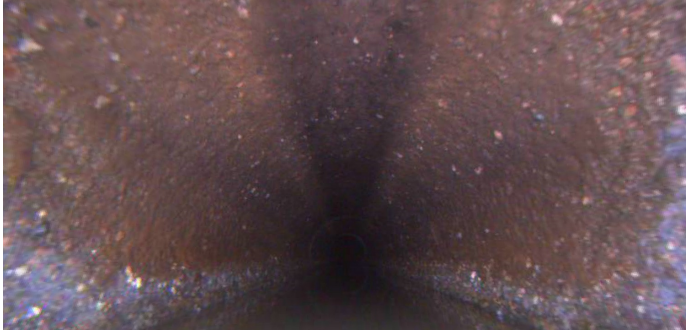
Code: **SAV**
Description: **Surface Aggregate Visible**

Distance (ft): **6.0**
Structural Grade: **3**
O&M Grade: **0**
Clock Start/From: **8**
Clock To: **4**
1st Value:
2nd Value:
Value Percent:
Continuous Index: **S03**
Within 8" of Joint:
Remarks:

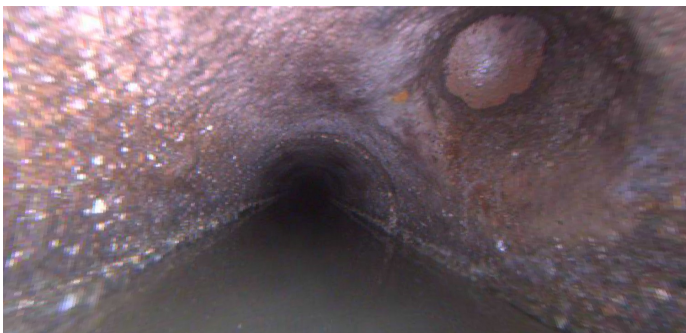
Code: **TFC**
Description: **Tap Factory Capped**

Distance (ft): **36.3**
Structural Grade: **0**
O&M Grade: **0**
Clock Start/From: **2**
Clock To:
1st Value: **4.000**
2nd Value:
Value Percent:
Continuous Index:
Within 8" of Joint:
Remarks:

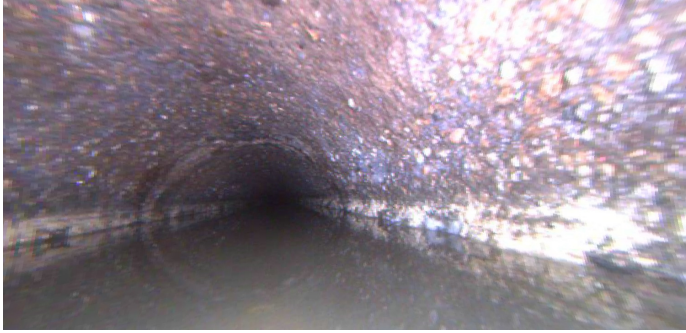
Code: **MWL**
Description: **Water Level**

Distance (ft): **60.7**
Structural Grade: **0**
O&M Grade: **0**
Clock Start/From:
Clock To:
1st Value:
2nd Value:
Value Percent: **30.000**
Continuous Index:
Within 8" of Joint: **NO**
Remarks:

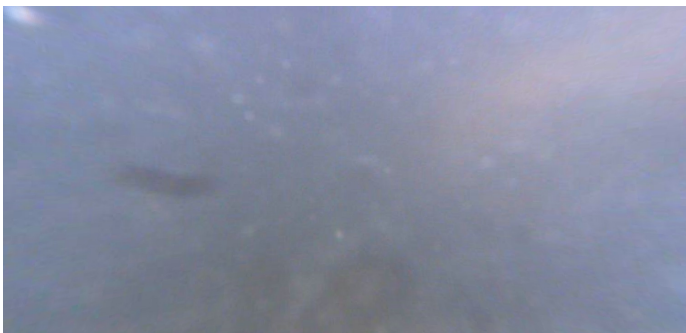
Code: **SAV**
Description: **Surface Aggregate Visible**

Distance (ft): **67.7**
Structural Grade: **3**
O&M Grade: **0**
Clock Start/From: **8**
Clock To: **4**
1st Value:
2nd Value:
Value Percent:
Continuous Index: **F03**
Within 8" of Joint:
Remarks:

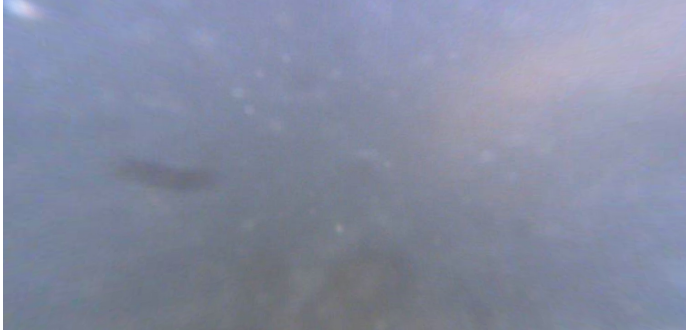
Code: **MWL**
Description: **Water Level**

Distance (ft): **67.7**
Structural Grade: **0**
O&M Grade: **0**
Clock Start/From:
Clock To:
1st Value:
2nd Value:
Value Percent: **100.000**
Continuous Index:
Within 8" of Joint: **NO**
Remarks:

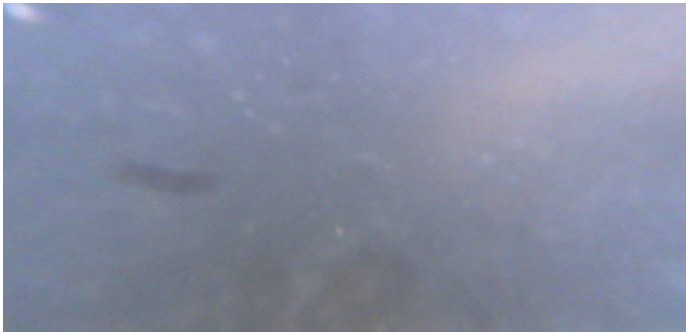
Code: **MCU**
Description: **Camera Underwater**

Distance (ft): **67.7**
Structural Grade: **0**
O&M Grade: **4**
Clock Start/From:
Clock To:
1st Value:
2nd Value:
Value Percent:
Continuous Index: **S01**
Within 8" of Joint: **NO**
Remarks: **front and rear**
