Profile/Photo Observation Report

| P.O.#: | 808_1 | Surveyor: | M. Pielacha | PSR: | P-902-0SL-045 |

| US MH: | M-902-79 | DS MH: | M-902-45 |

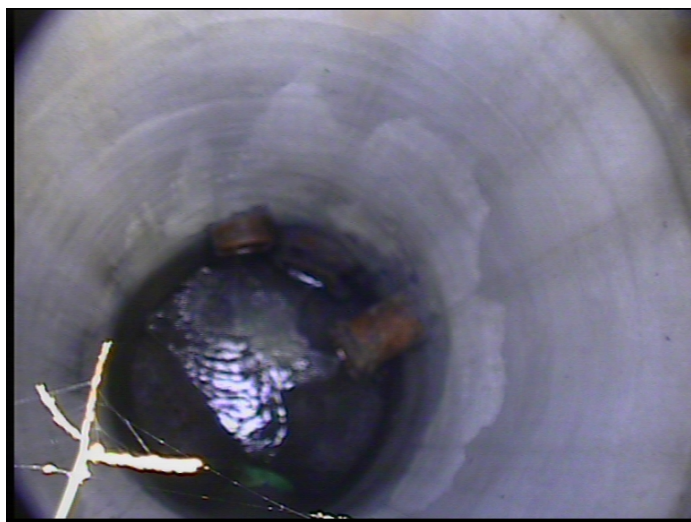
Code: **AMH**
Description: **Manhole**

Distance (ft): **.0**
Structural Grade: **0**
O&M Grade: **0**
Clock Start/From:
Clock To:
1st Value:
2nd Value:
Value Percent:
Continuous Index:
Within 8" of Joint: **NO**
Remarks: **M-902-45**

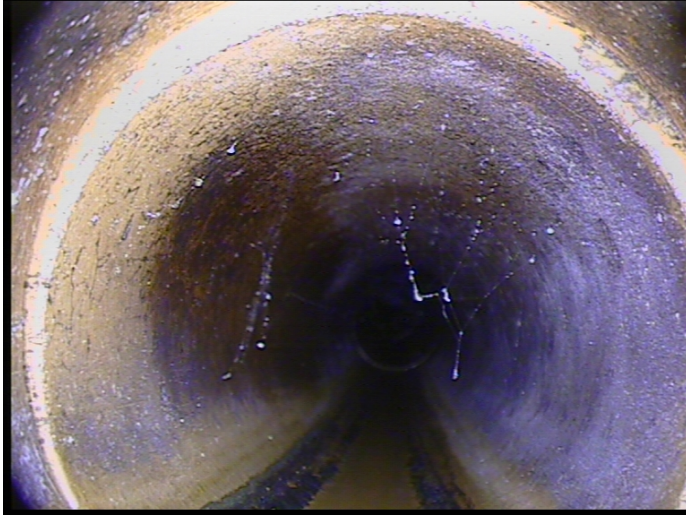
Code: **MWL**
Description: **Water Level**

Distance (ft): **.0**
Structural Grade: **0**
O&M Grade: **0**
Clock Start/From:
Clock To:
1st Value:
2nd Value:
Value Percent: **5.000**
Continuous Index:
Within 8" of Joint: **NO**
Remarks:

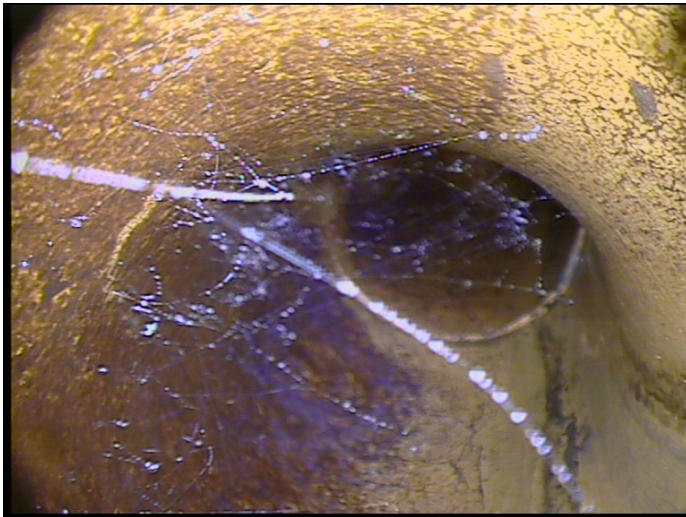
| | Position | Code | Observation | Video (sec) | Grade |
|--|---|---|---|---|---|
| | 17.5 | LR | Alignment Right | 157 | M 4 |

Code: **LR**
Description: **Alignment Right**

Distance (ft): **17.5**
Structural Grade: **0**
O&M Grade: **4**
Clock Start/From:
Clock To:
1st Value:
2nd Value:
Value Percent: **45.000**
Continuous Index:
Within 8" of Joint: **NO**
Remarks:

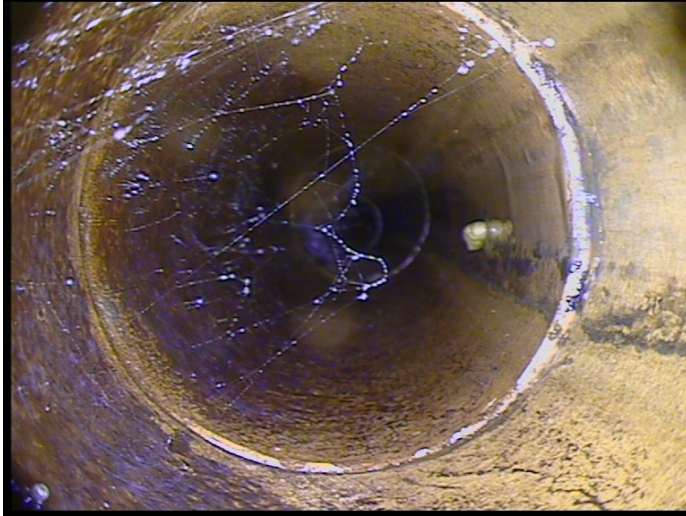
| Code: | MSA |
| Description: | Abandoned Survey |
| Distance (ft): | 17.5 |
| Remarks: | Line bends right |
