Profile/Photo Observation Report

Date:	03/21/2018	Weather:		Coding:	PACP 6.0
Pipe Length (ft):	266.8	Owner:	NA	Pre Clean:	Not Known
P.O.#:		Surveyor:	Selasie Honu	PSR:	P-902-080-079
Customer:		Clean Date:	01/01/1900	Shape:	C

Street:	38th pl	Flow Control:	Not Controlled
City:	Hobart, IN	Year Renewed:	
Location:	Other	Tape/Media #:	
Purpose:	Not Known	Dia/Height:	8"
Use:	Sanitary	Material:	VCP
Drain Area:	NA	Lining:	
Category:	NA		
Comment:	cnl

Location Details:		Direction of Survey:	Upstream
US MH:	M-902-080	DS MH:	M-902-079
		Total Length Surveyed (ft):	265.3

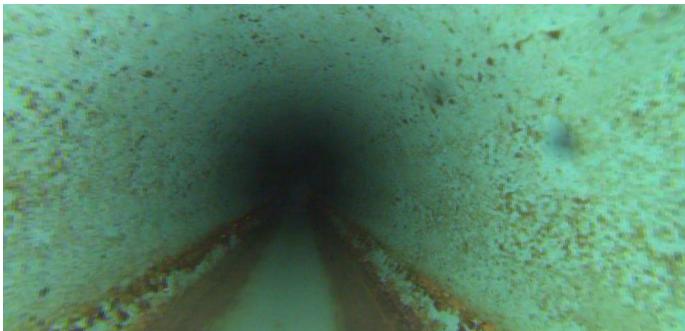
Code: **AMH**
Description: **Manhole**

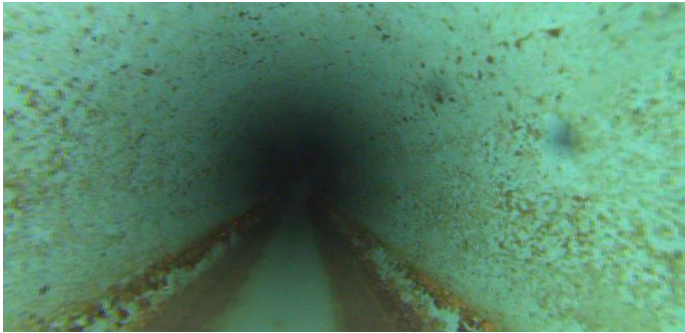
Code:	MWL
Description:	Water Level

Distance (ft):	.0
Structural Grade:	0
O&M Grade:	0
Clock Start/From:	
Clock To:	
1st Value:	
2nd Value:	
Value Percent:	5.000
Continuous Index:	
Within 8" of Joint:	NO
Remarks:

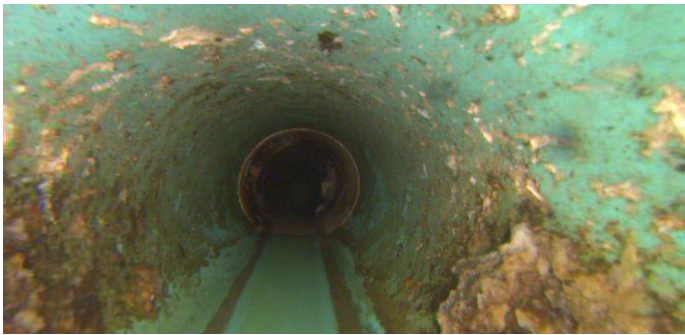
Code:	DAGS
Description:	Deposits Attached Grease

Distance (ft):	89.2
Structural Grade:	0
O&M Grade:	2
Clock Start/From:	8
Clock To:	4
1st Value:	
2nd Value:	
Value Percent:	5.000
Continuous Index:	
Within 8" of Joint:	NO
Remarks:

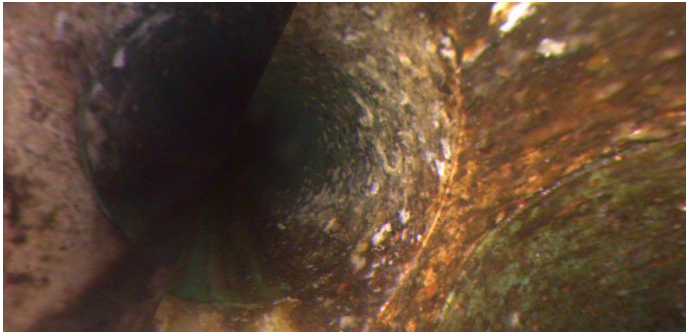
Code: **TF**
Description: **Tap Factory**

Distance (ft): **91.2**
Structural Grade: **0**
O&M Grade: **0**
Clock Start/From: **10**
Clock To:
1st Value: **4.000**
2nd Value:
Value Percent:
Continuous Index:
Within 8" of Joint:
Remarks:

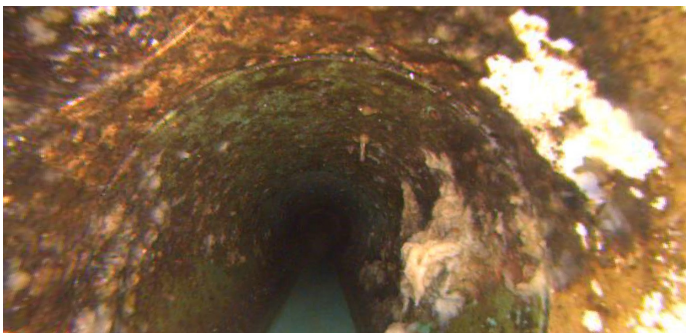
Code: **DAGS**
Description: **Deposits Attached Grease**

Distance (ft): **91.2**
Structural Grade: **0**
O&M Grade: **2**
Clock Start/From: **1**
Clock To: **4**
1st Value:
2nd Value:
Value Percent: **5.000**
Continuous Index:
Within 8" of Joint: **NO**
Remarks:

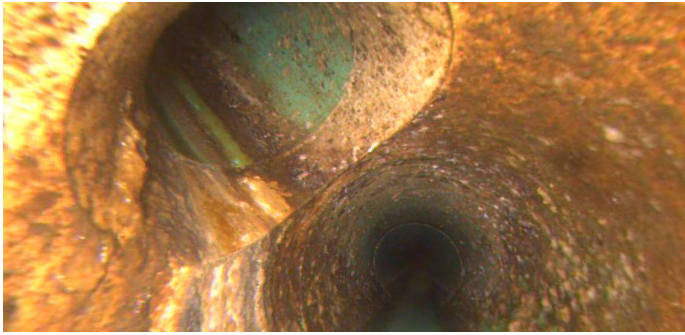
Code: **TF**
Description: **Tap Factory**

Distance (ft): **95.0**
Structural Grade: **0**
O&M Grade: **0**
Clock Start/From: **11**
Clock To:
1st Value: **4.000**
2nd Value:
Value Percent:
Continuous Index:
Within 8" of Joint:
Remarks:

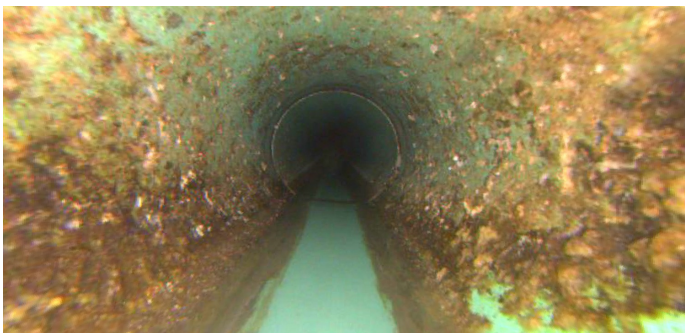
Code: **DAGS**
Description: **Deposits Attached Grease**

Distance (ft): **96.0**
Structural Grade: **0**
O&M Grade: **2**
Clock Start/From: **8**
Clock To: **4**
1st Value:
2nd Value:
Value Percent: **5.000**
Continuous Index:
Within 8" of Joint: **NO**
Remarks:

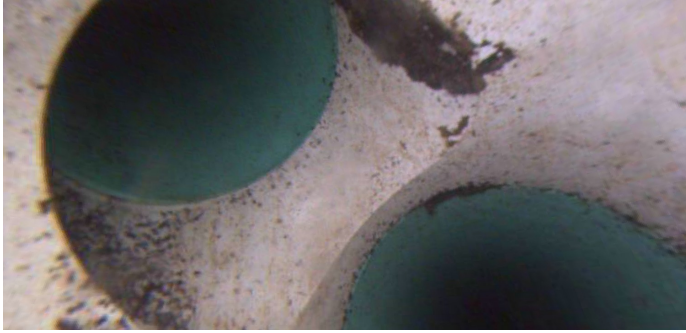
Code: **TF**
Description: **Tap Factory**

Distance (ft): **190.9**
Structural Grade: **0**
O&M Grade: **0**
Clock Start/From: **1**
Clock To:
1st Value: **4.000**
2nd Value:
Value Percent:
Continuous Index:
Within 8" of Joint:
Remarks:

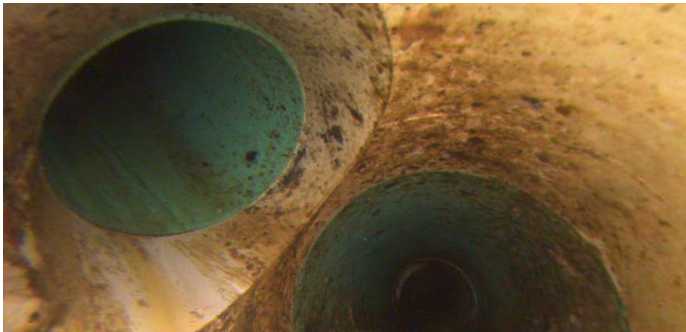
Code: **TF**
Description: **Tap Factory**

Distance (ft): **210.0**
Structural Grade: **0**
O&M Grade: **0**
Clock Start/From: **10**
Clock To:
1st Value: **4.000**
2nd Value:
Value Percent:
Continuous Index:
Within 8" of Joint:
Remarks:

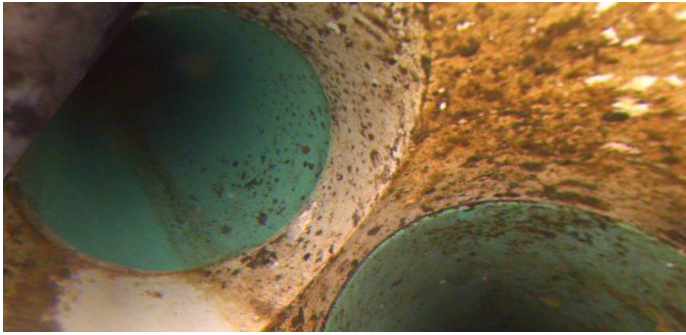
Code: **TF**
Description: **Tap Factory**

Distance (ft): **212.8**
Structural Grade: **0**
O&M Grade: **0**
Clock Start/From: **10**
Clock To:
1st Value: **4.000**
2nd Value:
Value Percent:
Continuous Index:
Within 8" of Joint:
Remarks:

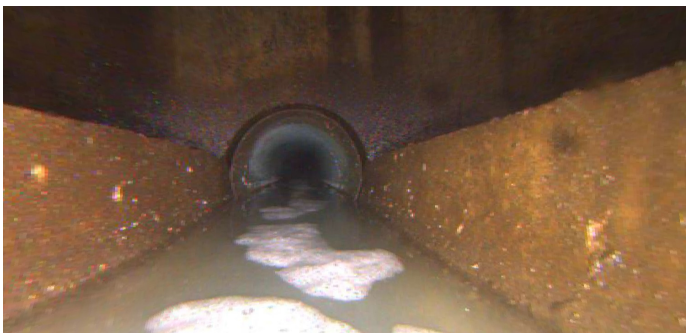
Code: **AMH**
Description: **Manhole**

Distance (ft): **265.3**
Structural Grade: **0**
O&M Grade: **0**
Clock Start/From:
Clock To:
1st Value:
2nd Value:
Value Percent:
Continuous Index:
Within 8" of Joint: **NO**
Remarks: **M-902-080**
