Profile/Photo Observation Report

Street:	N HOBART RD	Flow Control:	Not Controlled
City:	Hobart, IN	Year Renewed:	
Location:	Other	Tape/Media #:	
Purpose:	Not Known	Dia/Height:	10"
Use:	Sanitary	Material:	VCP
Drain Area:	NA	Lining:	
Category:	NA		
Comment:

Location Details:		Direction of Survey:	Upstream
US MH:	M-903-002	DS MH:	M-903-001
		Total Length Surveyed (ft):	71.2

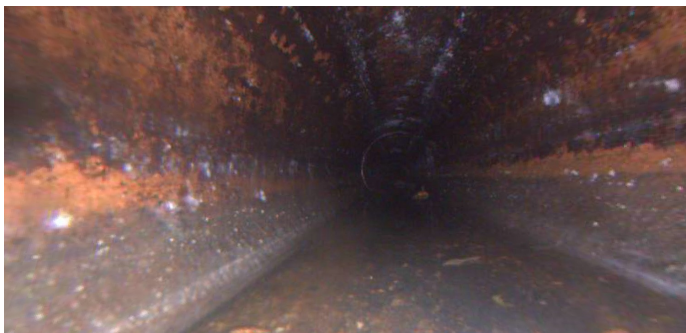
Code: **AMH**
Description: **Manhole**

Distance (ft): **.0**
Structural Grade: **0**
O&M Grade: **0**
Clock Start/From:
Clock To:
1st Value:
2nd Value:
Value Percent:
Continuous Index:
Within 8" of Joint: **NO**
Remarks: **M-903-001**

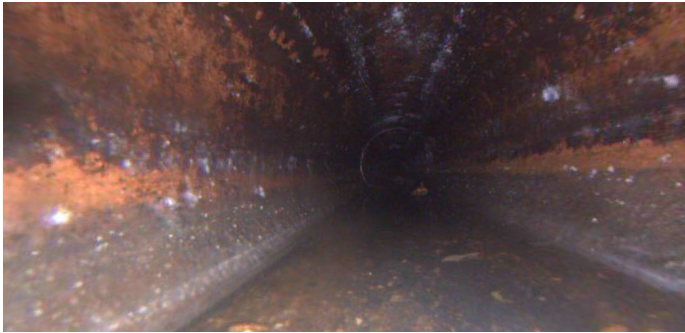
Code:	MWL
Description:	Water Level

Distance (ft):	.0
Structural Grade:	0
O&M Grade:	0
Clock Start/From:	
Clock To:	
1st Value:	
2nd Value:	
Value Percent:	10.000
Continuous Index:	
Within 8" of Joint:	NO
Remarks:

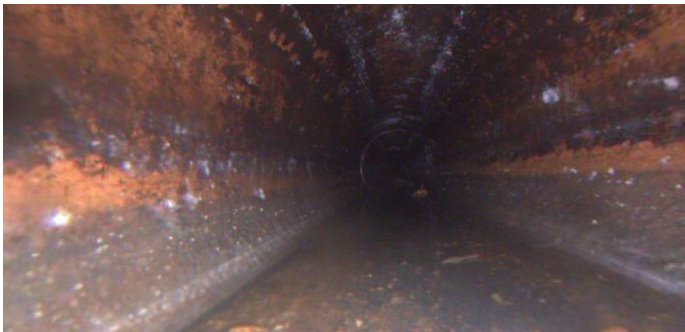
Code:	DAGS
Description:	Deposits Attached Grease

Distance (ft):	.0
Structural Grade:	0
O&M Grade:	2
Clock Start/From:	8
Clock To:	4
1st Value:	
2nd Value:	
Value Percent:	5.000
Continuous Index:	S01
Within 8" of Joint:	NO
Remarks:

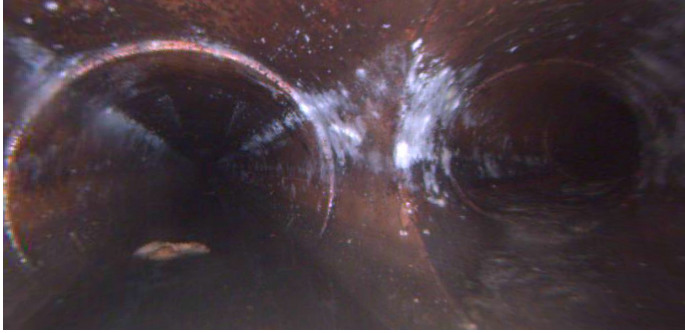
Code: **TF**
Description: **Tap Factory**

Distance (ft): **10.4**
Structural Grade: **0**
O&M Grade: **0**
Clock Start/From: **3**
Clock To:
1st Value: **4.000**
2nd Value:
Value Percent:
Continuous Index:
Within 8" of Joint:
Remarks:

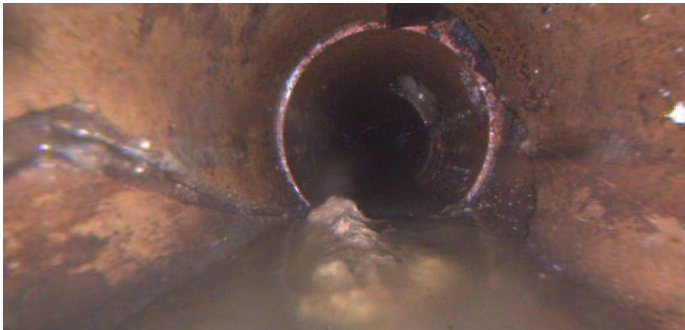
Code: **BVV**
Description: **Broken Void Visible**

Distance (ft): **50.0**
Structural Grade: **5**
O&M Grade: **0**
Clock Start/From: **8**
Clock To: **4**
1st Value:
2nd Value:
Value Percent:
Continuous Index:
Within 8" of Joint: **YES**
Remarks:

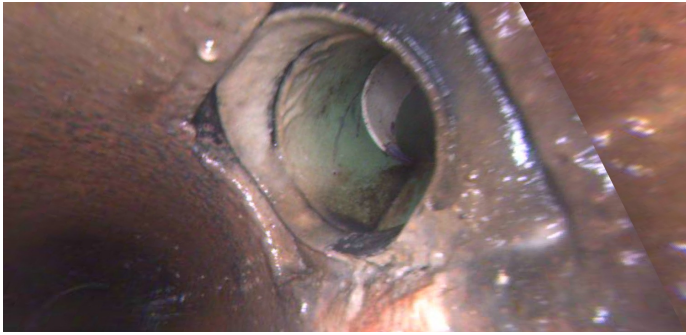
Code: **TB**
Description: **Tap Break-in**

Distance (ft): **51.6**
Structural Grade: **0**
O&M Grade: **0**
Clock Start/From: **2**
Clock To:
1st Value: **4.000**
2nd Value:
Value Percent:
Continuous Index:
Within 8" of Joint:
Remarks:

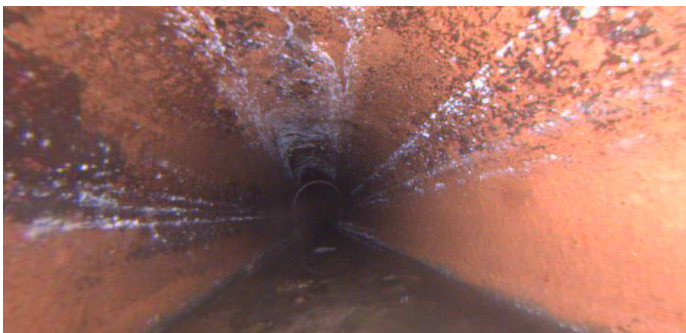
Code: **DAGS**
Description: **Deposits Attached Grease**

Distance (ft): **71.2**
Structural Grade: **0**
O&M Grade: **2**
Clock Start/From: **8**
Clock To: **4**
1st Value:
2nd Value:
Value Percent: **5.000**
Continuous Index: **F01**
Within 8" of Joint: **NO**
Remarks:

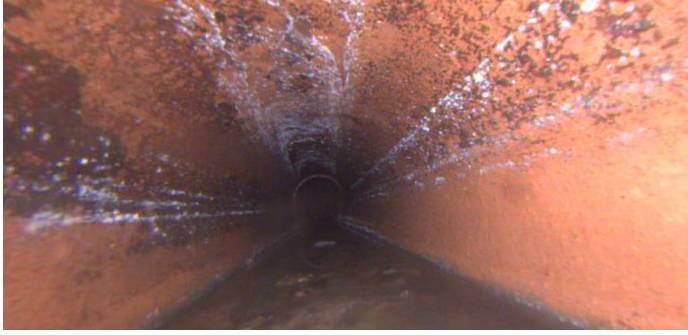
Code:	MSA
Description:	Abandoned Survey
Distance (ft):	71.2
Structural Grade:	0
O&M Grade:	0
Clock Start/From:	
Clock To:	
1st Value:	
2nd Value:	
Value Percent:	
Continuous Index:	
Within 8" of Joint:	NO
Remarks:	UNKNOWN
