Profile/Photo Observation Report

Street:	n hobart rd	Flow Control:	Not Controlled
City:	Hobart, IN	Year Renewed:	
Location:	Other	Tape/Media #:	
Purpose:	Not Known	Dia/Height:	10"
Use:	Sanitary	Material:	VCP
Drain Area:	NA	Lining:	
Category:	NA		
Comment:

Location Details:		Direction of Survey:	Upstream
US MH:	M-903-002	DS MH:	M-903-001
		Total Length Surveyed (ft):	71.2

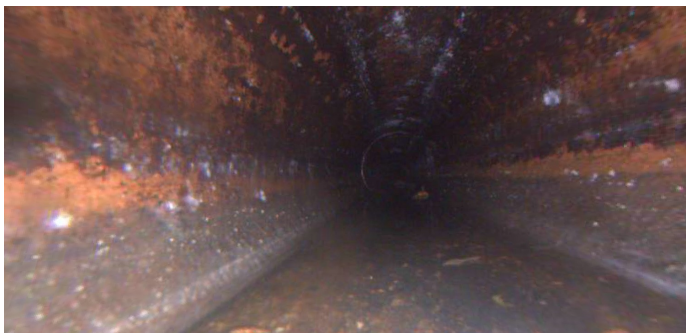
Code: **AMH**
Description: **Manhole**

Distance (ft): **.0**
Structural Grade: **0**
O&M Grade: **0**
Clock Start/From:
Clock To:
1st Value:
2nd Value:
Value Percent:
Continuous Index:
Within 8" of Joint: **NO**
Remarks: **M-903-001**

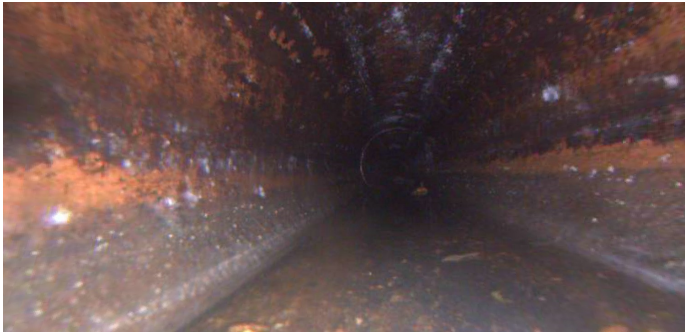
Code:	MWL
Description:	Water Level

Distance (ft):	.0
Structural Grade:	0
O&M Grade:	0
Clock Start/From:	
Clock To:	
1st Value:	
2nd Value:	
Value Percent:	10.000
Continuous Index:	
Within 8" of Joint:	NO
Remarks:

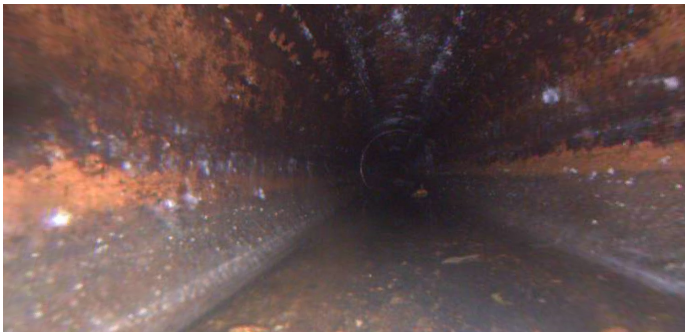
Code:	DAGS
Description:	Deposits Attached Grease

Distance (ft):	.0
Structural Grade:	0
O&M Grade:	2
Clock Start/From:	8
Clock To:	4
1st Value:	
2nd Value:	
Value Percent:	5.000
Continuous Index:	S01
Within 8" of Joint:	NO
Remarks:

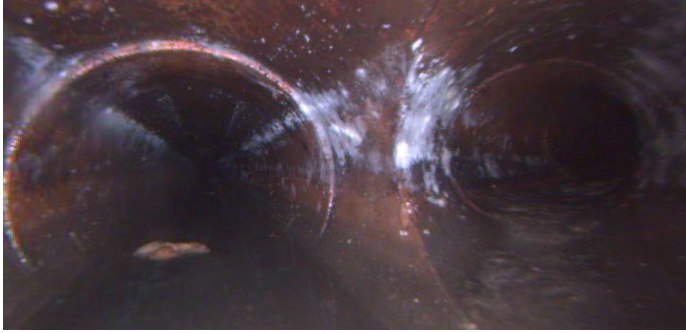
Code: **TF**
Description: **Tap Factory**

Distance (ft): **10.4**
Structural Grade: **0**
O&M Grade: **0**
Clock Start/From: **3**
Clock To:
1st Value: **4.000**
2nd Value:
Value Percent:
Continuous Index:
Within 8" of Joint:
Remarks:

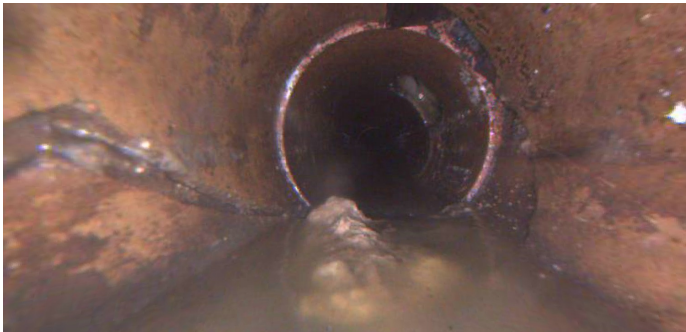
Code: **BVV**
Description: **Broken Void Visible**

Distance (ft): **50.0**
Structural Grade: **5**
O&M Grade: **0**
Clock Start/From: **8**
Clock To: **4**
1st Value:
2nd Value:
Value Percent:
Continuous Index:
Within 8" of Joint: **YES**
Remarks:

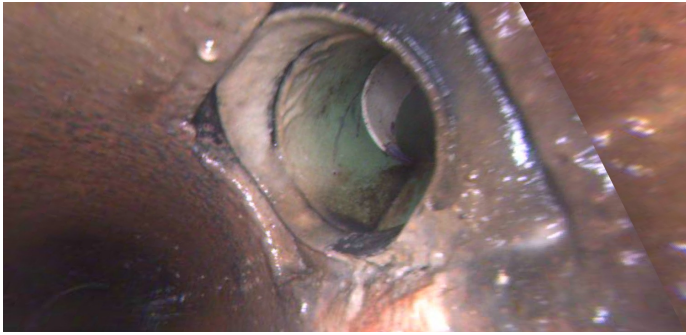
Code: **TB**
Description: **Tap Break-in**

Distance (ft): **51.6**
Structural Grade: **0**
O&M Grade: **0**
Clock Start/From: **2**
Clock To:
1st Value: **4.000**
2nd Value:
Value Percent:
Continuous Index:
Within 8" of Joint:
Remarks:

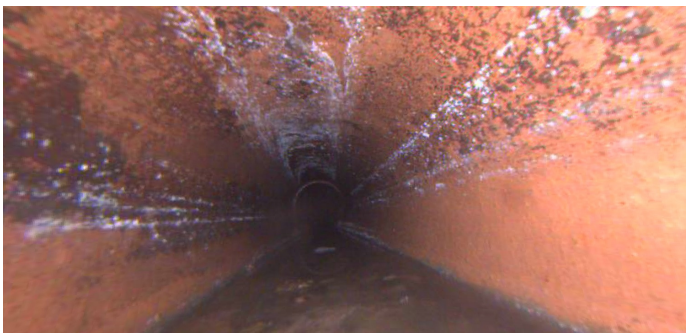
Code: **DAGS**
Description: **Deposits Attached Grease**

Distance (ft): **71.2**
Structural Grade: **0**
O&M Grade: **2**
Clock Start/From: **8**
Clock To: **4**
1st Value:
2nd Value:
Value Percent: **5.000**
Continuous Index: **F01**
Within 8" of Joint: **NO**
Remarks:

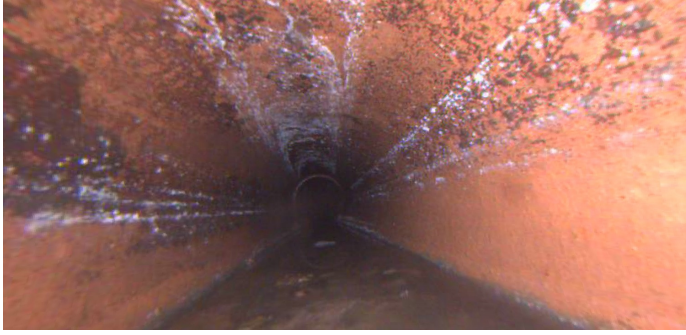
Code:	MSA
Description:	Abandoned Survey
Distance (ft):	71.2
Structural Grade:	0
O&M Grade:	0
Clock Start/From:	
Clock To:	
1st Value:	
2nd Value:	
Value Percent:	
Continuous Index:	
Within 8" of Joint:	NO
Remarks:	UNKNOWN
