Profile/Photo Observation Report

Street:	N HOBART RD	Flow Control:	Not Controlled
City:	Hobart, IN	Year Renewed:	
Location:	Light Highway	Tape/Media #:	
Purpose:	Routine Assessment	Dia/Height:	10"
Use:	Sanitary	Material:	VCP
Drain Area:	NA	Lining:	
Category:	NA		
Comment:

Location Details:		Direction of Survey:	Upstream
US MH:	M-903-002	DS MH:	M-903-001
		Total Length Surveyed (ft):	67.3

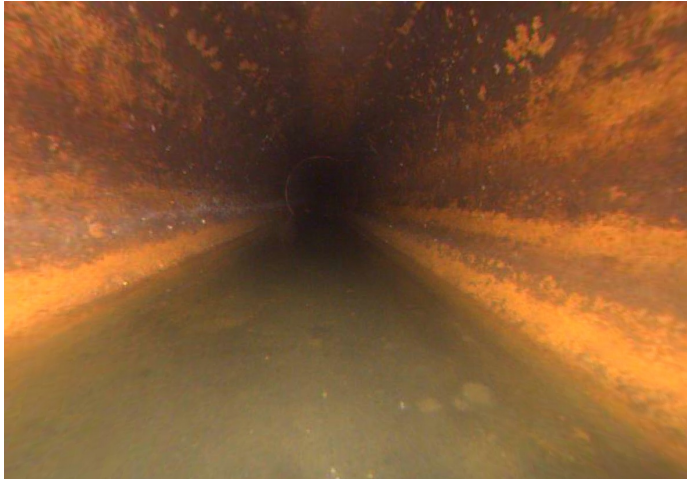
Code:	MWL
Description:	Water Level
Distance (ft):	.0
Structural Grade:	0
O&M Grade:	0
Clock Start/From:	
Clock To:	
1st Value:	
2nd Value:	
Value Percent:	20.000
Continuous Index:	
Within 8" of Joint:	NO
Remarks:

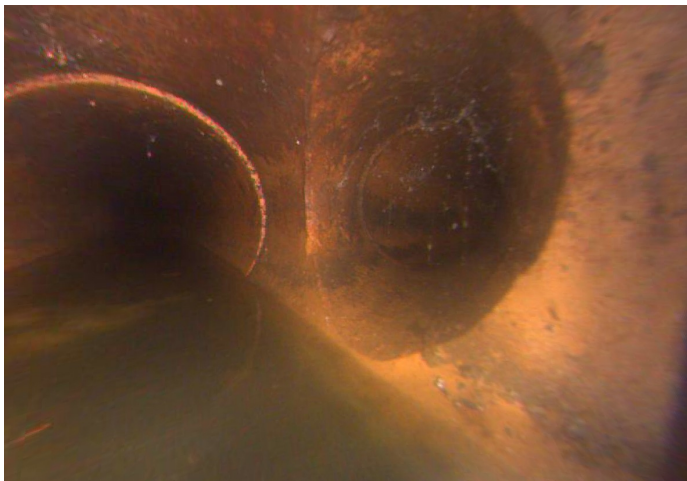
Code:	TF
Description:	Tap Factory
Distance (ft):	9.4
Structural Grade:	0
O&M Grade:	0
Clock Start/From:	3
Clock To:	
1st Value:	6.000
2nd Value:	
Value Percent:	
Continuous Index:	
Within 8" of Joint:	
Remarks:

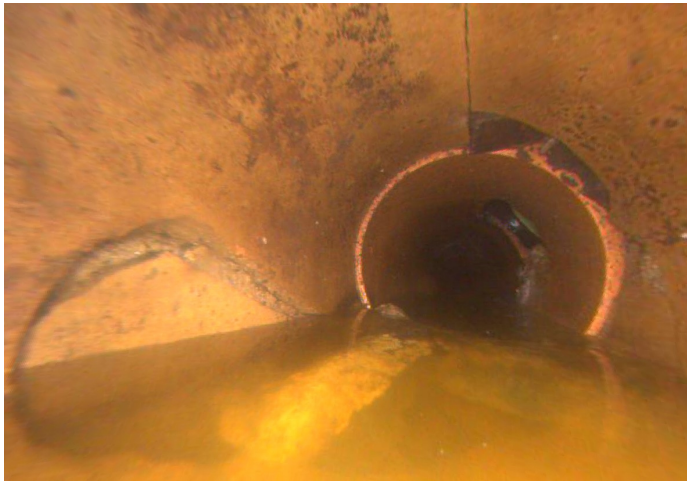
Code: **B**
Description: **Broken**

Distance (ft): **47.6**
Structural Grade: **5**
O&M Grade: **0**
Clock Start/From: **12**
Clock To: **8**
1st Value:
2nd Value:
Value Percent:
Continuous Index:
Within 8" of Joint: **YES**
Remarks:

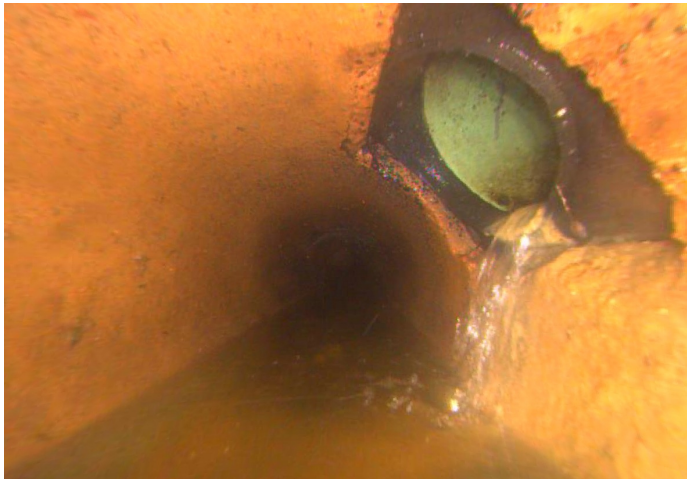
Code: **TBA**
Description: **Tap Break-in Active**

Distance (ft): **49.0**
Structural Grade: **0**
O&M Grade: **0**
Clock Start/From: **2**
Clock To:
1st Value: **6.000**
2nd Value:
Value Percent:
Continuous Index:
Within 8" of Joint:
Remarks:

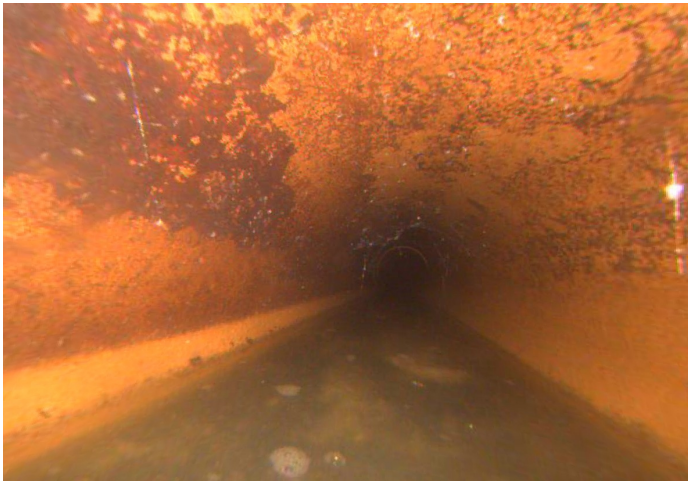
Code:	MSA
Description:	Abandoned Survey
Distance (ft):	67.3
Structural Grade:	0
O&M Grade:	0
Clock Start/From:	
Clock To:	
1st Value:	
2nd Value:	
Value Percent:	
Continuous Index:	
Within 8" of Joint:	NO
Remarks:	Unknown
