Profile/Photo Observation Report

Street:	Hobart Rd.	Flow Control:	Not Controlled
City:	Hobart, IN	Year Renewed:	
Location:	Light Highway	Tape/Media #:	
Purpose:	Routine Assessment	Dia/Height:	10"
Use:	Sanitary	Material:	VCP
Drain Area:	NA	Lining:	
Category:	NA		
Comment:

Location Details:		Direction of Survey:	Upstream
US MH:	M-903-002	DS MH:	M-903-001
		Total Length Surveyed (ft):	67.3

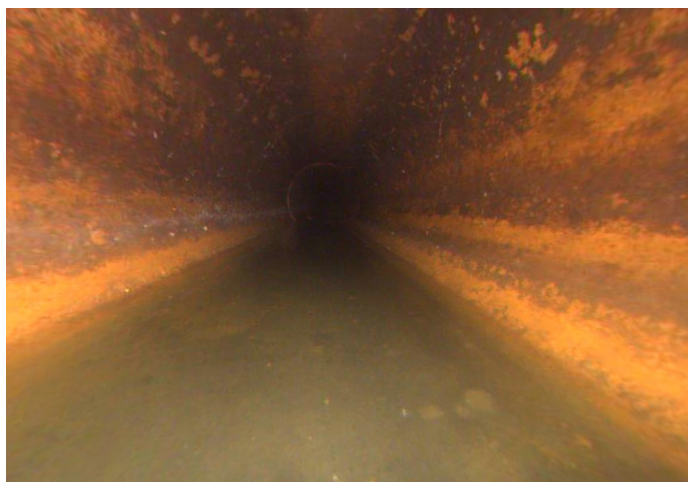
Code: **AMH**
Description: **Manhole**

Distance (ft): **.0**
Structural Grade: **0**
O&M Grade: **0**
Clock Start/From:
Clock To:
1st Value:
2nd Value:
Value Percent:
Continuous Index:
Within 8" of Joint: **NO**
Remarks: **M-903-001**

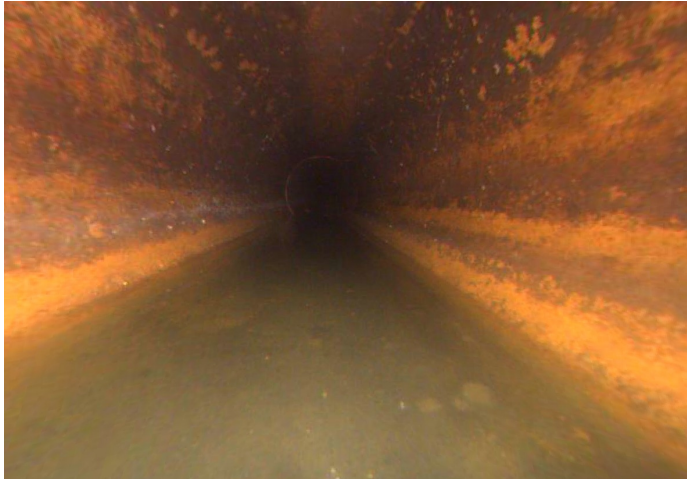
Code: **MWL**
Description: **Water Level**

Distance (ft): **.0**
Structural Grade: **0**
O&M Grade: **0**
Clock Start/From:
Clock To:
1st Value:
2nd Value:
Value Percent: **20.000**
Continuous Index:
Within 8" of Joint: **NO**
Remarks:

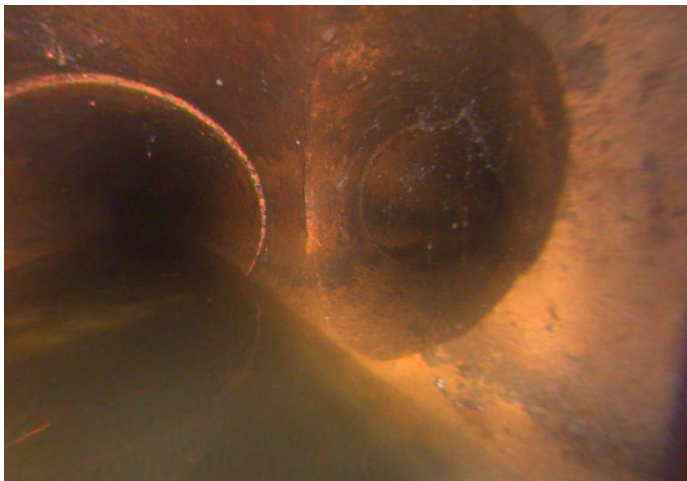
Code: **TF**
Description: **Tap Factory**

Distance (ft): **9.4**
Structural Grade: **0**
O&M Grade: **0**
Clock Start/From: **3**
Clock To:
1st Value: **6.000**
2nd Value:
Value Percent:
Continuous Index:
Within 8" of Joint:
Remarks:

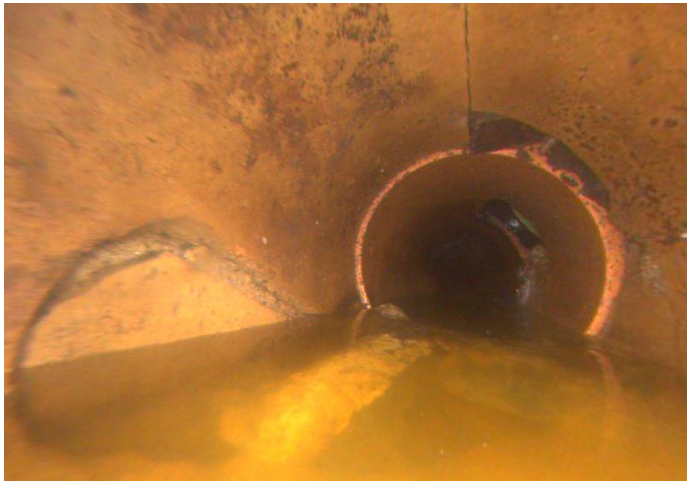
Code: **B**
Description: **Broken**

Distance (ft): **47.6**
Structural Grade: **5**
O&M Grade: **0**
Clock Start/From: **12**
Clock To: **8**
1st Value:
2nd Value:
Value Percent:
Continuous Index:
Within 8" of Joint: **YES**
Remarks:

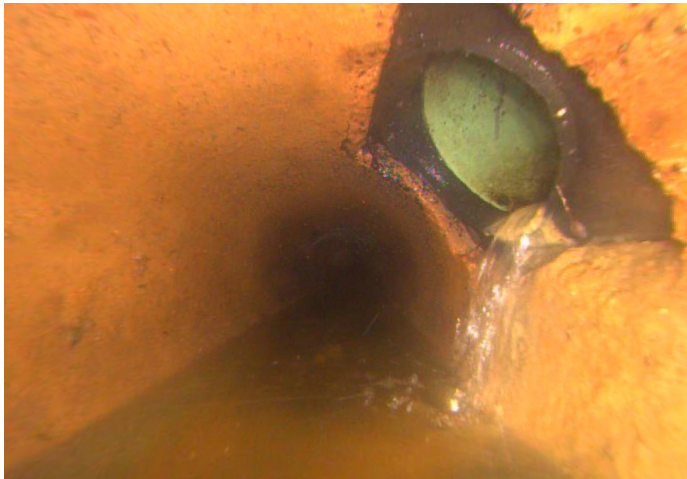
Code: **TBA**
Description: **Tap Break-in Active**

Distance (ft): **49.0**
Structural Grade: **0**
O&M Grade: **0**
Clock Start/From: **2**
Clock To:
1st Value: **6.000**
2nd Value:
Value Percent:
Continuous Index:
Within 8" of Joint:
Remarks:

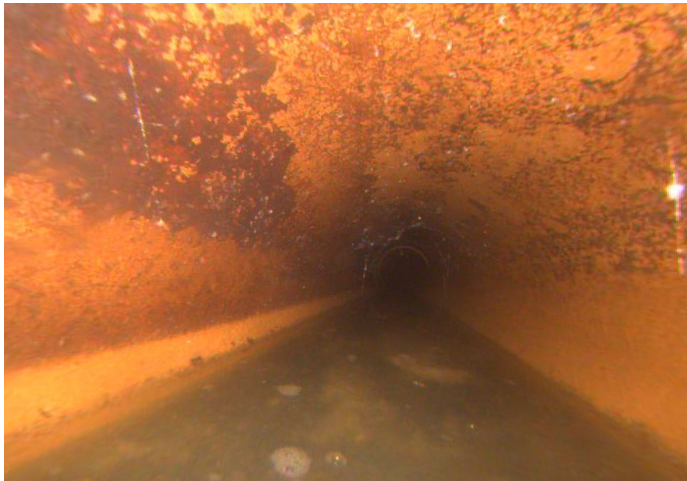
Code:	MSA
Description:	Abandoned Survey
Distance (ft):	67.3
Structural Grade:	0
O&M Grade:	0
Clock Start/From:	
Clock To:	
1st Value:	
2nd Value:	
Value Percent:	
Continuous Index:	
Within 8" of Joint:	NO
Remarks:	Unknown
