Profile/Photo Observation Report

| Street: | N SHELBY PL | Flow Control: | Not Controlled |
| City: | Hobart, IN | Year Renewed: | |

| US MH: | M-903-003 | DS MH: | M-903-004 |

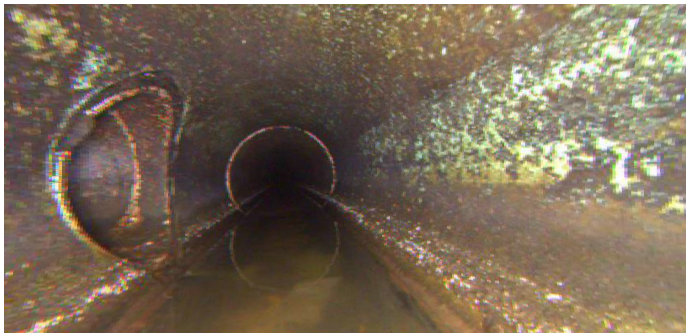
| Code: | MWL |
| Description: | Water Level |

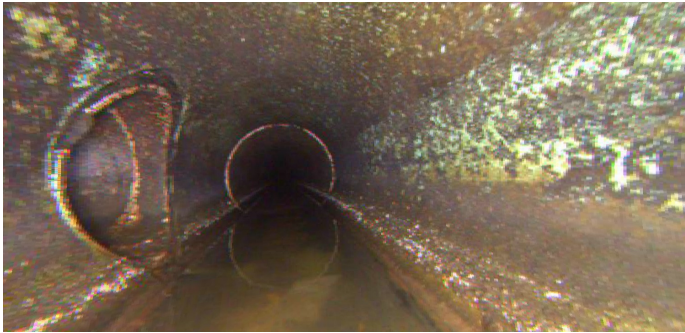
| Value Percent: | 10.000 |

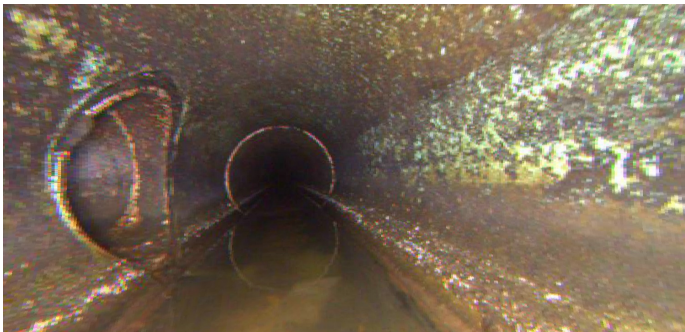
| Code: | DAZ |
| Description: | Deposits Attached Other |

| O&M Grade: | 2 |
| Clock Start/From: | 7 |
| Clock To: | 5 |
| Value Percent: | 5.000 |
| Remarks: | WANDER |

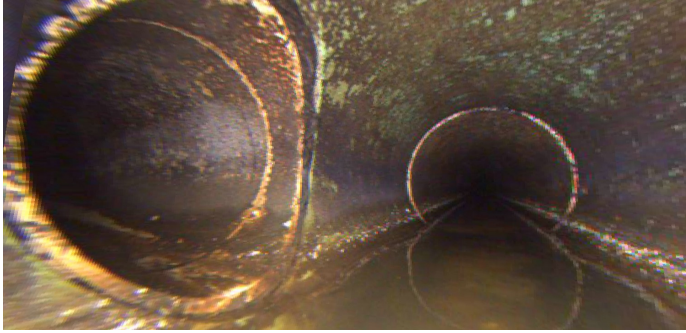
Code: **TF**
Description: **Tap Factory**

Distance (ft): **1.1**
Structural Grade: **0**
O&M Grade: **0**
Clock Start/From: **9**
Clock To:
1st Value: **4.000**
2nd Value:
Value Percent:
Continuous Index:
Within 8" of Joint:
Remarks:

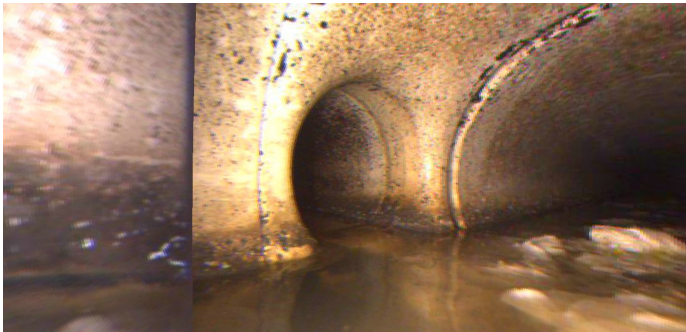
Code: **TF**
Description: **Tap Factory**

Distance (ft): **77.3**
Structural Grade: **0**
O&M Grade: **0**
Clock Start/From: **9**
Clock To:
1st Value: **4.000**
2nd Value:
Value Percent:
Continuous Index:
Within 8" of Joint:
Remarks:

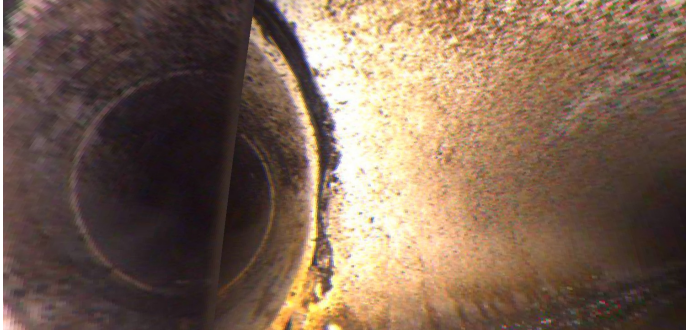
Code: **TF**
Description: **Tap Factory**

Distance (ft): **95.2**
Structural Grade: **0**
O&M Grade: **0**
Clock Start/From: **9**
Clock To:
1st Value: **4.000**
2nd Value:
Value Percent:
Continuous Index:
Within 8" of Joint:
Remarks:

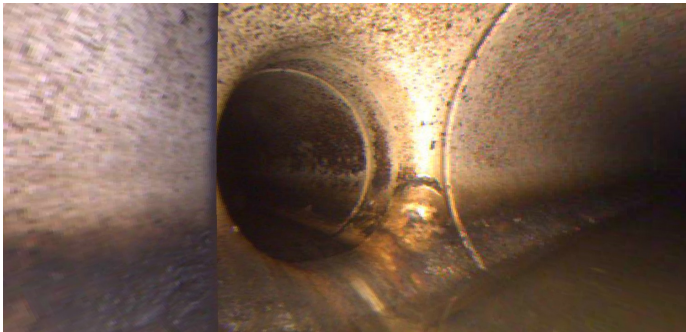
Code: **TF**
Description: **Tap Factory**

Distance (ft): **140.3**
Structural Grade: **0**
O&M Grade: **0**
Clock Start/From: **9**
Clock To:
1st Value: **4.000**
2nd Value:
Value Percent:
Continuous Index:
Within 8" of Joint:
Remarks:

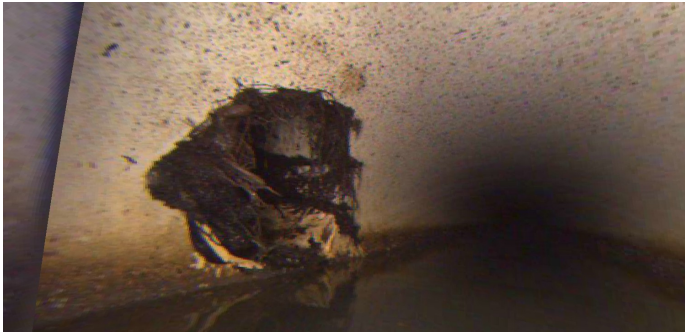
| | Position | Code | Observation | Video (sec) | Grade |
|---|---|---|---|---|---|
| | 171.3 | TFD | Tap Factory Defective | 437 | M 2 |

Code: **TFD**
Description: **Tap Factory Defective**

Distance (ft): **171.3**
Structural Grade: **0**
O&M Grade: **2**
Clock Start/From: **9**
Clock To:
1st Value: **4.000**
2nd Value:
Value Percent:
Continuous Index:
Within 8" of Joint: **NO**
Remarks: **ROOTS SURROUNDING MOUTH OF TAP**

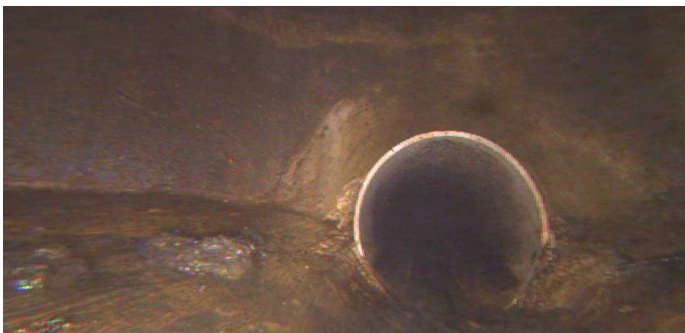
Code: **AMH**
Description: **Manhole**

Distance (ft): **196.1**
Structural Grade: **0**
O&M Grade: **0**
Clock Start/From:
Clock To:
1st Value:
2nd Value:
Value Percent:
Continuous Index:
Within 8" of Joint: **NO**
Remarks: **M-903-004**

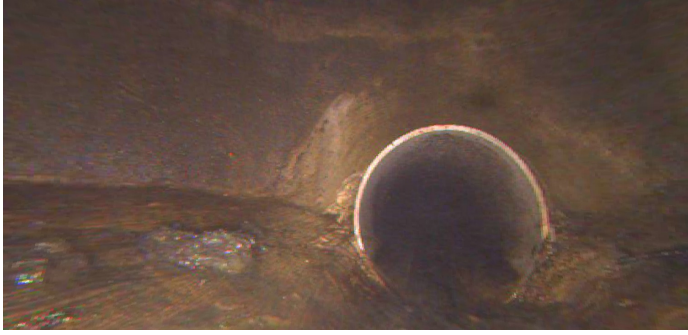
| Code: | DAZ |
| Description: | Deposits Attached Other |
| Distance (ft): | 196.1 |
| O&M Grade: | 2 |
| Value Percent: | 5.000 |
| Remarks: | WANDER |
