Profile/Photo Observation Report

| Street: | e 38th ave | Flow Control: | Not Controlled |
| City: | Hobart, IN | Year Renewed: | |

| US MH: | M-903-003 | DS MH: | M-903-004 |

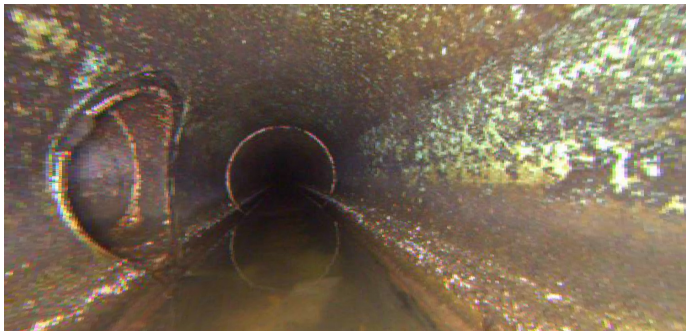
Code: **AMH**
Description: **Manhole**

Distance (ft): **.0**
Structural Grade: **0**
O&M Grade: **0**
Clock Start/From:
Clock To:
1st Value:
2nd Value:
Value Percent:
Continuous Index:
Within 8" of Joint: **NO**
Remarks: **M-903-003**

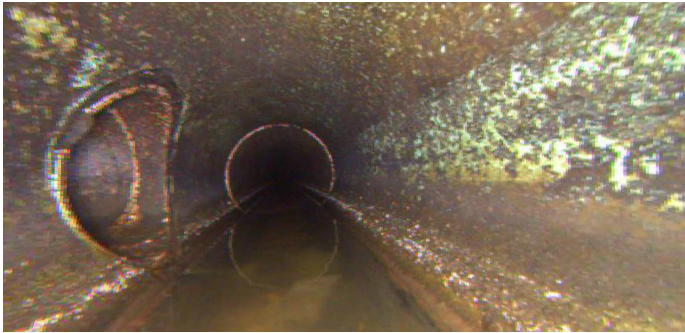
| Description: | Water Level |

| Value Percent: | 10.000 |

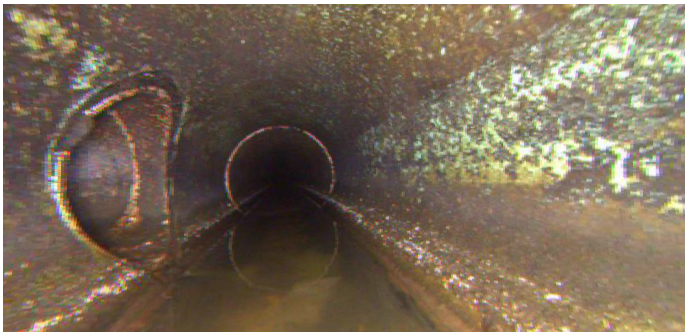
| Description: | Deposits Attached Other |

| O&M Grade: | 2 |
| Value Percent: | 5.000 |
| Remarks: | WANDER |

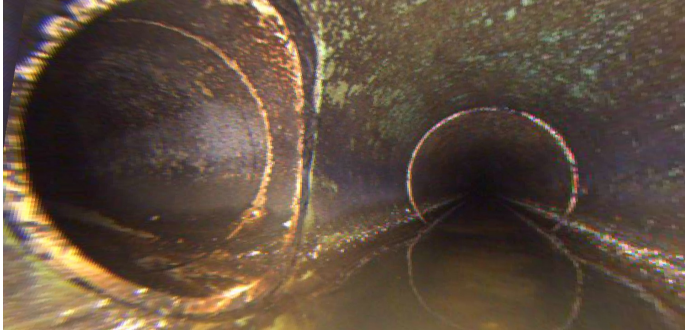
Code: **TF**
Description: **Tap Factory**

Distance (ft): **1.1**
Structural Grade: **0**
O&M Grade: **0**
Clock Start/From: **9**
Clock To:
1st Value: **4.000**
2nd Value:
Value Percent:
Continuous Index:
Within 8" of Joint:
Remarks:

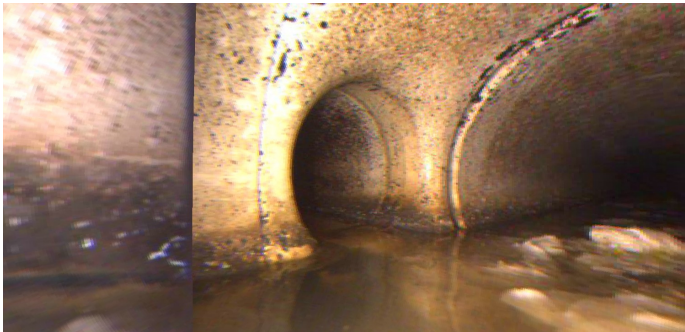
Code: **TF**
Description: **Tap Factory**

Distance (ft): **77.3**
Structural Grade: **0**
O&M Grade: **0**
Clock Start/From: **9**
Clock To:
1st Value: **4.000**
2nd Value:
Value Percent:
Continuous Index:
Within 8" of Joint:
Remarks:

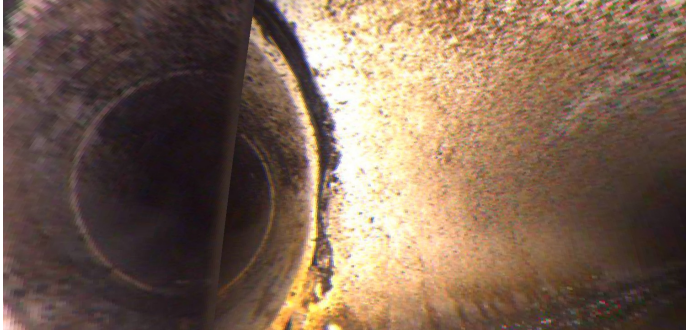
Code: **TF**
Description: **Tap Factory**

Distance (ft): **95.2**
Structural Grade: **0**
O&M Grade: **0**
Clock Start/From: **9**
Clock To:
1st Value: **4.000**
2nd Value:
Value Percent:
Continuous Index:
Within 8" of Joint:
Remarks:

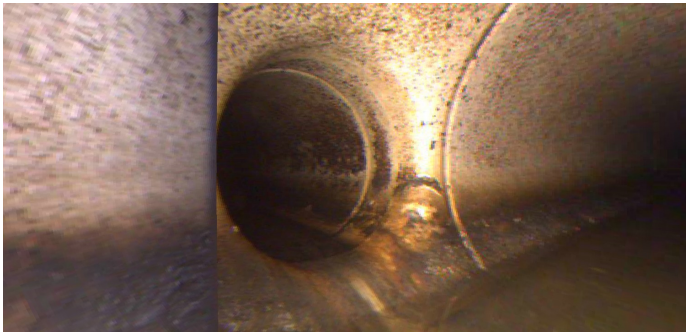
Code: **TF**
Description: **Tap Factory**

Distance (ft): **140.3**
Structural Grade: **0**
O&M Grade: **0**
Clock Start/From: **9**
Clock To:
1st Value: **4.000**
2nd Value:
Value Percent:
Continuous Index:
Within 8" of Joint:
Remarks:

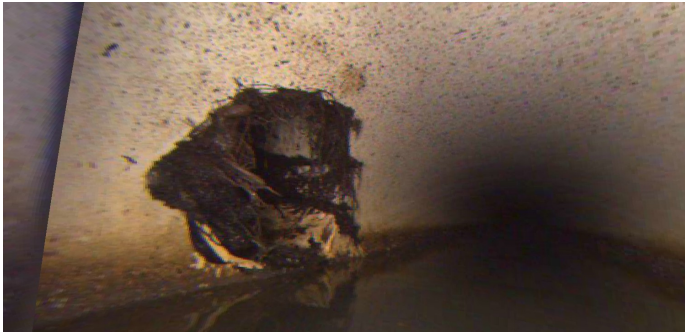
Code: **TFD**
Description: **Tap Factory Defective**

Distance (ft): **171.3**
Structural Grade: **0**
O&M Grade: **2**
Clock Start/From: **9**
Clock To:
1st Value: **4.000**
2nd Value:
Value Percent:
Continuous Index:
Within 8" of Joint: **NO**
Remarks: **ROOTS SURROUNDING MOUTH OF TAP**

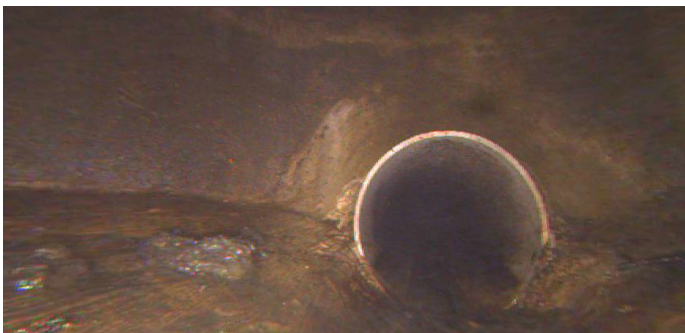
Code: **AMH**
Description: **Manhole**

Distance (ft): **196.1**
Structural Grade: **0**
O&M Grade: **0**
Clock Start/From:
Clock To:
1st Value:
2nd Value:
Value Percent:
Continuous Index:
Within 8" of Joint: **NO**
Remarks: **M-903-004**

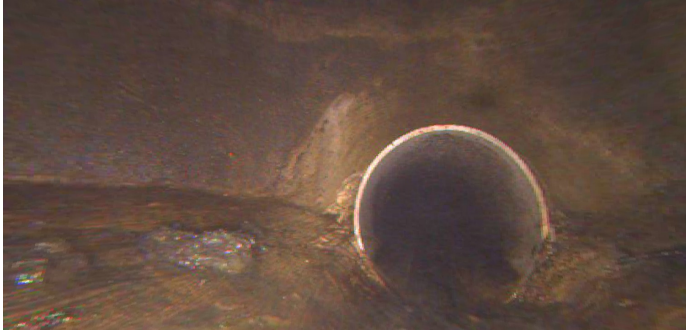
| Description: | Deposits Attached Other |
| O&M Grade: | 2 |
| Value Percent: | 5.000 |
| Remarks: | WANDER |
