Profile/Photo Observation Report

Date:	03/23/2018	Weather:		Coding:	PACP 6.0
Pipe Length (ft):	189.9	Owner:	NA	Pre Clean:	Not Known
P.O.#:		Surveyor:	Jen Costello	PSR:	P-903-003-004
Customer:		Clean Date:	01/01/1900	Shape:	C

Street:	N SHELBY PL	Flow Control:	Not Controlled
City:	Hobart, IN	Year Renewed:	
Location:	Other	Tape/Media #:	
Purpose:	Not Known	Dia/Height:	10"
Use:	Sanitary	Material:	PVC
Drain Area:	NA	Lining:	
Category:	NA		
Comment:

Location Details:		Direction of Survey:	Upstream
US MH:	M-903-003	DS MH:	M-903-004
		Total Length Surveyed (ft):	192.2

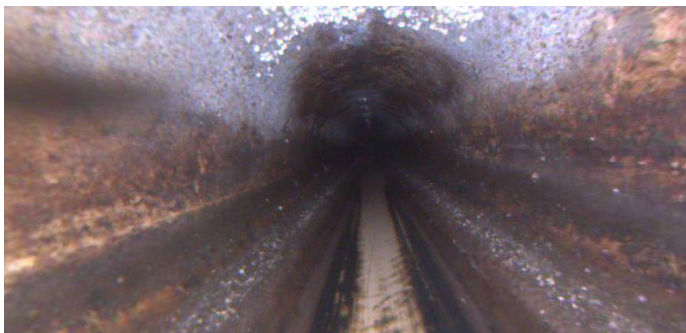
Code: **AMH**
Description: **Manhole**

Distance (ft): **.0**
Structural Grade: **0**
O&M Grade: **0**
Clock Start/From:
Clock To:
1st Value:
2nd Value:
Value Percent:
Continuous Index:
Within 8" of Joint: **NO**
Remarks: **M-903-004**

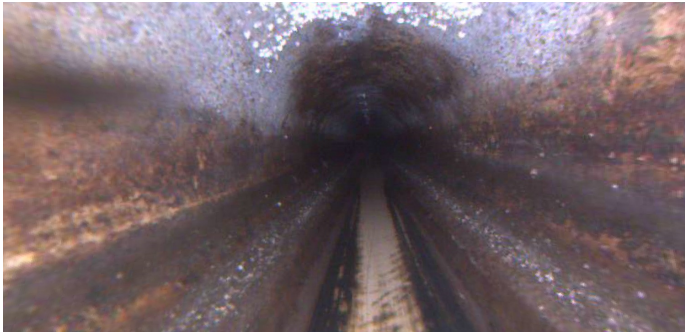
Code:	MWL
Description:	Water Level

Distance (ft):	.0
Structural Grade:	0
O&M Grade:	0
Clock Start/From:	
Clock To:	
1st Value:	
2nd Value:	
Value Percent:	5.000
Continuous Index:	
Within 8" of Joint:	NO
Remarks:

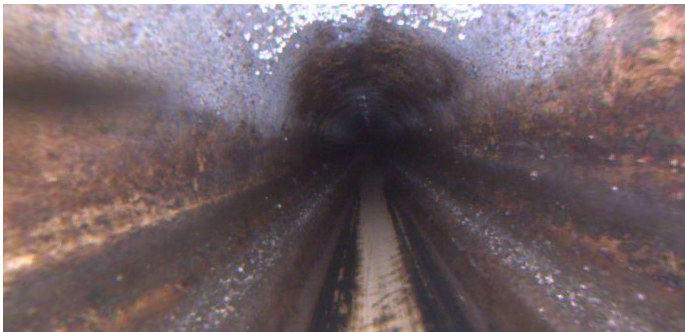
Code:	DAGS
Description:	Deposits Attached Grease

Distance (ft):	.0
Structural Grade:	0
O&M Grade:	2
Clock Start/From:	8
Clock To:	4
1st Value:	
2nd Value:	
Value Percent:	5.000
Continuous Index:	S01
Within 8" of Joint:	NO
Remarks:

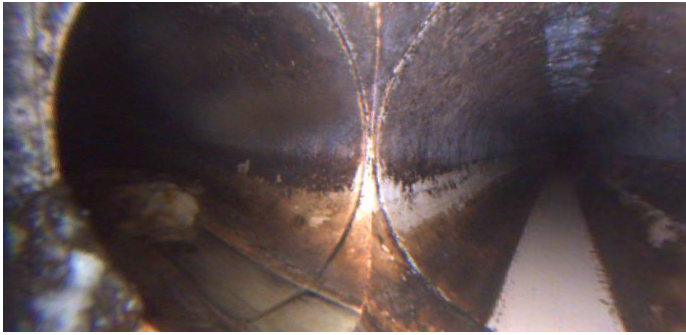
Code: **TFA**
Description: **Tap Factory Active**

Distance (ft): **25.4**
Structural Grade: **0**
O&M Grade: **0**
Clock Start/From: **9**
Clock To:
1st Value: **4.000**
2nd Value:
Value Percent:
Continuous Index:
Within 8" of Joint:
Remarks:

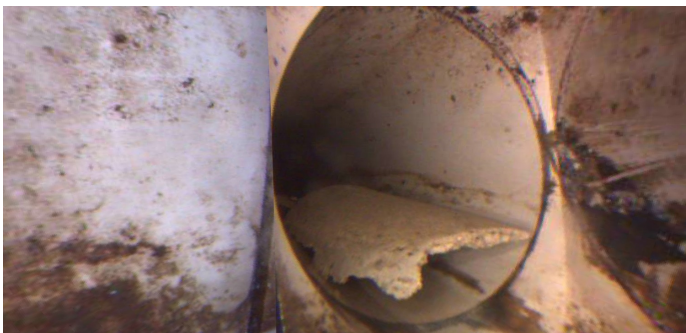
Code: **TFD**
Description: **Tap Factory Defective**

Distance (ft): **91.4**
Structural Grade: **0**
O&M Grade: **2**
Clock Start/From: **3**
Clock To:
1st Value: **4.000**
2nd Value:
Value Percent:
Continuous Index:
Within 8" of Joint:
Remarks: **debris**

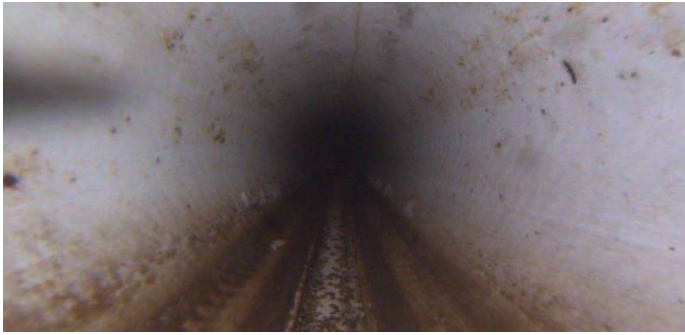
Code: **DAGS**
Description: **Deposits Attached Grease**

Distance (ft): **119.2**
Structural Grade: **0**
O&M Grade: **2**
Clock Start/From: **8**
Clock To: **4**
1st Value:
2nd Value:
Value Percent: **5.000**
Continuous Index: **F01**
Within 8" of Joint: **NO**
Remarks:

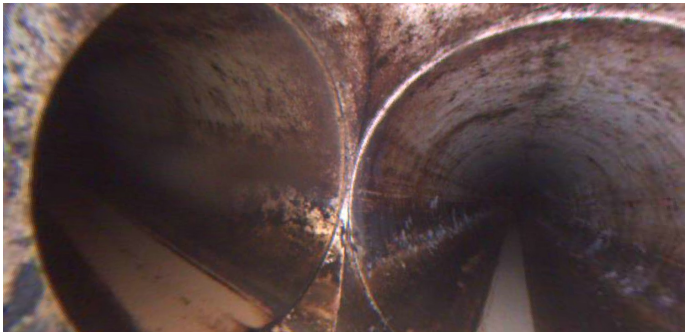
Code: **TFA**
Description: **Tap Factory Active**

Distance (ft): **143.2**
Structural Grade: **0**
O&M Grade: **0**
Clock Start/From: **9**
Clock To:
1st Value: **4.000**
2nd Value:
Value Percent:
Continuous Index:
Within 8" of Joint:
Remarks:

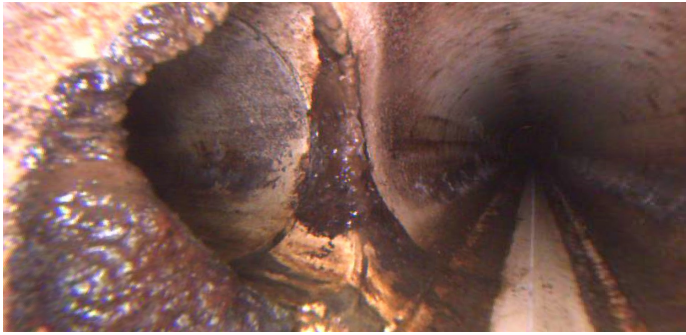
Code: **TFD**
Description: **Tap Factory Defective**

Distance (ft): **149.8**
Structural Grade: **0**
O&M Grade: **2**
Clock Start/From: **3**
Clock To:
1st Value: **4.000**
2nd Value:
Value Percent:
Continuous Index:
Within 8" of Joint:
Remarks: **dae**

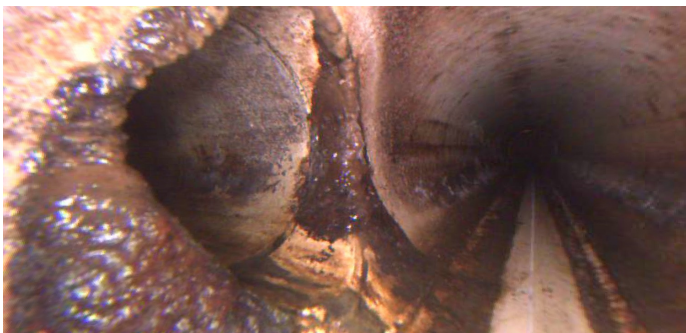
Code: **DAE**
Description: **Deposits Attached Encrustation**

Distance (ft): **149.8**
Structural Grade: **0**
O&M Grade: **5**
Clock Start/From: **1**
Clock To: **3**
1st Value:
2nd Value:
Value Percent: **40.000**
Continuous Index:
Within 8" of Joint: **NO**
Remarks:

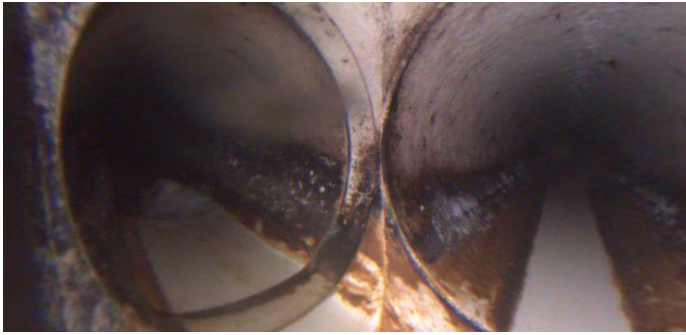
Code: **TFA**
Description: **Tap Factory Active**

Distance (ft): **182.7**
Structural Grade: **0**
O&M Grade: **0**
Clock Start/From: **9**
Clock To:
1st Value: **4.000**
2nd Value:
Value Percent:
Continuous Index:
Within 8" of Joint:
Remarks:

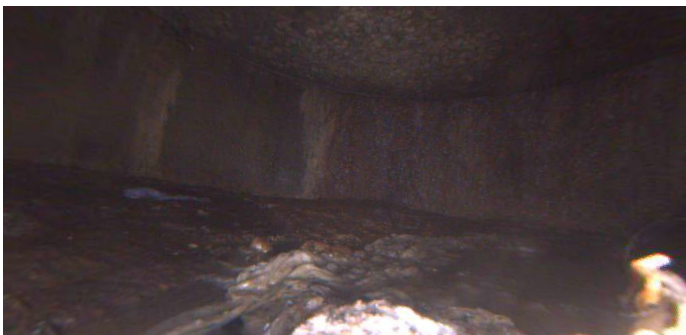
Code: **AMH**
Description: **Manhole**

Distance (ft): **192.2**
Structural Grade: **0**
O&M Grade: **0**
Clock Start/From:
Clock To:
1st Value:
2nd Value:
Value Percent:
Continuous Index:
Within 8" of Joint: **NO**
Remarks: **M-903-003**
