Profile/Photo Observation Report

Date:	03/23/2018	Weather:		Coding:	PACP 6.0
Pipe Length (ft):	189.9	Owner:	NA	Pre Clean:	Not Known
P.O.#:		Surveyor:	Jen Costello	PSR:	P-903-003-004
Customer:		Clean Date:	01/01/1900	Shape:	C

Street:	e 38th ave	Flow Control:	Not Controlled
City:	Hobart, IN	Year Renewed:	
Location:	Other	Tape/Media #:	
Purpose:	Not Known	Dia/Height:	10"
Use:	Sanitary	Material:	PVC
Drain Area:	NA	Lining:	
Category:	NA		
Comment:

Location Details:		Direction of Survey:	Upstream
US MH:	M-903-003	DS MH:	M-903-004
		Total Length Surveyed (ft):	192.2

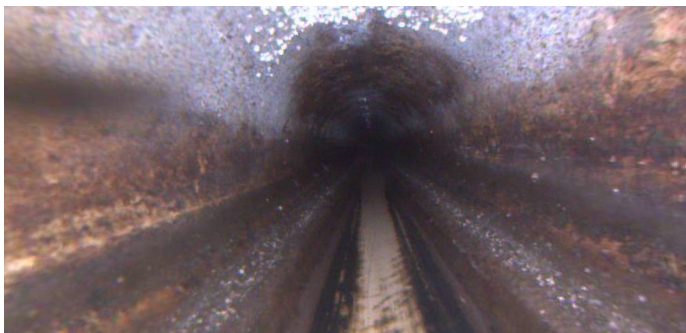
Code: **AMH**
Description: **Manhole**

Distance (ft): **.0**
Structural Grade: **0**
O&M Grade: **0**
Clock Start/From:
Clock To:
1st Value:
2nd Value:
Value Percent:
Continuous Index:
Within 8" of Joint: **NO**
Remarks: **M-903-004**

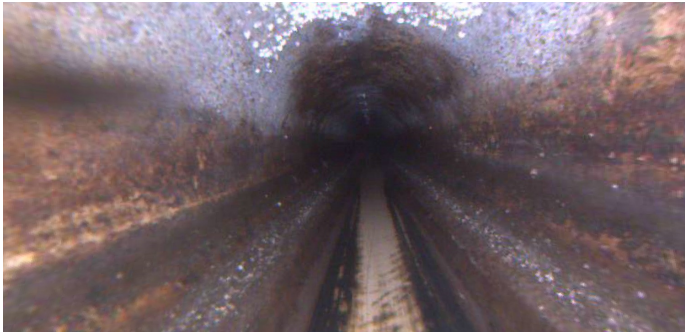
Code:	MWL
Description:	Water Level

Distance (ft):	.0
Structural Grade:	0
O&M Grade:	0
Clock Start/From:	
Clock To:	
1st Value:	
2nd Value:	
Value Percent:	5.000
Continuous Index:	
Within 8" of Joint:	NO
Remarks:

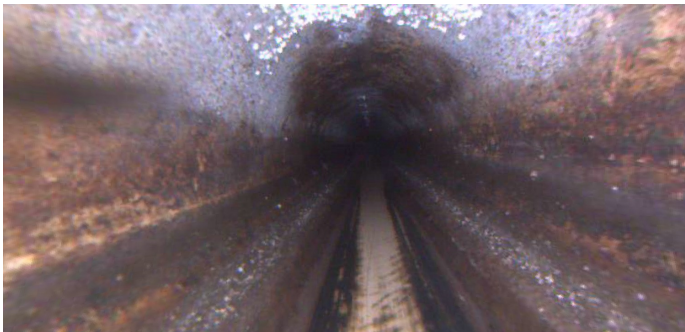
Code:	DAGS
Description:	Deposits Attached Grease

Distance (ft):	.0
Structural Grade:	0
O&M Grade:	2
Clock Start/From:	8
Clock To:	4
1st Value:	
2nd Value:	
Value Percent:	5.000
Continuous Index:	S01
Within 8" of Joint:	NO
Remarks:

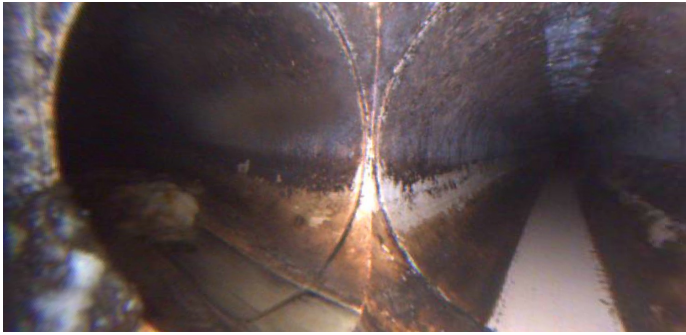
Code: **TFA**
Description: **Tap Factory Active**

Distance (ft): **25.4**
Structural Grade: **0**
O&M Grade: **0**
Clock Start/From: **9**
Clock To:
1st Value: **4.000**
2nd Value:
Value Percent:
Continuous Index:
Within 8" of Joint:
Remarks:

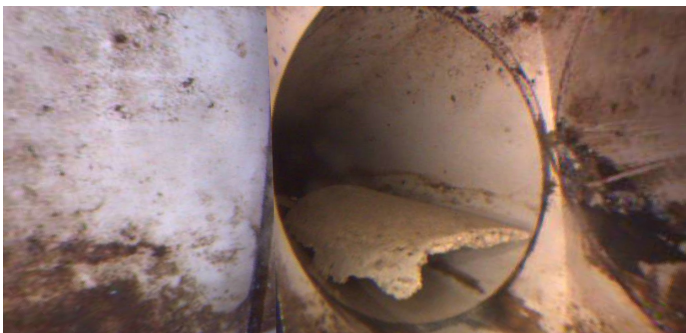
Code: **TFD**
Description: **Tap Factory Defective**

Distance (ft): **91.4**
Structural Grade: **0**
O&M Grade: **2**
Clock Start/From: **3**
Clock To:
1st Value: **4.000**
2nd Value:
Value Percent:
Continuous Index:
Within 8" of Joint:
Remarks: **debris**

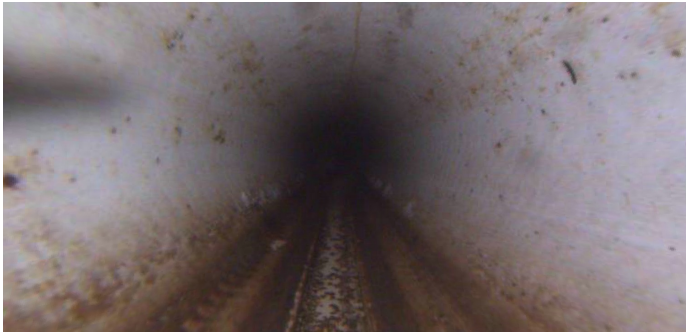
Code: **DAGS**
Description: **Deposits Attached Grease**

Distance (ft): **119.2**
Structural Grade: **0**
O&M Grade: **2**
Clock Start/From: **8**
Clock To: **4**
1st Value:
2nd Value:
Value Percent: **5.000**
Continuous Index: **F01**
Within 8" of Joint: **NO**
Remarks:

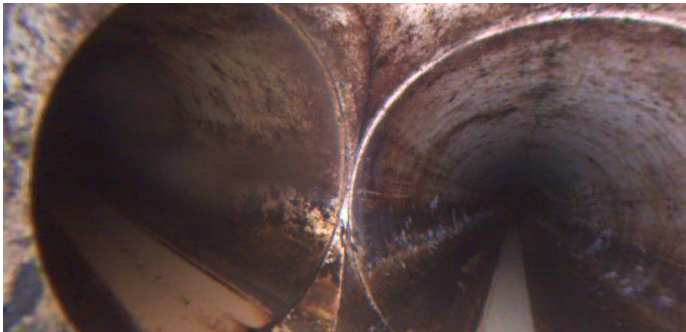
Code: **TFA**
Description: **Tap Factory Active**

Distance (ft): **143.2**
Structural Grade: **0**
O&M Grade: **0**
Clock Start/From: **9**
Clock To:
1st Value: **4.000**
2nd Value:
Value Percent:
Continuous Index:
Within 8" of Joint:
Remarks:

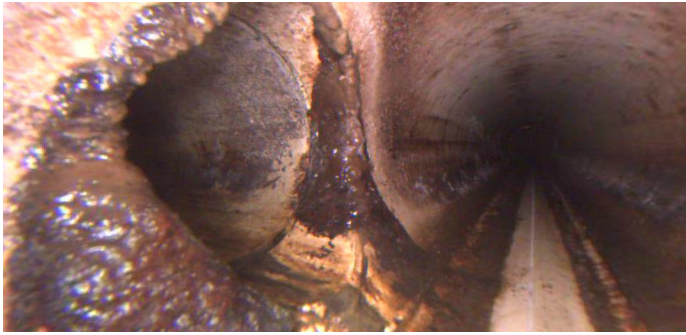
Code: **TFD**
Description: **Tap Factory Defective**

Distance (ft): **149.8**
Structural Grade: **0**
O&M Grade: **2**
Clock Start/From: **3**
Clock To:
1st Value: **4.000**
2nd Value:
Value Percent:
Continuous Index:
Within 8" of Joint:
Remarks: **dae**

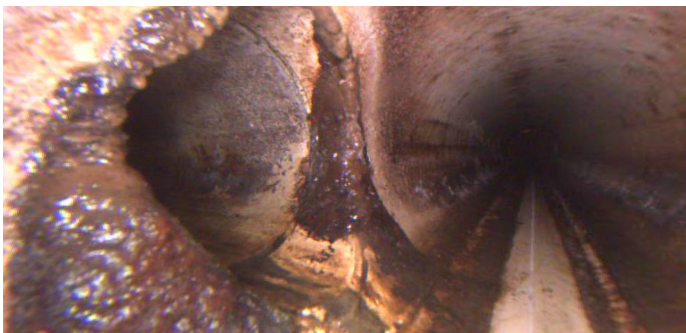
Code: **DAE**
Description: **Deposits Attached Encrustation**

Distance (ft): **149.8**
Structural Grade: **0**
O&M Grade: **5**
Clock Start/From: **1**
Clock To: **3**
1st Value:
2nd Value:
Value Percent: **40.000**
Continuous Index:
Within 8" of Joint: **NO**
Remarks:

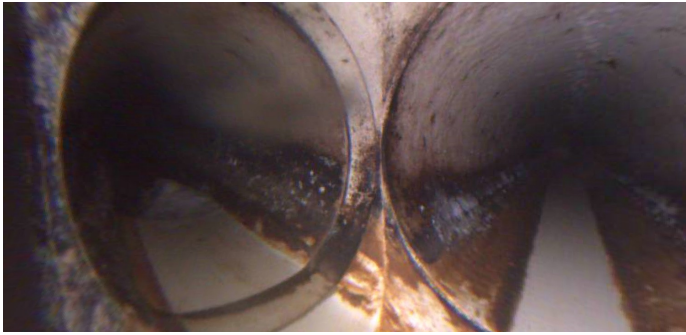
Code: **TFA**
Description: **Tap Factory Active**

Distance (ft): **182.7**
Structural Grade: **0**
O&M Grade: **0**
Clock Start/From: **9**
Clock To:
1st Value: **4.000**
2nd Value:
Value Percent:
Continuous Index:
Within 8" of Joint:
Remarks:

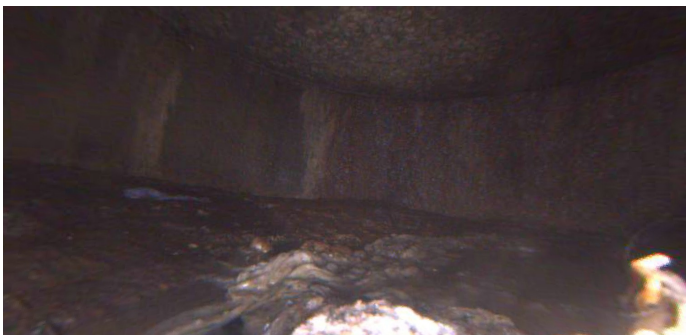
Code: **AMH**
Description: **Manhole**

Distance (ft): **192.2**
Structural Grade: **0**
O&M Grade: **0**
Clock Start/From:
Clock To:
1st Value:
2nd Value:
Value Percent:
Continuous Index:
Within 8" of Joint: **NO**
Remarks: **M-903-003**
