Profile/Photo Observation Report

| P.O.#: | | Surveyor: | Justin Gonzales | PSR: | P-903-005-006 |

| Street: | E 38TH AVE & SPENCER PL | Flow Control: | Not Controlled |

| US MH: | M-903-005 | DS MH: | M-903-006 |

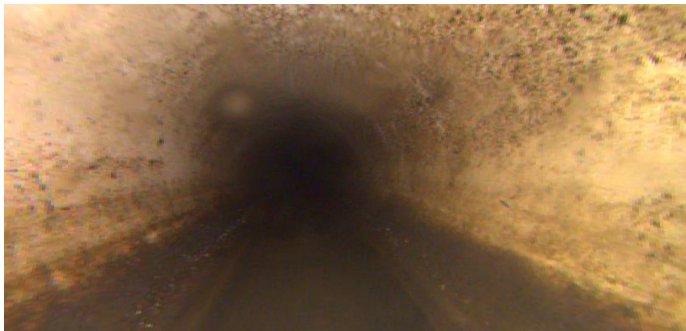
Code: **AMH**
Description: **Manhole**

Distance (ft): **.0**
Structural Grade: **0**
O&M Grade: **0**
Clock Start/From:
Clock To:
1st Value:
2nd Value:
Value Percent:
Continuous Index:
Within 8" of Joint: **NO**
Remarks: **M-903-006**

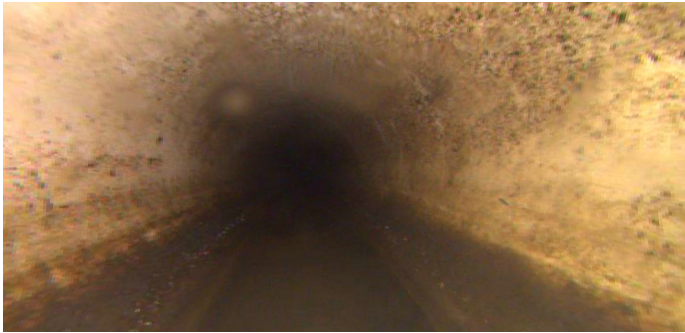
| Code: | MWL |
| Description: | Water Level |

| Distance (ft): | .0 |
| Value Percent: | 5.000 |

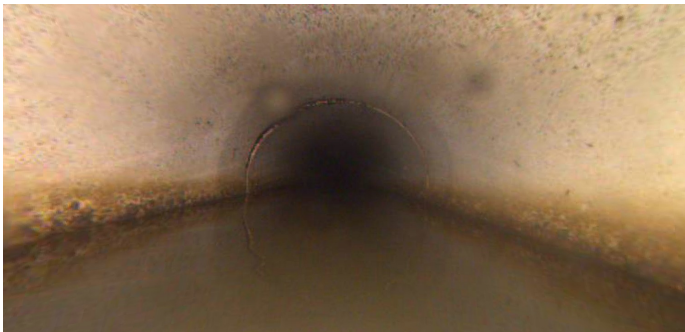
| Code: | MWL |
| Description: | Water Level |

| Distance (ft): | 35.1 |
| Value Percent: | 30.000 |

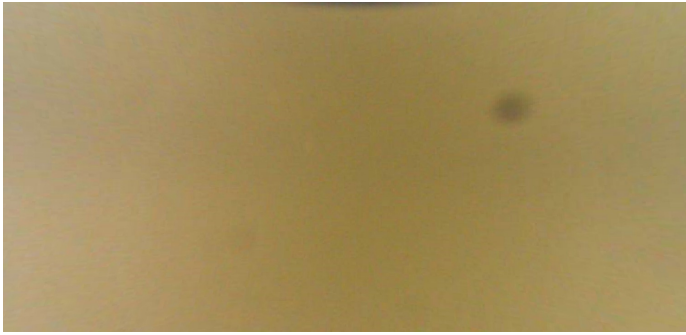
| | Position | Code | Observation | Video (sec) | Grade |
|--|---|---|---|---|---|
| | 75.7 | MCU | Camera Underwater | 195 | M 4 |

Code: **MCU**
Description: **Camera Underwater**

Distance (ft): **75.7**
Structural Grade: **0**
O&M Grade: **4**
Clock Start/From:
Clock To:
1st Value:
2nd Value:
Value Percent:
Continuous Index:
Within 8" of Joint: **NO**
Remarks:

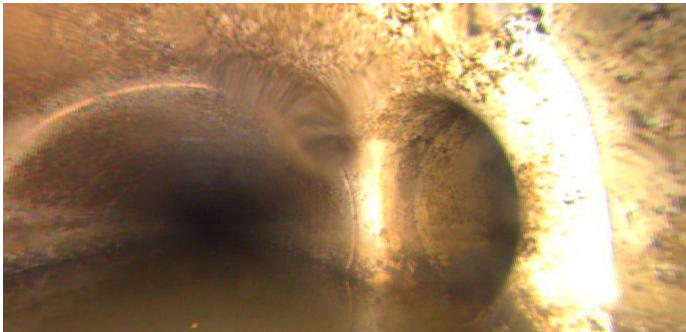
Code: **TF**
Description: **Tap Factory**

Distance (ft): **85.4**
Structural Grade: **0**
O&M Grade: **0**
Clock Start/From: **3**
Clock To:
1st Value: **4.000**
2nd Value:
Value Percent:
Continuous Index:
Within 8" of Joint:
Remarks:

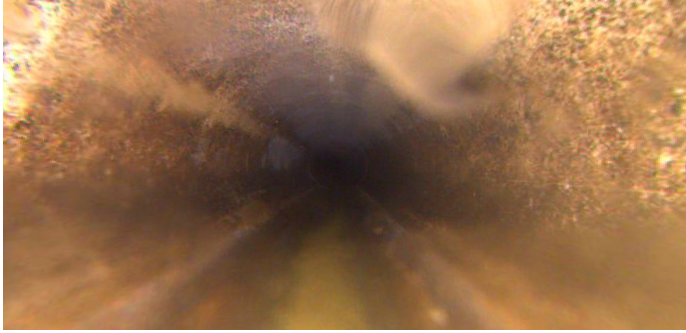
Code: **MWL**
Description: **Water Level**

Distance (ft): **106.5**
Structural Grade: **0**
O&M Grade: **0**
Clock Start/From:
Clock To:
1st Value:
2nd Value:
Value Percent: **5.000**
Continuous Index:
Within 8" of Joint: **NO**
Remarks:

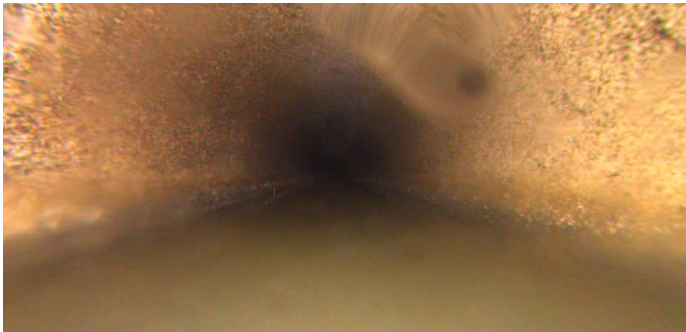
Code: **MWL**
Description: **Water Level**

Distance (ft): **128.0**
Structural Grade: **0**
O&M Grade: **0**
Clock Start/From:
Clock To:
1st Value:
2nd Value:
Value Percent: **20.000**
Continuous Index:
Within 8" of Joint: **NO**
Remarks:

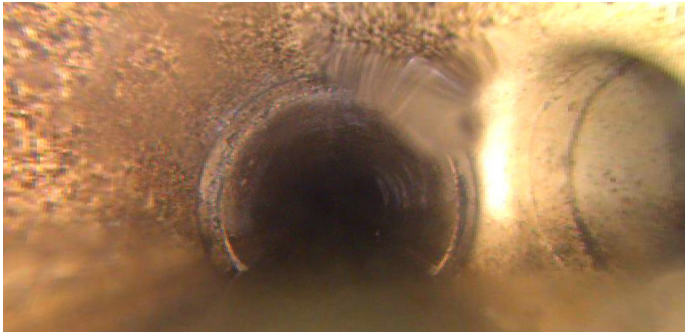
Code: **TF**
Description: **Tap Factory**

Distance (ft): **147.1**
Structural Grade: **0**
O&M Grade: **0**
Clock Start/From: **3**
Clock To:
1st Value: **4.000**
2nd Value:
Value Percent:
Continuous Index:
Within 8" of Joint:
Remarks:

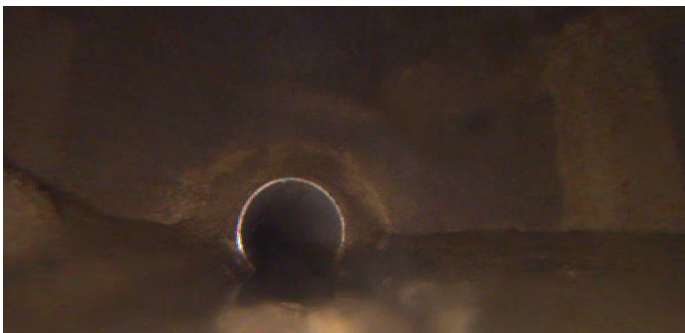
Code: **AMH**
Description: **Manhole**

Distance (ft): **157.3**
Structural Grade: **0**
O&M Grade: **0**
Clock Start/From:
Clock To:
1st Value:
2nd Value:
Value Percent:
Continuous Index:
Within 8" of Joint: **NO**
Remarks: **M-903-005**
