## Profile/Photo Observation Report

| Street: | <b>e 38th ave</b> | Flow Control: | <b>Not Controlled</b> |
| City: | <b>Hobart, IN</b> | Year Renewed: | |

| US MH: | <b>M-903-005</b> | DS MH: | <b>M-903-006</b> |

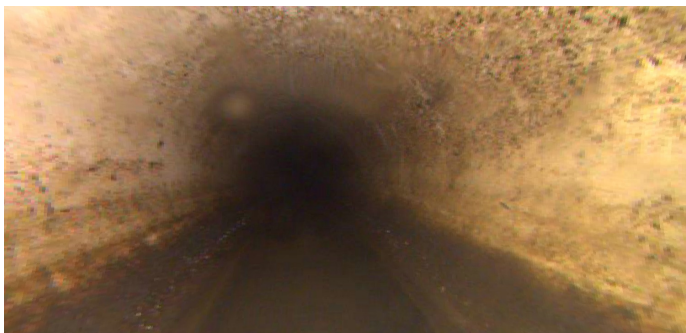
Code: **AMH**  
Description: **Manhole**

Distance (ft): **.0**  
Structural Grade: **0**  
O&M Grade: **0**  
Clock Start/From:  
Clock To:  
1st Value:  
2nd Value:  
Value Percent:  
Continuous Index:  
Within 8" of Joint: **NO**  
Remarks: **M-903-006**

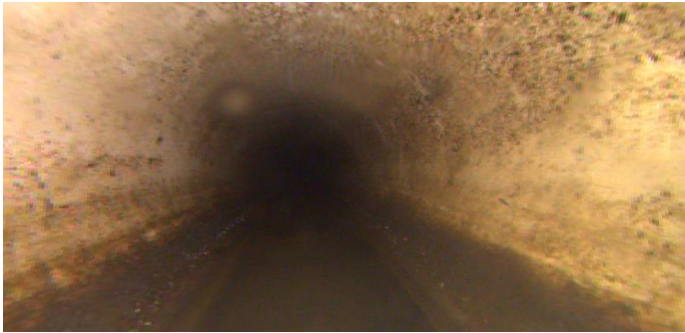
| Description: | <b>Water Level</b> |

| Value Percent: | <b>5.000</b> |

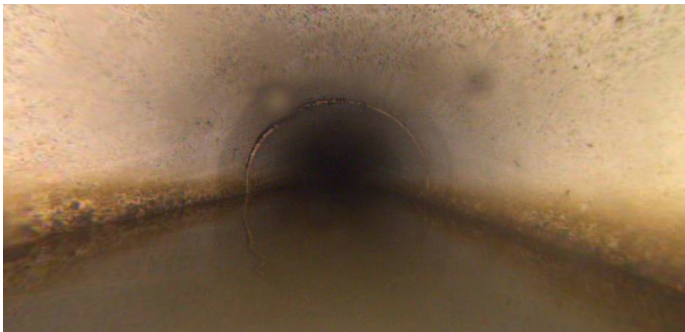
| Description: | <b>Water Level</b> |

| Value Percent: | <b>30.000</b> |

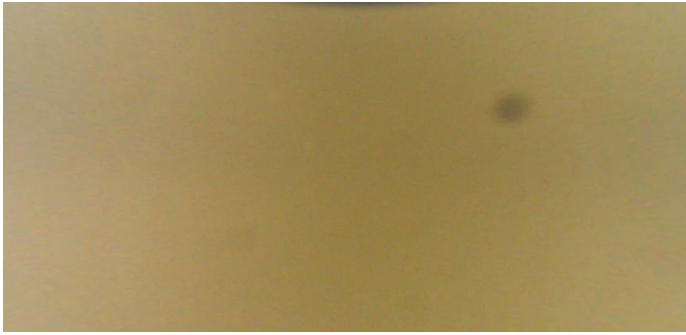
| | Position | Code | Observation | Video (sec) | Grade |
|--|---|---|---|---|---|
| | 75.7 | MCU | Camera Underwater | 195 | M 4 |

Code: **MCU**  
Description: **Camera Underwater**

Distance (ft): **75.7**  
Structural Grade: **0**  
O&M Grade: **4**  
Clock Start/From:  
Clock To:  
1st Value:  
2nd Value:  
Value Percent:  
Continuous Index:  
Within 8" of Joint: **NO**  
Remarks:

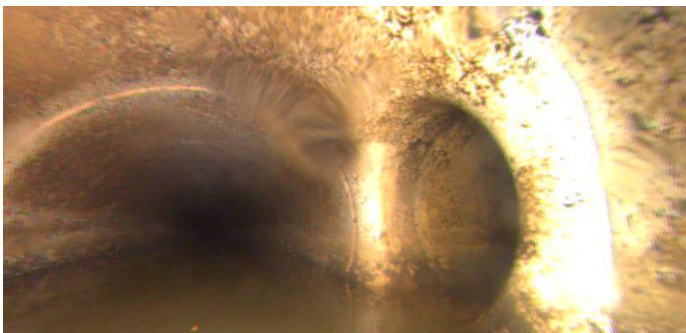
Code: **TF**  
Description: **Tap Factory**

Distance (ft): **85.4**  
Structural Grade: **0**  
O&M Grade: **0**  
Clock Start/From: **3**  
Clock To:  
1st Value: **4.000**  
2nd Value:  
Value Percent:  
Continuous Index:  
Within 8" of Joint:  
Remarks:

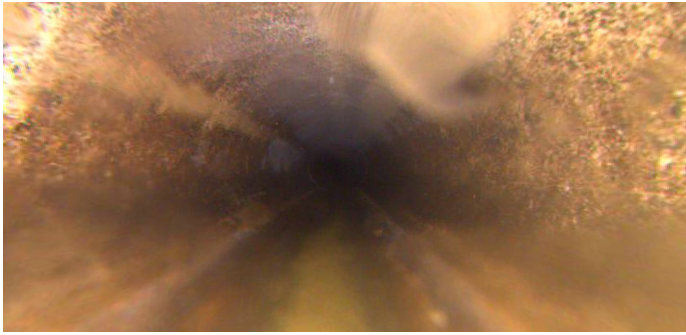
Code: **MWL**  
Description: **Water Level**

Distance (ft): **106.5**  
Structural Grade: **0**  
O&M Grade: **0**  
Clock Start/From:  
Clock To:  
1st Value:  
2nd Value:  
Value Percent: **5.000**  
Continuous Index:  
Within 8" of Joint: **NO**  
Remarks:

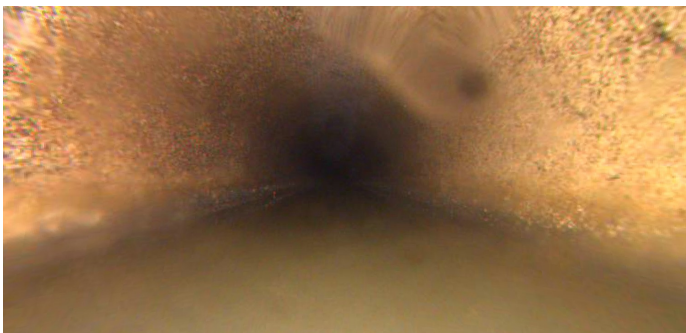
Code: **MWL**  
Description: **Water Level**

Distance (ft): **128.0**  
Structural Grade: **0**  
O&M Grade: **0**  
Clock Start/From:  
Clock To:  
1st Value:  
2nd Value:  
Value Percent: **20.000**  
Continuous Index:  
Within 8" of Joint: **NO**  
Remarks:

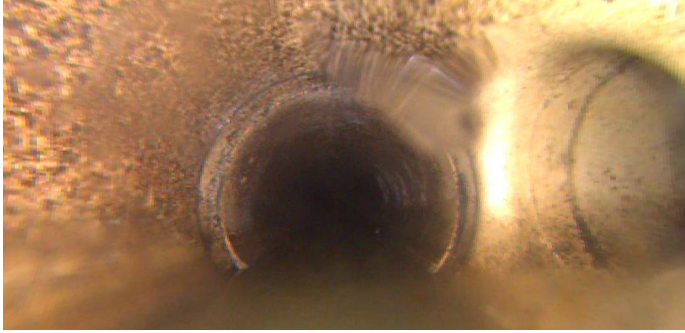
Code: **TF**  
Description: **Tap Factory**

Distance (ft): **147.1**  
Structural Grade: **0**  
O&M Grade: **0**  
Clock Start/From: **3**  
Clock To:  
1st Value: **4.000**  
2nd Value:  
Value Percent:  
Continuous Index:  
Within 8" of Joint:  
Remarks:

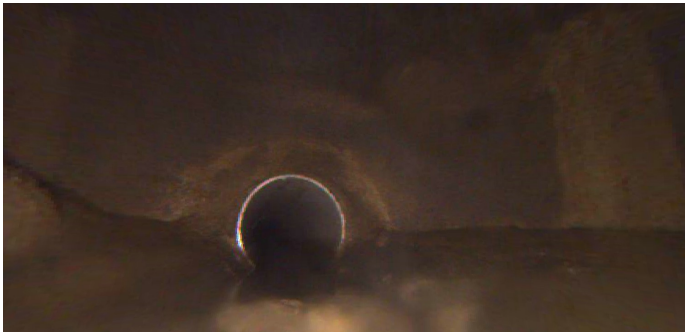
Code: **AMH**  
Description: **Manhole**

Distance (ft): **157.3**  
Structural Grade: **0**  
O&M Grade: **0**  
Clock Start/From:  
Clock To:  
1st Value:  
2nd Value:  
Value Percent:  
Continuous Index:  
Within 8" of Joint: **NO**  
Remarks: **M-903-005**
