## Profile/Photo Observation Report

Street:	<b>e 38th ave</b>	Flow Control:	<b>Not Controlled</b>
City:	<b>Hobart, IN</b>	Year Renewed:	
Location:	<b>Other</b>	Tape/Media #:	
Purpose:	<b>Not Known</b>	Dia/Height:	<b>10"</b>
Use:	<b>Sanitary</b>	Material:	<b>PVC</b>
Drain Area:	<b>NA</b>	Lining:	
Category:	<b>NA</b>		
Comment:

Location Details:		Direction of Survey:	<b>Downstream</b>
US MH:	<b>M-903-006</b>	DS MH:	<b>M-903-007</b>
		Total Length Surveyed (ft):	<b>1.1</b>

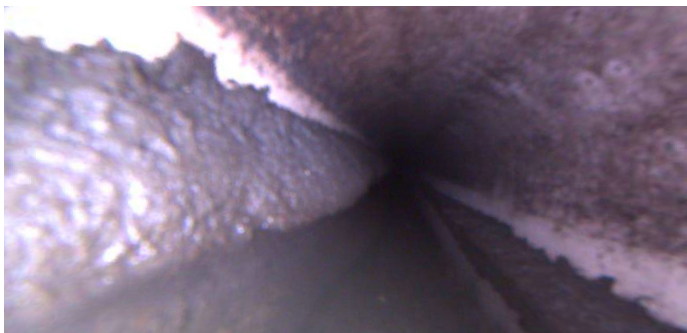
Code: **AMH**  
 Description: **Manhole**  
 Distance (ft): **.0**  
 Structural Grade: **0**  
 O&M Grade: **0**  
 Clock Start/From:  
 Clock To:  
 1st Value:  
 2nd Value:  
 Value Percent:  
 Continuous Index:  
 Within 8" of Joint: **NO**  
 Remarks: **M-903-006**

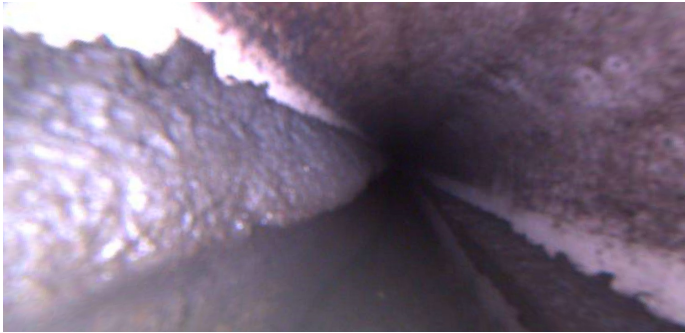
Code:	<b>MWL</b>
Description:	<b>Water Level</b>

Distance (ft):	<b>.0</b>
Structural Grade:	<b>0</b>
O&M Grade:	<b>0</b>
Clock Start/From:	
Clock To:	
1st Value:	
2nd Value:	
Value Percent:	<b>10.000</b>
Continuous Index:	
Within 8" of Joint:	<b>NO</b>
Remarks:

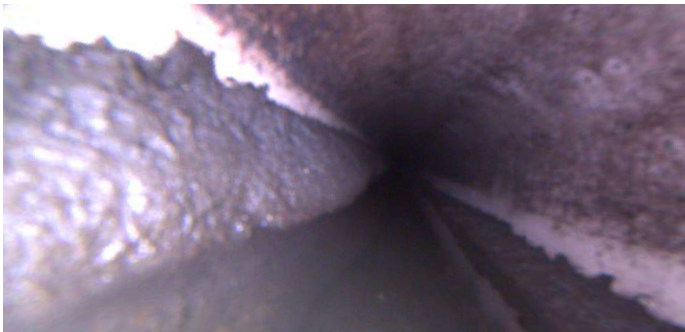
Code:	<b>DAGS</b>
Description:	<b>Deposits Attached Grease</b>

Distance (ft):	<b>.0</b>
Structural Grade:	<b>0</b>
O&M Grade:	<b>3</b>
Clock Start/From:	<b>8</b>
Clock To:	<b>4</b>
1st Value:	
2nd Value:	
Value Percent:	<b>20.000</b>
Continuous Index:	
Within 8" of Joint:	<b>NO</b>
Remarks:

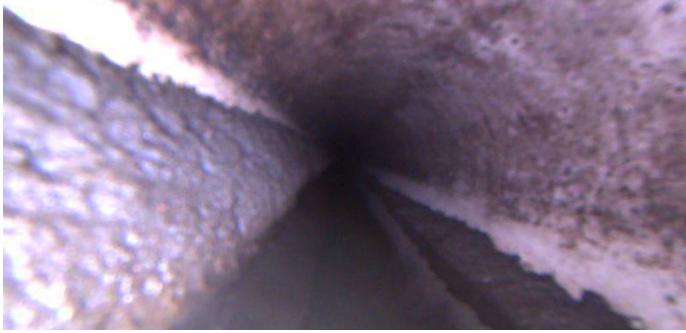
Code:	<b>MSA</b>
Description:	<b>Abandoned Survey</b>
Distance (ft):	<b>1.1</b>
Structural Grade:	<b>0</b>
O&M Grade:	<b>0</b>
Clock Start/From:	
Clock To:	
1st Value:	
2nd Value:	
Value Percent:	
Continuous Index:	
Within 8" of Joint:	<b>NO</b>
Remarks:	<b>DAGS</b>
