Profile/Photo Observation Report

Street:	E 38TH AVE & SPENCER PL	Flow Control:	Not Controlled
City:	Hobart, IN	Year Renewed:	
Location:	Other	Tape/Media #:	
Purpose:	Not Known	Dia/Height:	10"
Use:	Sanitary	Material:	VCP
Drain Area:	NA	Lining:	
Category:	NA		
Comment:

Location Details:		Direction of Survey:	Upstream
US MH:	M-903-006	DS MH:	M-903-007
		Total Length Surveyed (ft):	1.7

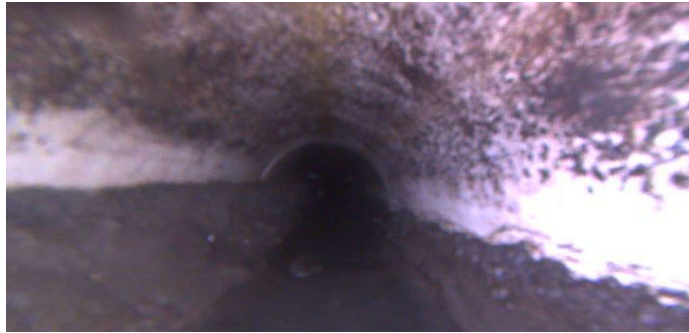
Code: **MWL**
Description: **Water Level**

Distance (ft): **.0**
Structural Grade: **0**
O&M Grade: **0**
Clock Start/From:
Clock To:
1st Value:
2nd Value:
Value Percent: **10.000**
Continuous Index:
Within 8" of Joint: **NO**
Remarks:

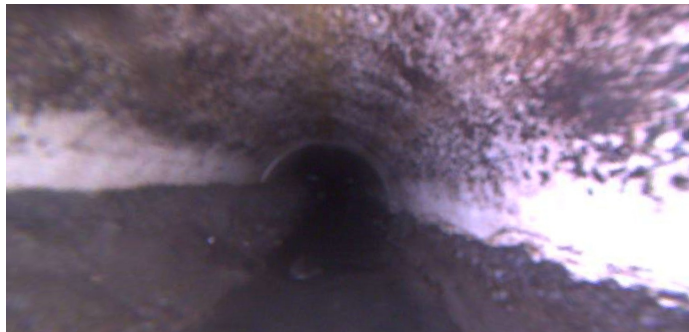
Code: **DAGS**
Description: **Deposits Attached Grease**

Distance (ft): **.0**
Structural Grade: **0**
O&M Grade: **2**
Clock Start/From: **8**
Clock To: **4**
1st Value:
2nd Value:
Value Percent: **10.000**
Continuous Index:
Within 8" of Joint: **NO**
Remarks:

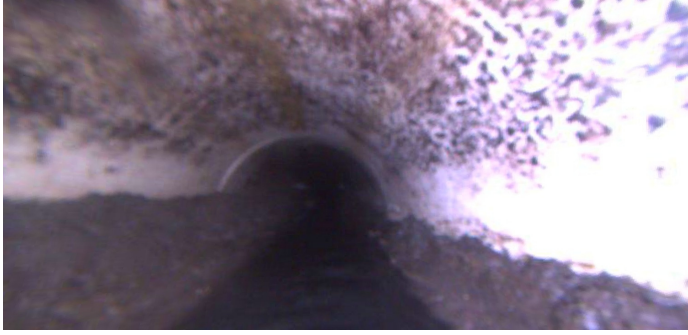
Code:	MSA
Description:	Abandoned Survey
Distance (ft):	1.7
Structural Grade:	0
O&M Grade:	0
Clock Start/From:	
Clock To:	
1st Value:	
2nd Value:	
Value Percent:	
Continuous Index:	
Within 8" of Joint:	NO
Remarks:	DAGS
