Profile/Photo Observation Report

Street:	e 38th ave	Flow Control:	Not Controlled
City:	Hobart, IN	Year Renewed:	
Location:	Other	Tape/Media #:	
Purpose:	Not Known	Dia/Height:	10"
Use:	Sanitary	Material:	VCP
Drain Area:	NA	Lining:	
Category:	NA		
Comment:

Location Details:		Direction of Survey:	Upstream
US MH:	M-903-006	DS MH:	M-903-007
		Total Length Surveyed (ft):	1.7

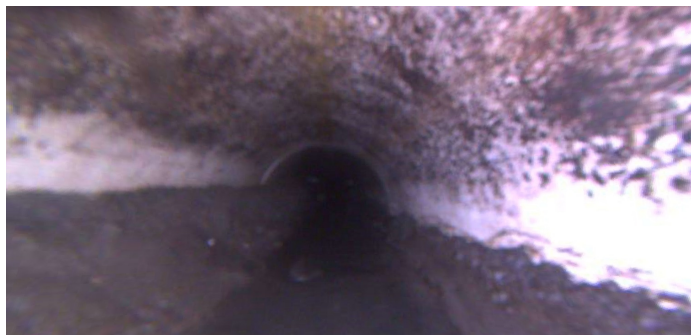
Code: **AMH**
Description: **Manhole**

Distance (ft): **.0**
Structural Grade: **0**
O&M Grade: **0**
Clock Start/From:
Clock To:
1st Value:
2nd Value:
Value Percent:
Continuous Index:
Within 8" of Joint: **NO**
Remarks: **M-903-007**

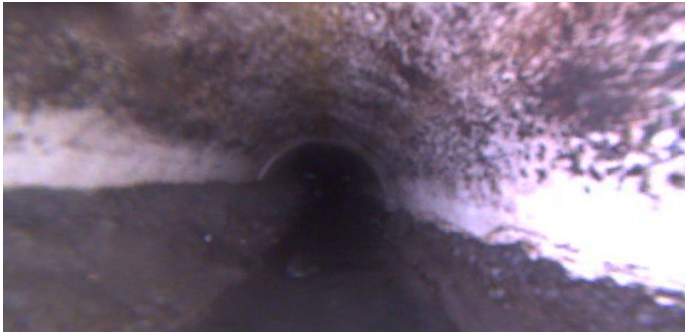
Code:	MWL
Description:	Water Level

Distance (ft):	.0
Structural Grade:	0
O&M Grade:	0
Clock Start/From:	
Clock To:	
1st Value:	
2nd Value:	
Value Percent:	10.000
Continuous Index:	
Within 8" of Joint:	NO
Remarks:

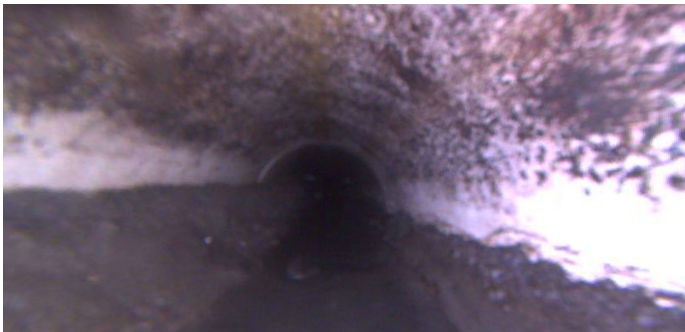
Code:	DAGS
Description:	Deposits Attached Grease

Distance (ft):	.0
Structural Grade:	0
O&M Grade:	2
Clock Start/From:	8
Clock To:	4
1st Value:	
2nd Value:	
Value Percent:	10.000
Continuous Index:	
Within 8" of Joint:	NO
Remarks:

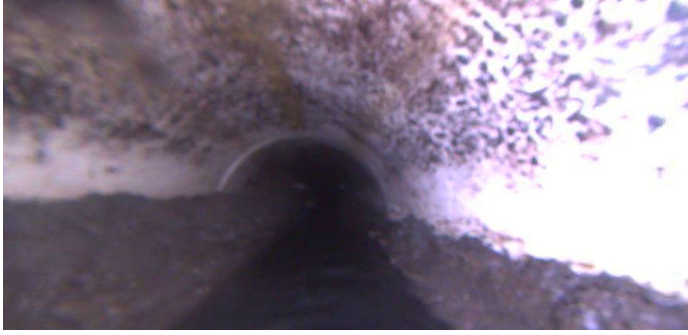
Code:	MSA
Description:	Abandoned Survey
Distance (ft):	1.7
Structural Grade:	0
O&M Grade:	0
Clock Start/From:	
Clock To:	
1st Value:	
2nd Value:	
Value Percent:	
Continuous Index:	
Within 8" of Joint:	NO
Remarks:	DAGS
