Profile/Photo Observation Report

Street:	E 38TH AVE & SPENCER PL	Flow Control:	Not Controlled
City:	Hobart, IN	Year Renewed:	
Location:	Other	Tape/Media #:	
Purpose:	Not Known	Dia/Height:	10"
Use:	Sanitary	Material:	VCP
Drain Area:	NA	Lining:	
Category:	NA		
Comment:

Location Details:		Direction of Survey:	Upstream
US MH:	M-903-006	DS MH:	M-903-009
		Total Length Surveyed (ft):	13.6

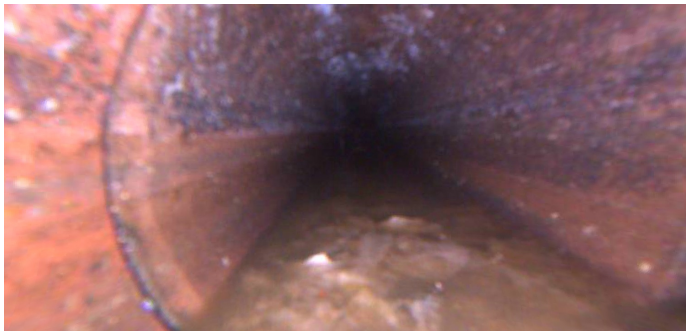
Code: **AMH**
Description: **Manhole**

Distance (ft): **.0**
Structural Grade: **0**
O&M Grade: **0**
Clock Start/From:
Clock To:
1st Value:
2nd Value:
Value Percent:
Continuous Index:
Within 8" of Joint: **NO**
Remarks: **M-903-009**

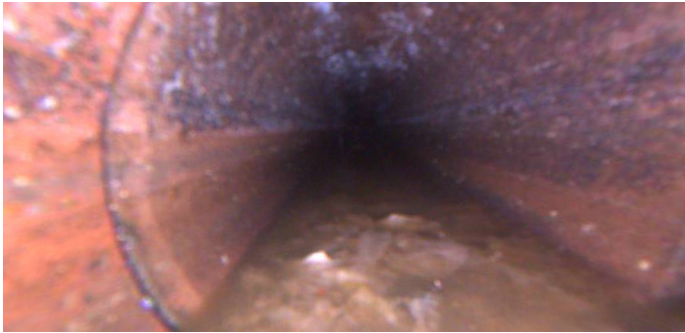
Code:	MWL
Description:	Water Level

Distance (ft):	.0
Structural Grade:	0
O&M Grade:	0
Clock Start/From:	
Clock To:	
1st Value:	
2nd Value:	
Value Percent:	10.000
Continuous Index:	
Within 8" of Joint:	NO
Remarks:

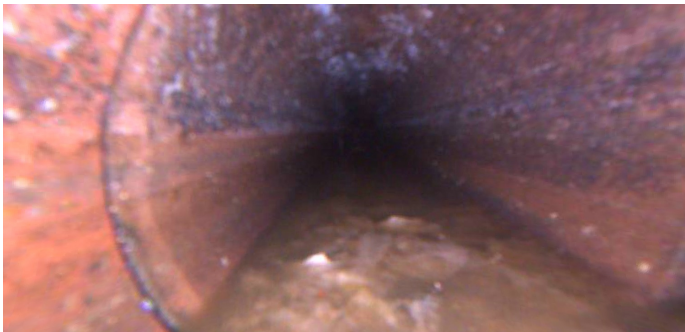
Code:	DAGS
Description:	Deposits Attached Grease

Distance (ft):	.0
Structural Grade:	0
O&M Grade:	2
Clock Start/From:	8
Clock To:	4
1st Value:	
2nd Value:	
Value Percent:	5.000
Continuous Index:	S01
Within 8" of Joint:	NO
Remarks:

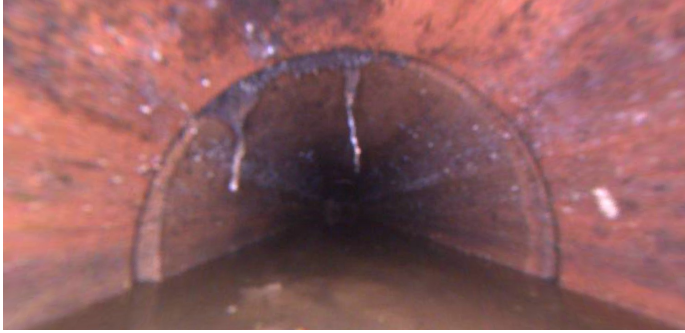
Code: **RFJ**
Description: **Roots Fine Joint**

Distance (ft): **5.8**
Structural Grade: **0**
O&M Grade: **1**
Clock Start/From: **11**
Clock To: **12**
1st Value:
2nd Value:
Value Percent:
Continuous Index:
Within 8" of Joint: **YES**
Remarks:

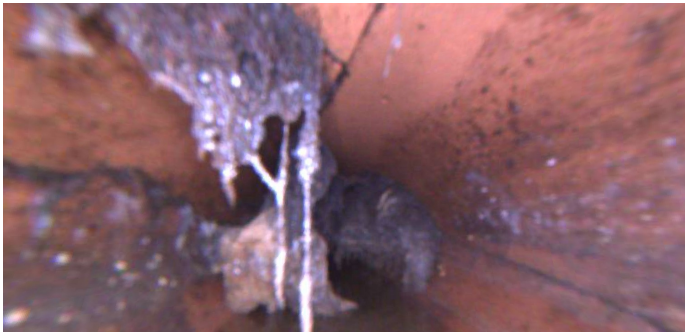
Code: **FM**
Description: **Fracture Multiple**

Distance (ft): **11.4**
Structural Grade: **4**
O&M Grade: **0**
Clock Start/From: **8**
Clock To: **4**
1st Value:
2nd Value:
Value Percent:
Continuous Index:
Within 8" of Joint: **YES**
Remarks:

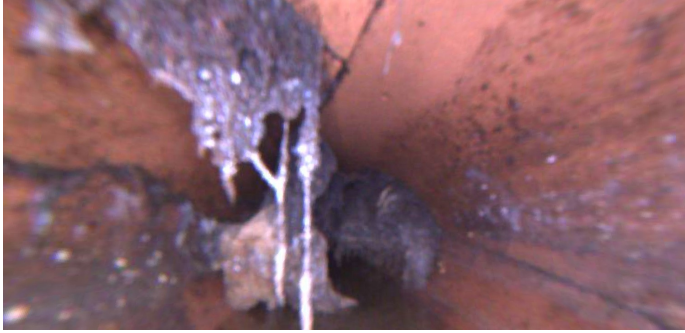
Code: **RMB**
Description: **Roots Medium Barrel**

Distance (ft): **11.4**
Structural Grade: **0**
O&M Grade: **4**
Clock Start/From: **8**
Clock To: **4**
1st Value:
2nd Value:
Value Percent: **40.000**
Continuous Index:
Within 8" of Joint: **NO**
Remarks:
