## Profile/Photo Observation Report

Street:	<b>N UNION ST</b>	Flow Control:	<b>Not Controlled</b>
City:	<b>Hobart, IN</b>	Year Renewed:	
Location:	<b>Other</b>	Tape/Media #:	
Purpose:	<b>Not Known</b>	Dia/Height:	<b>10"</b>
Use:	<b>Sanitary</b>	Material:	<b>VCP</b>
Drain Area:	<b>NA</b>	Lining:	
Category:	<b>NA</b>		
Comment:

Location Details:		Direction of Survey:	<b>Upstream</b>
US MH:	<b>M-903-006</b>	DS MH:	<b>M-903-009</b>
		Total Length Surveyed (ft):	<b>13.6</b>

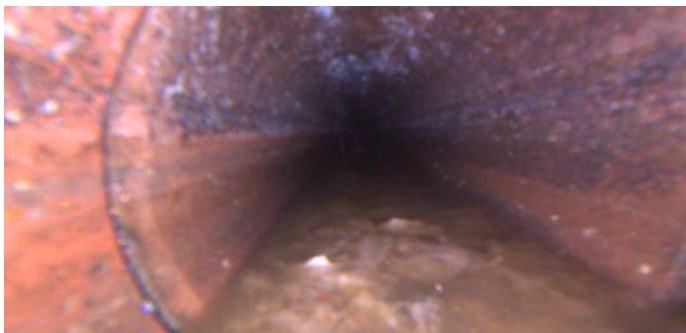
Code: **AMH**  
Description: **Manhole**

Distance (ft): **.0**  
Structural Grade: **0**  
O&M Grade: **0**  
Clock Start/From:  
Clock To:  
1st Value:  
2nd Value:  
Value Percent:  
Continuous Index:  
Within 8" of Joint: **NO**  
Remarks: **M-903-009**

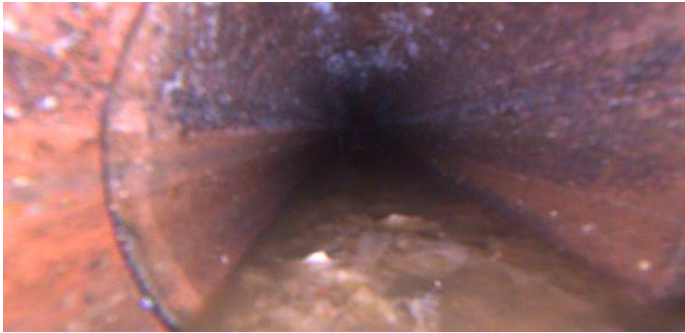
Code:	<b>MWL</b>
Description:	<b>Water Level</b>

Distance (ft):	<b>.0</b>
Structural Grade:	<b>0</b>
O&M Grade:	<b>0</b>
Clock Start/From:	
Clock To:	
1st Value:	
2nd Value:	
Value Percent:	<b>10.000</b>
Continuous Index:	
Within 8" of Joint:	<b>NO</b>
Remarks:

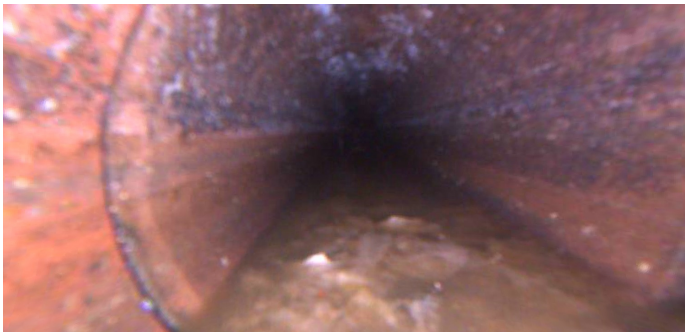
Code:	<b>DAGS</b>
Description:	<b>Deposits Attached Grease</b>

Distance (ft):	<b>.0</b>
Structural Grade:	<b>0</b>
O&M Grade:	<b>2</b>
Clock Start/From:	<b>8</b>
Clock To:	<b>4</b>
1st Value:	
2nd Value:	
Value Percent:	<b>5.000</b>
Continuous Index:	<b>S01</b>
Within 8" of Joint:	<b>NO</b>
Remarks:

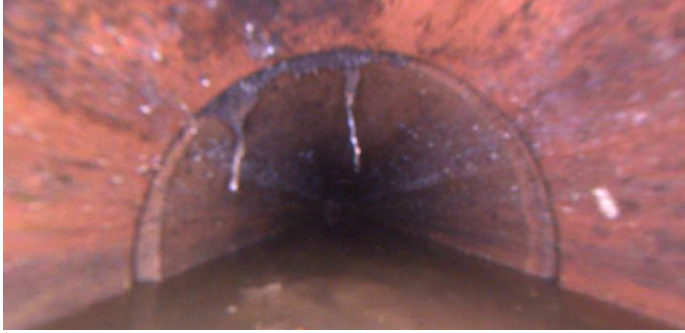
Code: **RFJ**  
Description: **Roots Fine Joint**

Distance (ft): **5.8**  
Structural Grade: **0**  
O&M Grade: **1**  
Clock Start/From: **11**  
Clock To: **12**  
1st Value:  
2nd Value:  
Value Percent:  
Continuous Index:  
Within 8" of Joint: **YES**  
Remarks:

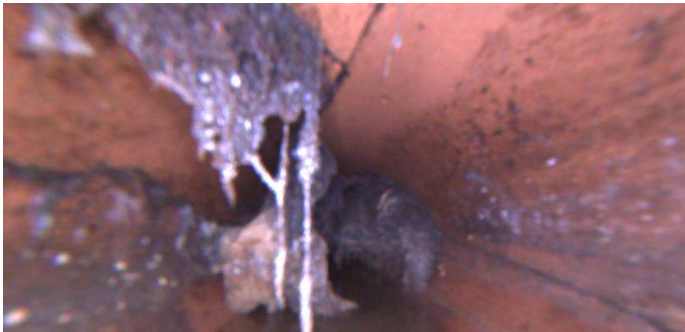
Code: **FM**  
Description: **Fracture Multiple**

Distance (ft): **11.4**  
Structural Grade: **4**  
O&M Grade: **0**  
Clock Start/From: **8**  
Clock To: **4**  
1st Value:  
2nd Value:  
Value Percent:  
Continuous Index:  
Within 8" of Joint: **YES**  
Remarks:

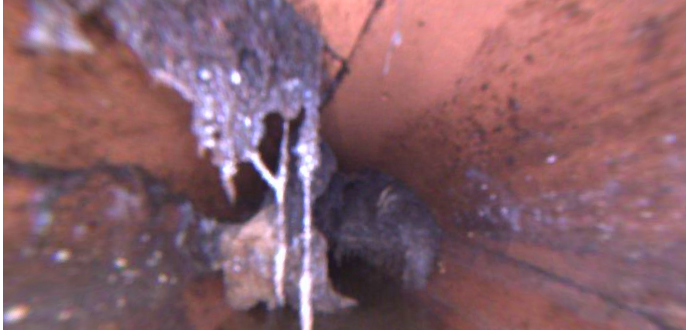
Code: **RMB**  
Description: **Roots Medium Barrel**

Distance (ft): **11.4**  
Structural Grade: **0**  
O&M Grade: **4**  
Clock Start/From: **8**  
Clock To: **4**  
1st Value:  
2nd Value:  
Value Percent: **40.000**  
Continuous Index:  
Within 8" of Joint: **NO**  
Remarks:
