Profile/Photo Observation Report

| Street: | East 38th Avenue | Flow Control: | Not Controlled |
| Use: | Sanitary Sewage Pipe | Material: | VCP |
| US MH: | M-903-006 | DS MH: | M-903-009 |

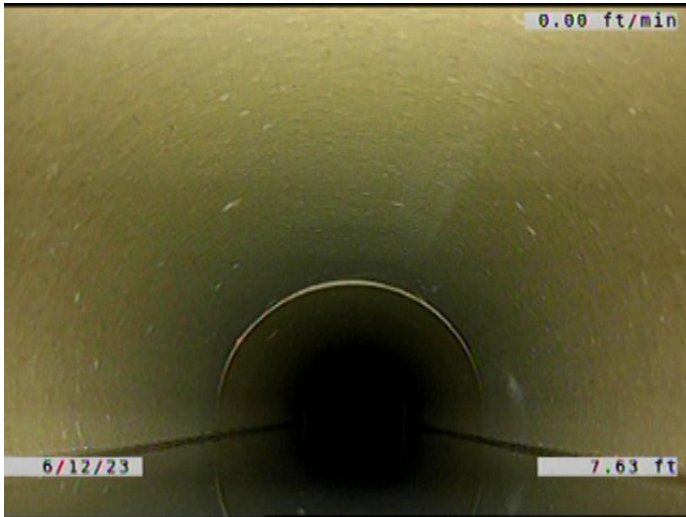
Code: **MWLS**
Description: **Miscellaneous Water Level Sag**

Distance (ft): **7.6**
Structural Grade: **2**
O&M Grade: **0**
Clock Start/From:
Clock To:
1st Value:
2nd Value:
Value Percent: **30.000**
Continuous Index: **S01**
Within 8" of Joint: **NO**
Remarks:

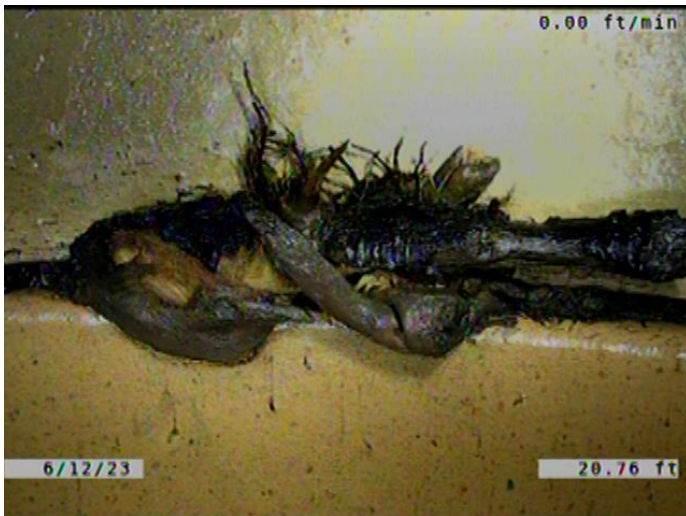
Code: **RFJ**
Description: **Roots Fine Joint**

Distance (ft): **20.8**
Structural Grade: **0**
O&M Grade: **1**
Clock Start/From: **8**
Clock To: **4**
1st Value:
2nd Value:
Value Percent:
Continuous Index: **S02**
Within 8" of Joint: **YES**
Remarks:

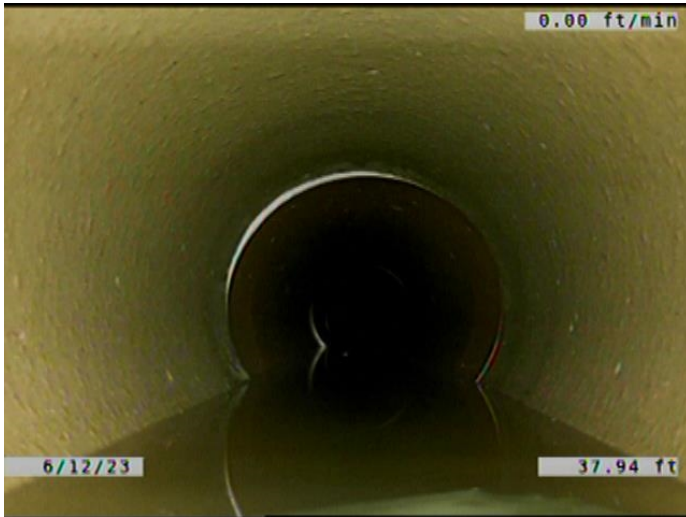
Code: **MWLS**
Description: **Miscellaneous Water Level Sag**

Distance (ft): **37.9**
Structural Grade: **2**
O&M Grade: **0**
Clock Start/From:
Clock To:
1st Value:
2nd Value:
Value Percent: **30.000**
Continuous Index: **F01**
Within 8" of Joint: **NO**
Remarks:

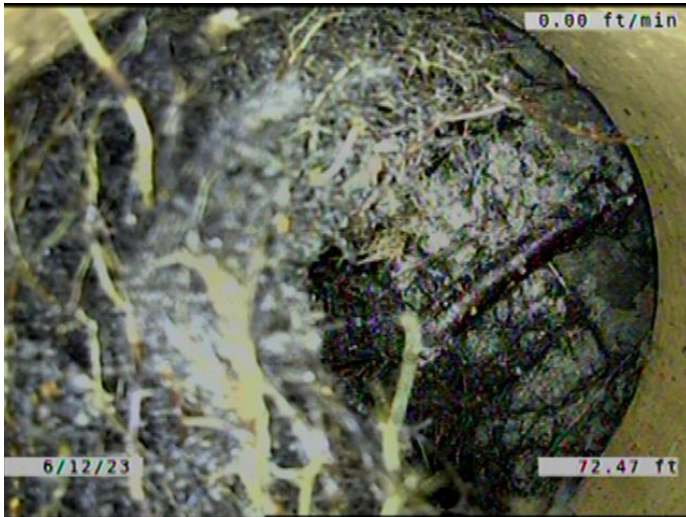
Code: **TFD**
Description: **Tap Factory Defective**

Distance (ft): **72.5**
Structural Grade: **0**
O&M Grade: **3**
Clock Start/From: **10**
Clock To:
1st Value: **6.000**
2nd Value:
Value Percent:
Continuous Index:
Within 8" of Joint: **YES**
Remarks: **LOOKS TO BE 100% PLUGGED.
ROOTS DIRT. ROOTS GROWING INTO**

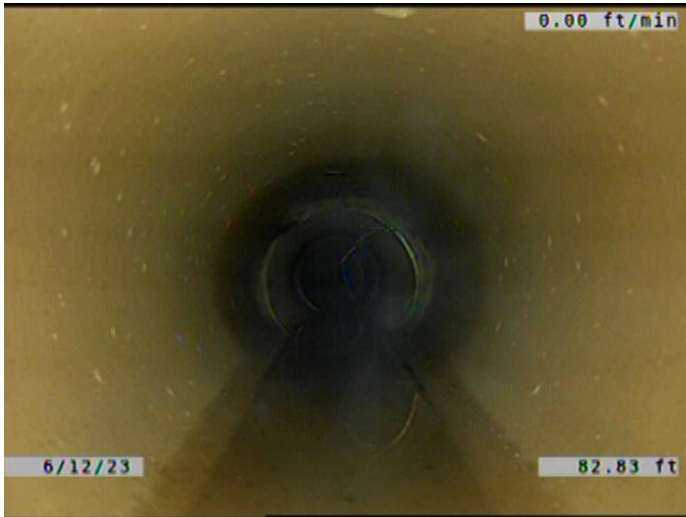
Code: **MWLS**
Description: **Miscellaneous Water Level Sag**

Distance (ft): **82.8**
Structural Grade: **2**
O&M Grade: **0**
Clock Start/From:
Clock To:
1st Value:
2nd Value:
Value Percent: **10.000**
Continuous Index: **S03**
Within 8" of Joint: **NO**
Remarks:

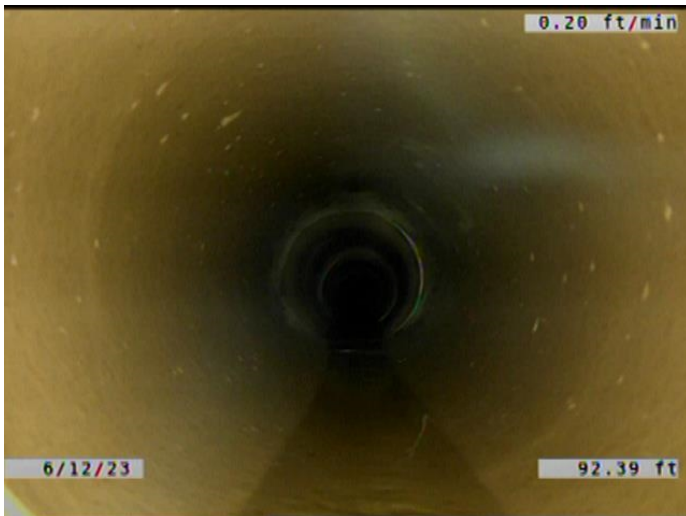
Code: **MWLS**
Description: **Miscellaneous Water Level Sag**

Distance (ft): **92.4**
Structural Grade: **2**
O&M Grade: **0**
Clock Start/From:
Clock To:
1st Value:
2nd Value:
Value Percent: **10.000**
Continuous Index: **F03**
Within 8" of Joint: **NO**
Remarks:

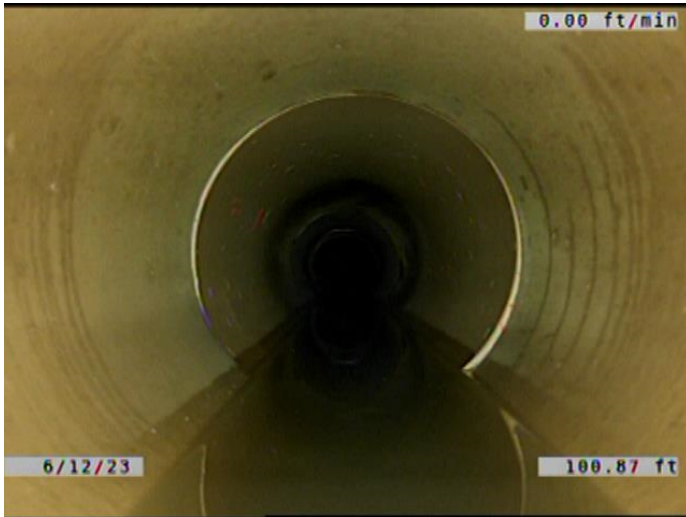
Code: **MWLS**
Description: **Miscellaneous Water Level Sag**

Distance (ft): **100.8**
Structural Grade: **2**
O&M Grade: **0**
Clock Start/From:
Clock To:
1st Value:
2nd Value:
Value Percent: **15.000**
Continuous Index: **S04**
Within 8" of Joint: **NO**
Remarks:

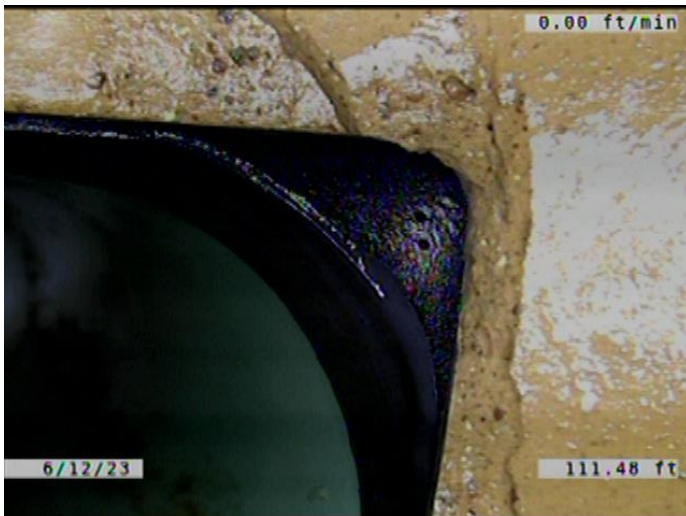
Code: **SSS**
Description: **Surface Damage Surface Spalling**

Distance (ft): **111.5**
Structural Grade: **2**
O&M Grade: **0**
Clock Start/From: **11**
Clock To: **1**
1st Value:
2nd Value:
Value Percent:
Continuous Index:
Within 8" of Joint: **NO**
Remarks:

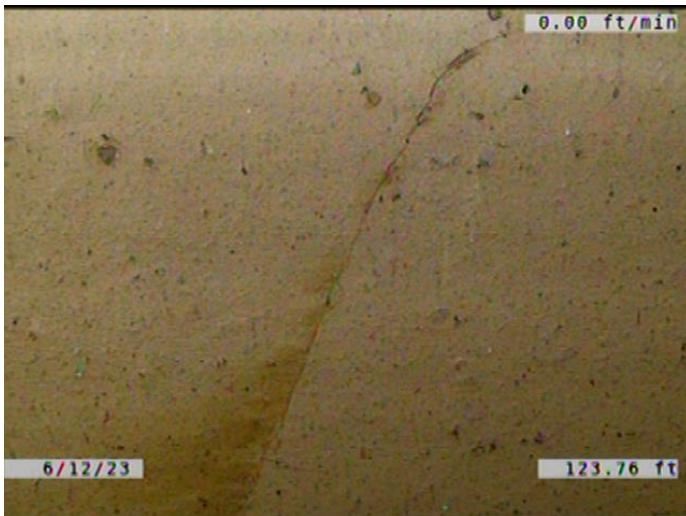
| Code: | CM |
| Description: | Crack Multiple |
| Distance (ft): | 123.8 |
| Structural Grade: | 3 |

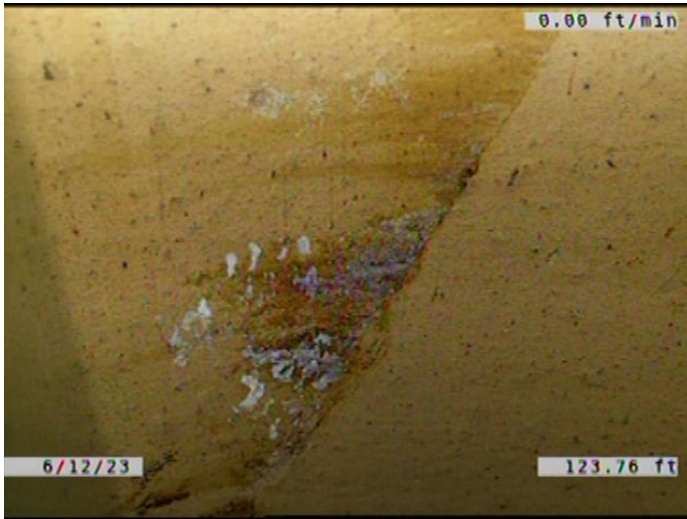
Code: **ISB**
Description: **Infiltration Stain Barrel**

Distance (ft): **123.8**
Structural Grade: **0**
O&M Grade: **1**
Clock Start/From: **8**
Clock To: **11**
1st Value:
2nd Value:
Value Percent:
Continuous Index: **S06**
Within 8" of Joint: **YES**
Remarks:

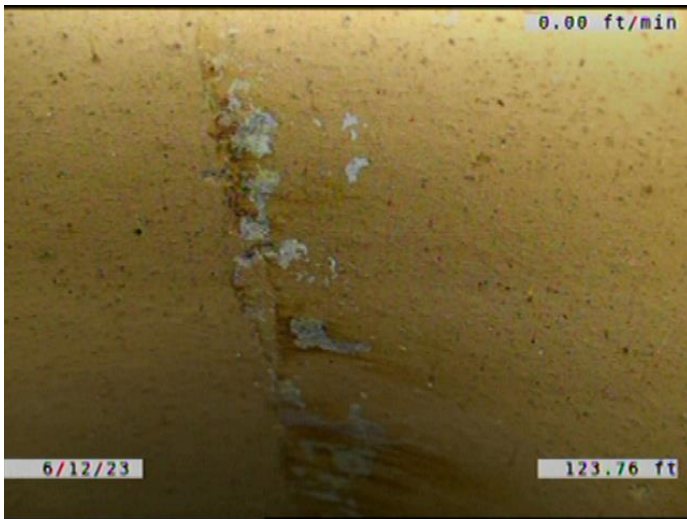
Code: **ISB**
Description: **Infiltration Stain Barrel**

Distance (ft): **123.8**
Structural Grade: **0**
O&M Grade: **1**
Clock Start/From: **2**
Clock To: **4**
1st Value:
2nd Value:
Value Percent:
Continuous Index: **S07**
Within 8" of Joint: **YES**
Remarks:

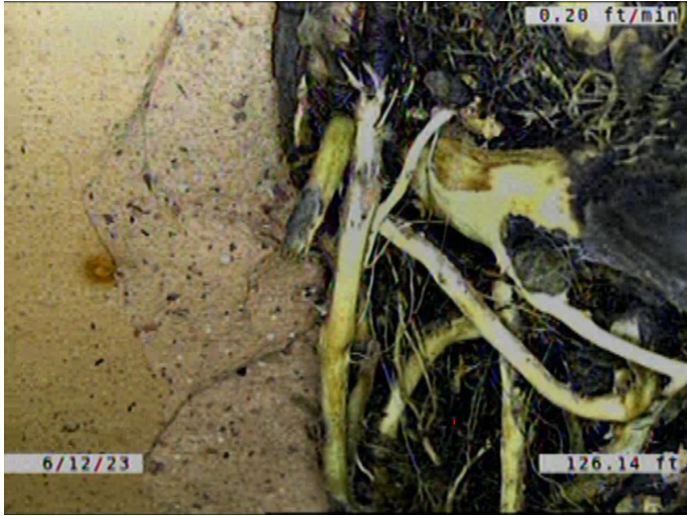
Code: **SSS**
Description: **Surface Damage Surface Spalling**

Distance (ft): **126.1**
Structural Grade: **2**
O&M Grade: **0**
Clock Start/From: **2**
Clock To:
1st Value:
2nd Value:
Value Percent:
Continuous Index:
Within 8" of Joint: **NO**
Remarks:

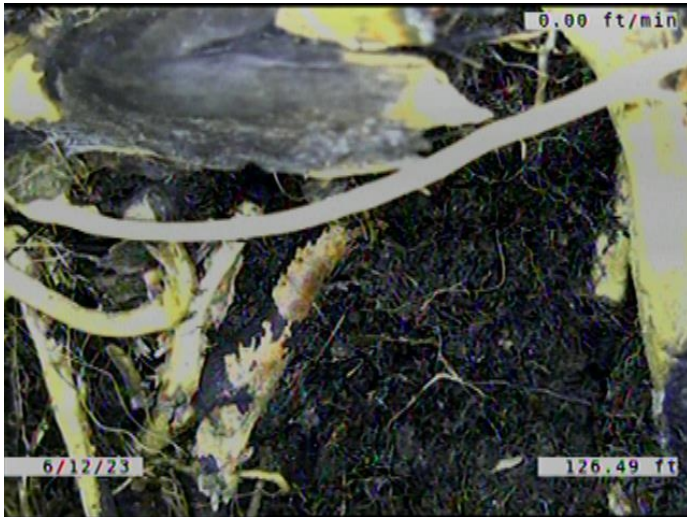
Code: **TBD**
Description: **Tap Break-in/Hammer Defective**

Distance (ft): **126.5**
Structural Grade: **0**
O&M Grade: **3**
Clock Start/From: **2**
Clock To:
1st Value: **6.000**
2nd Value:
Value Percent:
Continuous Index:
Within 8" of Joint: **YES**
Remarks: **LOOKS TO BE 100% PLUGED WITH ROOTS.**

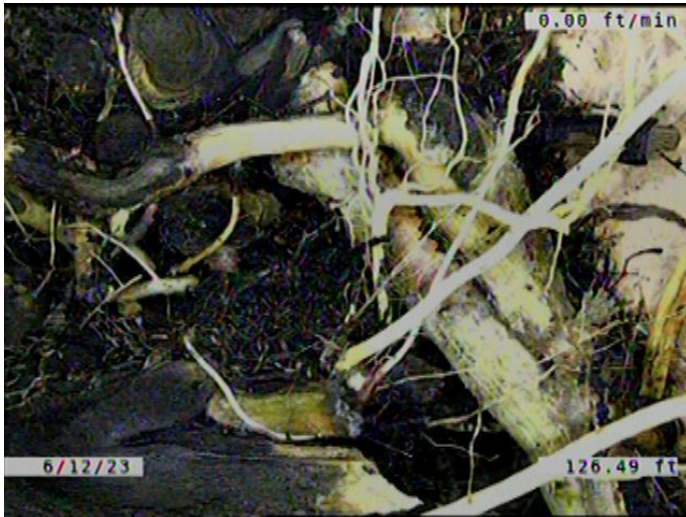
Code: **RML**
 Description: **Roots Medium Lateral**

Distance (ft): **126.5**
 Structural Grade: **0**
 O&M Grade: **3**
 Clock Start/From: **1**
 Clock To: **3**
 1st Value:
 2nd Value:
 Value Percent: **5.000**
 Continuous Index:
 Within 8" of Joint: **NO**
 Remarks:

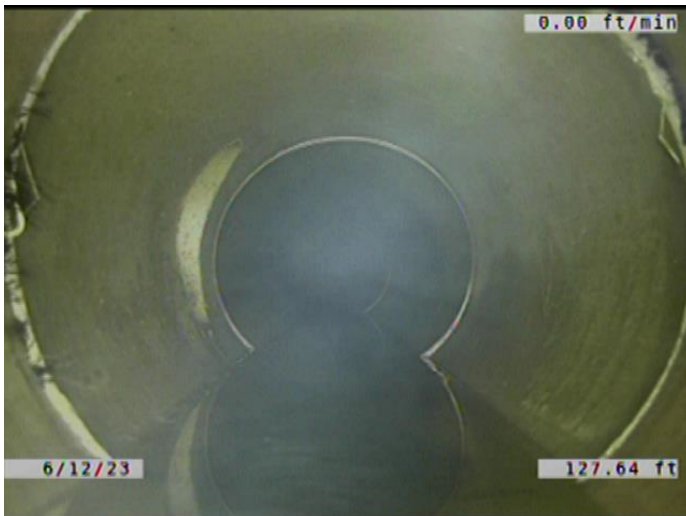
Code: **ISB**
 Description: **Infiltration Stain Barrel**

Distance (ft): **127.6**
 Structural Grade: **0**
 O&M Grade: **1**
 Clock Start/From: **8**
 Clock To: **11**
 1st Value:
 2nd Value:
 Value Percent:
 Continuous Index: **F06**
 Within 8" of Joint: **YES**
 Remarks:

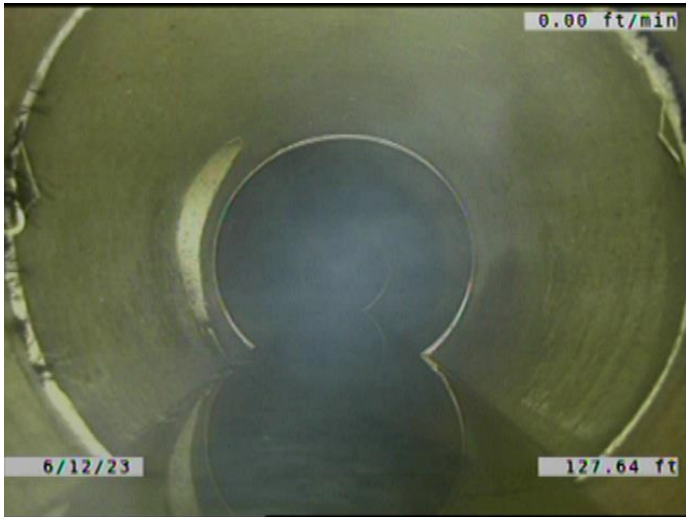
Code: **ISB**
Description: **Infiltration Stain Barrel**

Distance (ft): **127.6**
Structural Grade: **0**
O&M Grade: **1**
Clock Start/From: **2**
Clock To: **4**
1st Value:
2nd Value:
Value Percent:
Continuous Index: **F07**
Within 8" of Joint: **YES**
Remarks:

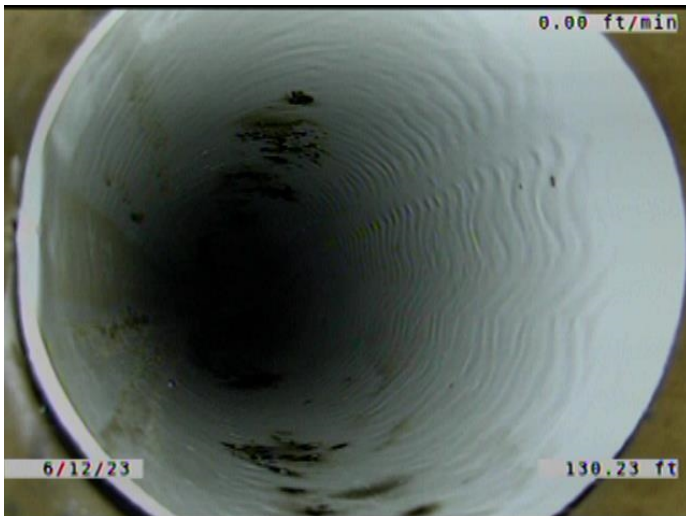
Code: **TF**
Description: **Tap Factory**

Distance (ft): **130.2**
Structural Grade: **0**
O&M Grade: **0**
Clock Start/From: **10**
Clock To:
1st Value: **6.000**
2nd Value:
Value Percent:
Continuous Index:
Within 8" of Joint: **YES**
Remarks: **SERVICE REPLCED WITH PVC.
CONSTANTLY RUNNING WATER.**

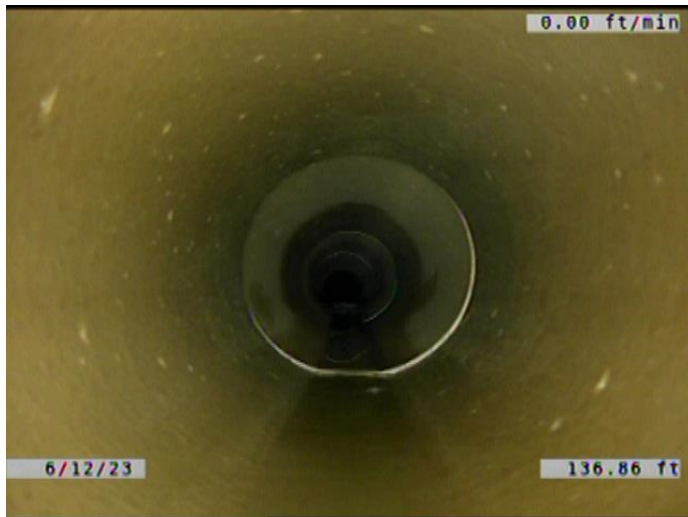
Code: **MWLS**
Description: **Miscellaneous Water Level Sag**

Distance (ft): **136.9**
Structural Grade: **2**
O&M Grade: **0**
Clock Start/From:
Clock To:
1st Value:
2nd Value:
Value Percent: **15.000**
Continuous Index: **F04**
Within 8" of Joint: **NO**
Remarks:

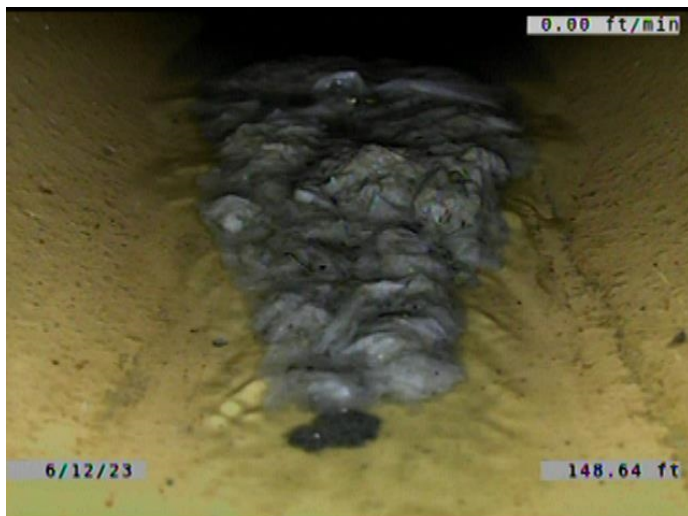
Code: **DAR**
Description: **Deposits Attached Ragging**

Distance (ft): **148.6**
Structural Grade: **0**
O&M Grade: **2**
Clock Start/From: **5**
Clock To: **7**
1st Value:
2nd Value:
Value Percent: **5.000**
Continuous Index:
Within 8" of Joint: **YES**
Remarks:

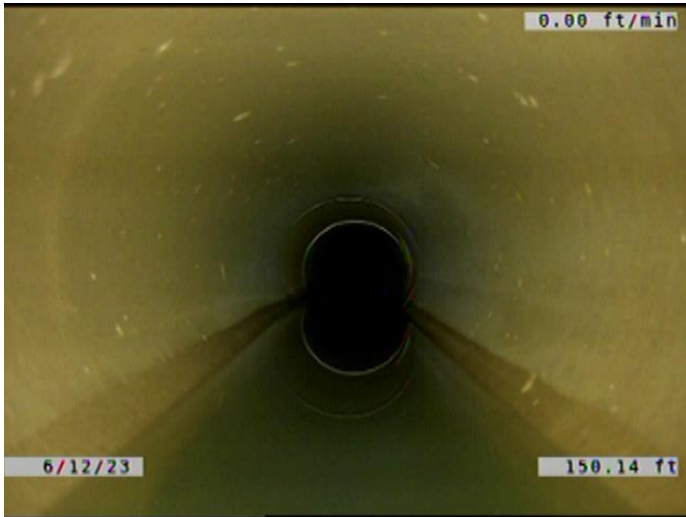
Code: **MWLS**
Description: **Miscellaneous Water Level Sag**

Distance (ft): **150.1**
Structural Grade: **2**
O&M Grade: **0**
Clock Start/From:
Clock To:
1st Value:
2nd Value:
Value Percent: **15.000**
Continuous Index: **S08**
Within 8" of Joint: **NO**
Remarks:

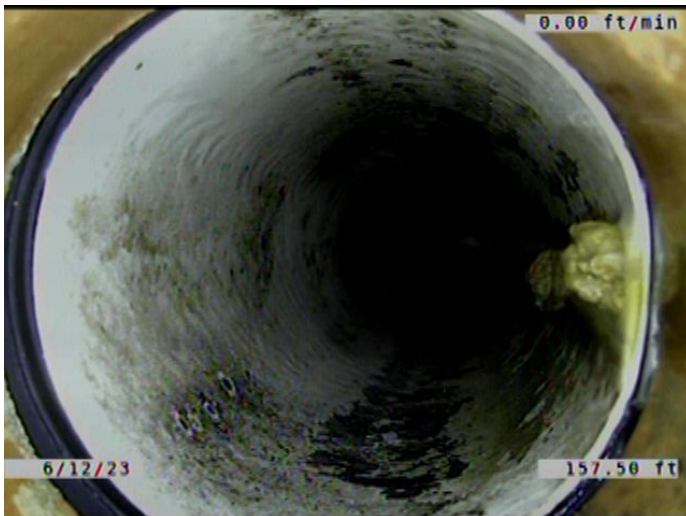
Code: **TF**
Description: **Tap Factory**

Distance (ft): **157.5**
Structural Grade: **0**
O&M Grade: **0**
Clock Start/From: **3**
Clock To:
1st Value: **6.000**
2nd Value:
Value Percent:
Continuous Index:
Within 8" of Joint: **YES**
Remarks: **SERVICE REPLACED WITH PVC.
CONSTANTLY RUNNING WATER.**

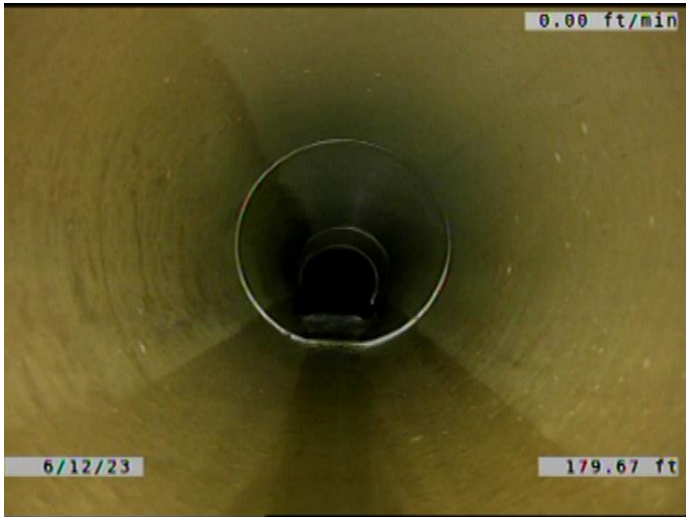
Code: **MWLS**
Description: **Miscellaneous Water Level Sag**

Distance (ft): **179.7**
Structural Grade: **2**
O&M Grade: **0**
Clock Start/From:
Clock To:
1st Value:
2nd Value:
Value Percent: **15.000**
Continuous Index: **F08**
Within 8" of Joint: **NO**
Remarks:

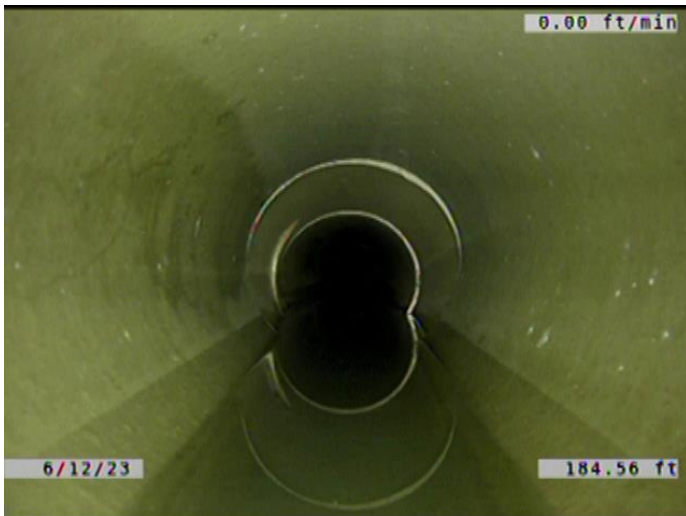
Code: **MWLS**
Description: **Miscellaneous Water Level Sag**

Distance (ft): **184.6**
Structural Grade: **2**
O&M Grade: **0**
Clock Start/From:
Clock To:
1st Value:
2nd Value:
Value Percent: **15.000**
Continuous Index: **S09**
Within 8" of Joint: **NO**
Remarks:

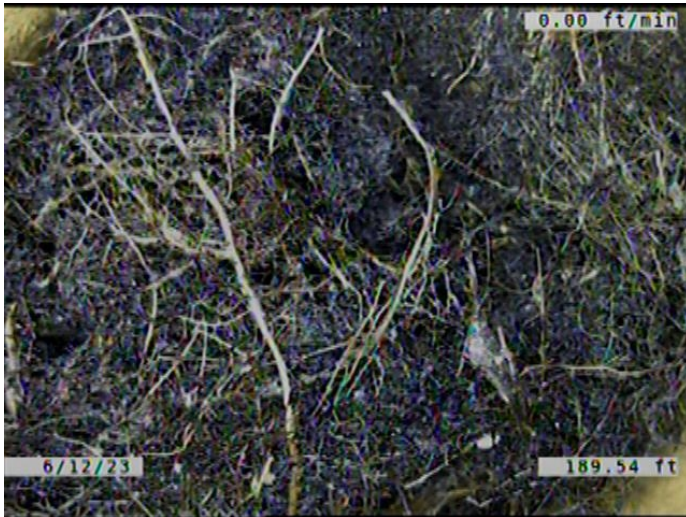
Code: **TFD**
Description: **Tap Factory Defective**

Distance (ft): **189.5**
Structural Grade: **0**
O&M Grade: **3**
Clock Start/From: **9**
Clock To:
1st Value: **6.000**
2nd Value:
Value Percent:
Continuous Index:
Within 8" of Joint: **YES**
Remarks: **100% PLUGGED WITH ROOTS.**

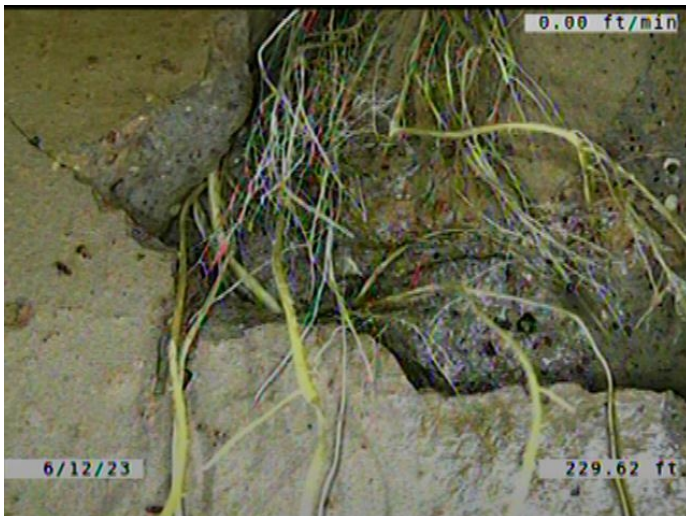
Code: **B**
Description: **Broken**

Distance (ft): **204.1**
Structural Grade: **4**
O&M Grade: **0**
Clock Start/From: **7**
Clock To: **5**
1st Value:
2nd Value:
Value Percent:
Continuous Index:
Within 8" of Joint: **YES**
Remarks:

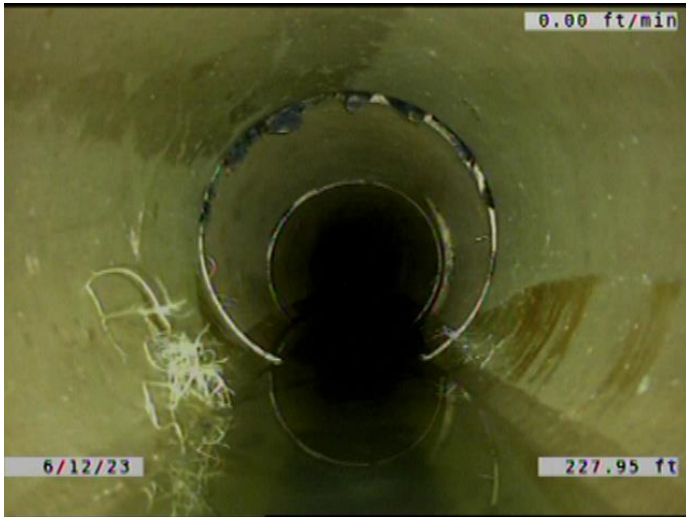
Code: **ISB**
 Description: **Infiltration Stain Barrel**

Distance (ft): **227.9**
 Structural Grade: **0**
 O&M Grade: **1**
 Clock Start/From: **3**
 Clock To: **4**
 1st Value:
 2nd Value:
 Value Percent:
 Continuous Index:
 Within 8" of Joint: **YES**
 Remarks:

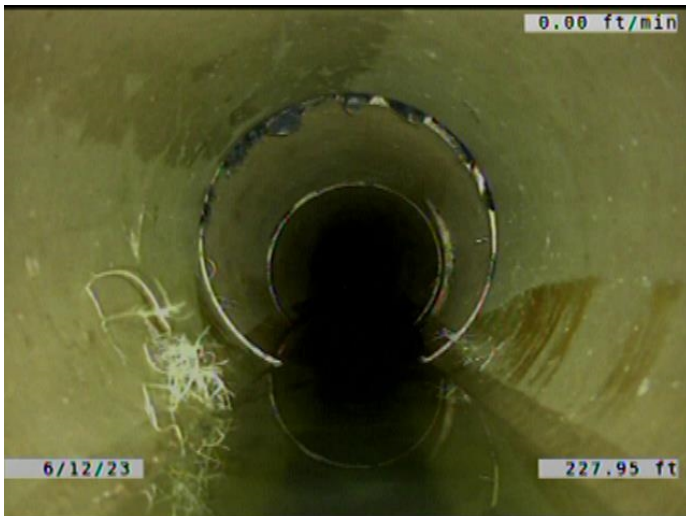
Code: **ISB**
 Description: **Infiltration Stain Barrel**

Distance (ft): **227.9**
 Structural Grade: **0**
 O&M Grade: **1**
 Clock Start/From: **8**
 Clock To: **9**
 1st Value:
 2nd Value:
 Value Percent:
 Continuous Index:
 Within 8" of Joint: **YES**
 Remarks:

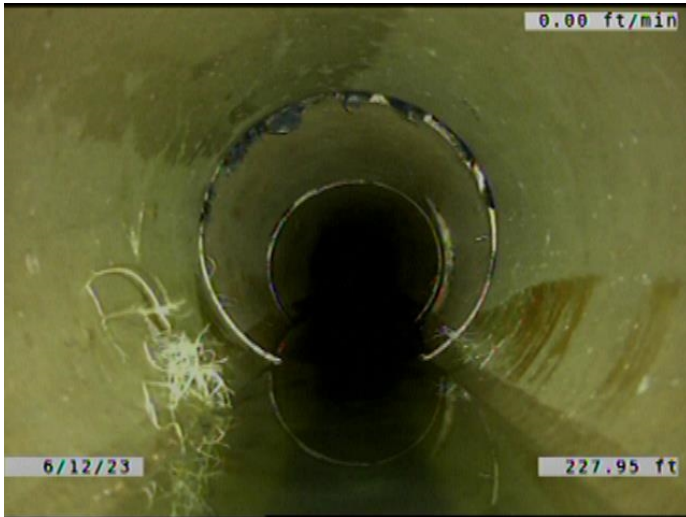
Code: **FM**
Description: **Fracture Multiple**

Distance (ft): **228.0**
Structural Grade: **4**
O&M Grade: **0**
Clock Start/From: **12**
Clock To: **12**
1st Value:
2nd Value:
Value Percent:
Continuous Index:
Within 8" of Joint: **YES**
Remarks:

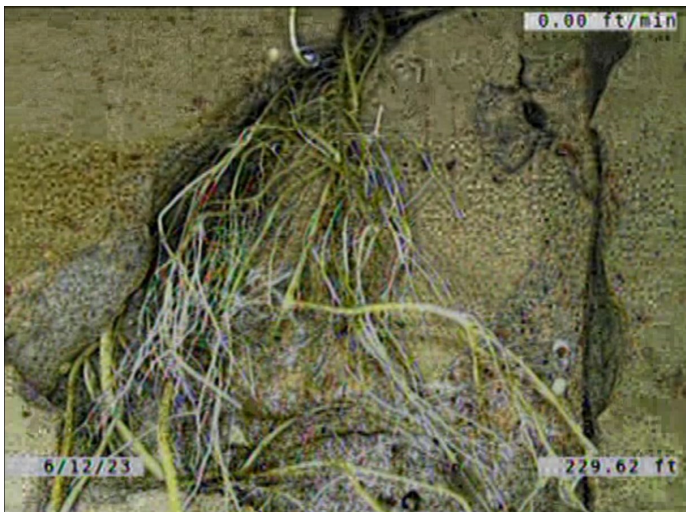
Code: **B**
Description: **Broken**

Distance (ft): **229.6**
Structural Grade: **4**
O&M Grade: **0**
Clock Start/From: **8**
Clock To:
1st Value:
2nd Value:
Value Percent:
Continuous Index:
Within 8" of Joint: **NO**
Remarks:

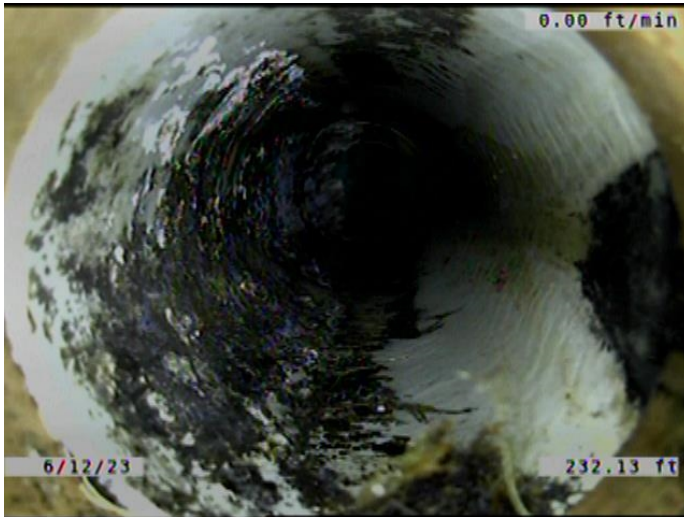
| Code: | TF |
| Description: | Tap Factory |
| Remarks: | SERVICE REPLACED WITH PVC. ROOTS GROWING FROM THE SERVIC |

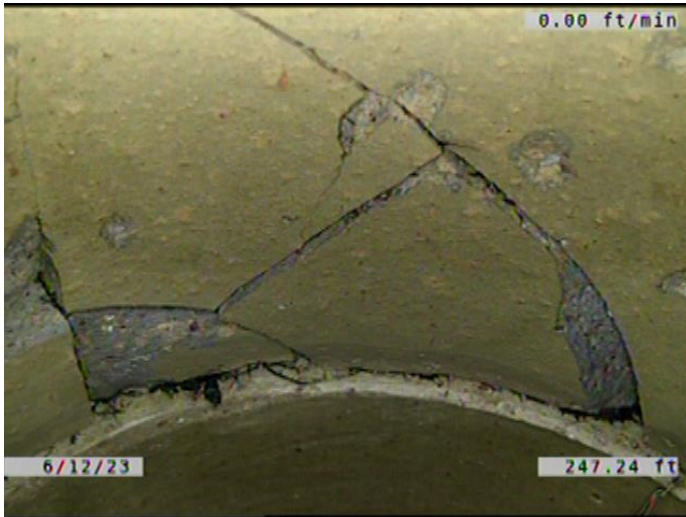
Code: **B**
Description: **Broken**

Distance (ft): **247.2**
Structural Grade: **4**
O&M Grade: **0**
Clock Start/From: **11**
Clock To: **1**
1st Value:
2nd Value:
Value Percent:
Continuous Index: **S10**
Within 8" of Joint: **YES**
Remarks:

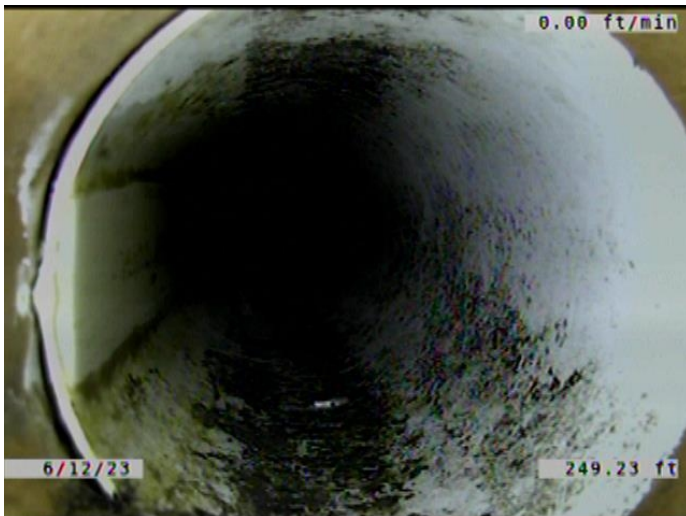
Code: **TF**
Description: **Tap Factory**

Distance (ft): **249.2**
Structural Grade: **0**
O&M Grade: **0**
Clock Start/From: **9**
Clock To:
1st Value: **6.000**
2nd Value:
Value Percent:
Continuous Index:
Within 8" of Joint: **YES**
Remarks: **CONSTANTLY RUNNING WATER.
ROOTS GROWING FROM THE SERVIC**

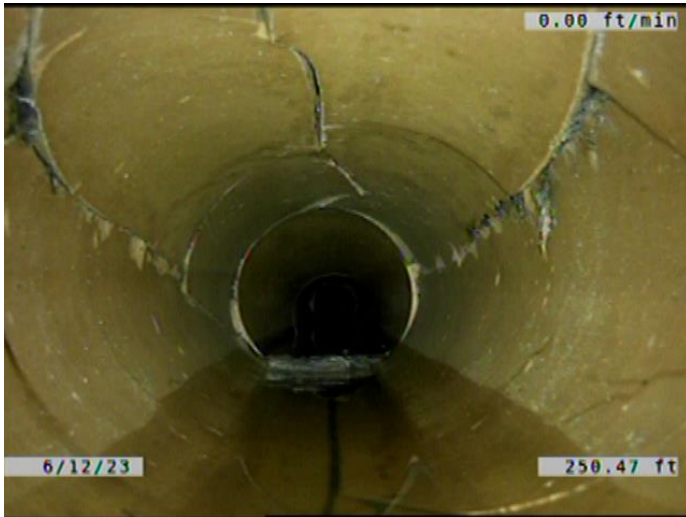
Code: **DR**
Description: **Deformed Rigid**

Distance (ft): **250.5**
Structural Grade: **4**
O&M Grade: **0**
Clock Start/From:
Clock To:
1st Value:
2nd Value:
Value Percent: **5.000**
Continuous Index: **S11**
Within 8" of Joint: **NO**
Remarks:

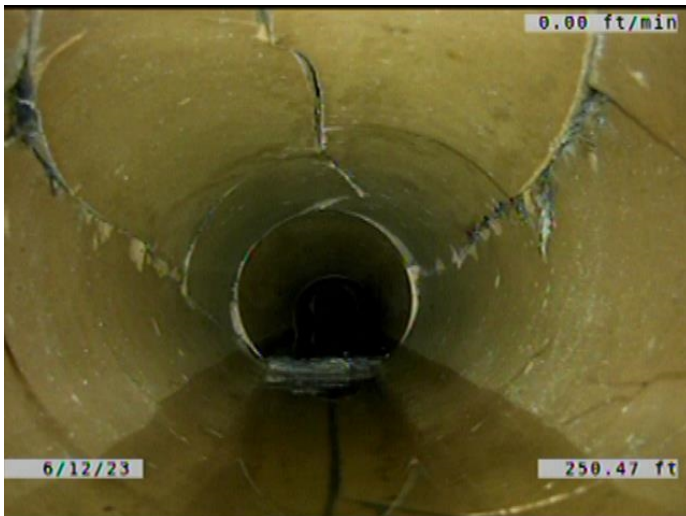
Code: **MWLS**
Description: **Miscellaneous Water Level Sag**

Distance (ft): **250.5**
Structural Grade: **2**
O&M Grade: **0**
Clock Start/From:
Clock To:
1st Value:
2nd Value:
Value Percent: **15.000**
Continuous Index: **F09**
Within 8" of Joint: **NO**
Remarks:

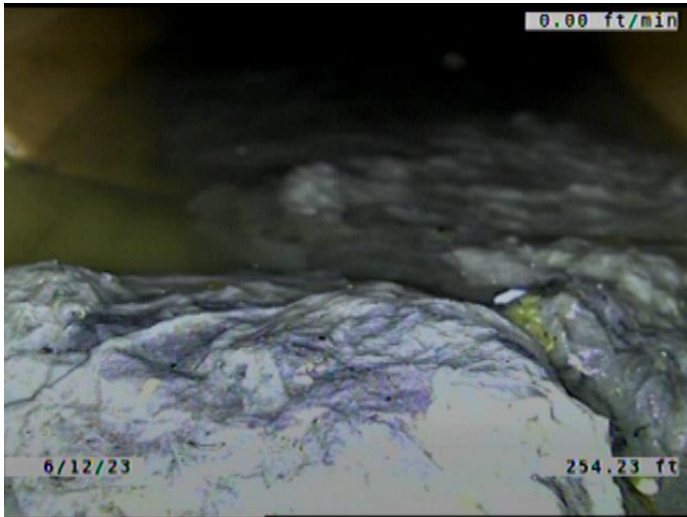
Code: **DAR**
 Description: **Deposits Attached Ragging**

Distance (ft): **254.2**
 Structural Grade: **0**
 O&M Grade: **2**
 Clock Start/From: **5**
 Clock To: **7**
 1st Value:
 2nd Value:
 Value Percent: **5.000**
 Continuous Index:
 Within 8" of Joint: **YES**
 Remarks:

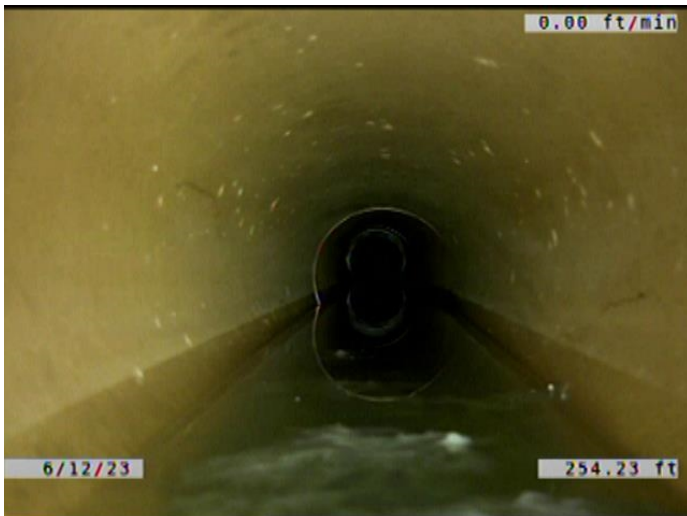
Code: **MWLS**
 Description: **Miscellaneous Water Level Sag**

Distance (ft): **254.2**
 Structural Grade: **2**
 O&M Grade: **0**
 Clock Start/From:
 Clock To:
 1st Value:
 2nd Value:
 Value Percent: **30.000**
 Continuous Index: **S12**
 Within 8" of Joint: **NO**
 Remarks:

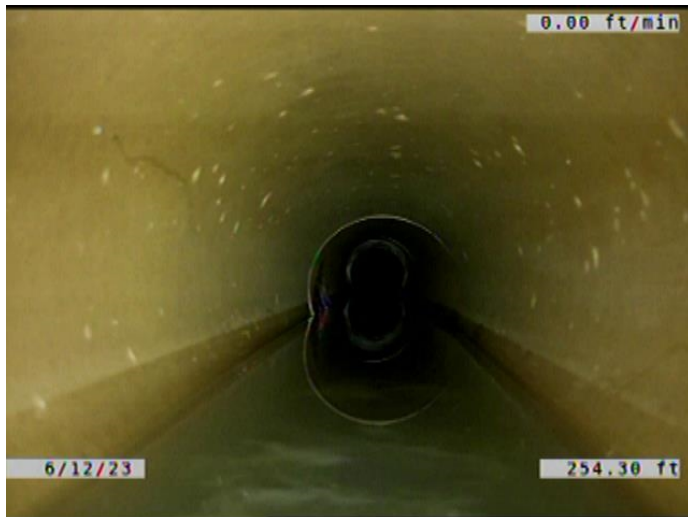
Code: **B**
Description: **Broken**

Distance (ft): **254.3**
Structural Grade: **4**
O&M Grade: **0**
Clock Start/From: **11**
Clock To: **1**
1st Value:
2nd Value:
Value Percent:
Continuous Index: **F10**
Within 8" of Joint: **YES**
Remarks:

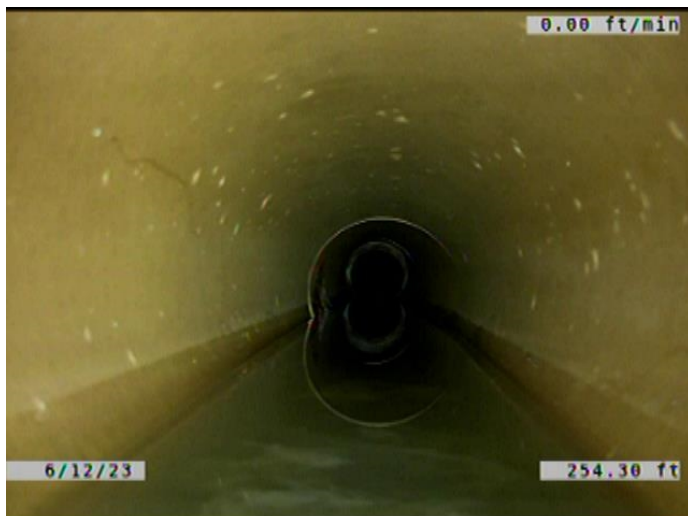
Code: **DR**
Description: **Deformed Rigid**

Distance (ft): **254.3**
Structural Grade: **4**
O&M Grade: **0**
Clock Start/From:
Clock To:
1st Value:
2nd Value:
Value Percent: **5.000**
Continuous Index: **F11**
Within 8" of Joint: **NO**
Remarks:

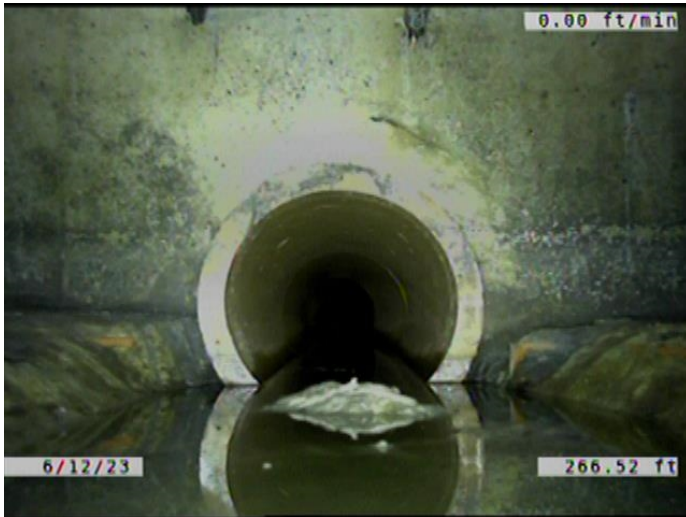
Code: **MWLS**
Description: **Miscellaneous Water Level Sag**

Distance (ft): **266.5**
Structural Grade: **2**
O&M Grade: **0**
Clock Start/From:
Clock To:
1st Value:
2nd Value:
Value Percent: **30.000**
Continuous Index: **F12**
Within 8" of Joint: **NO**
Remarks:

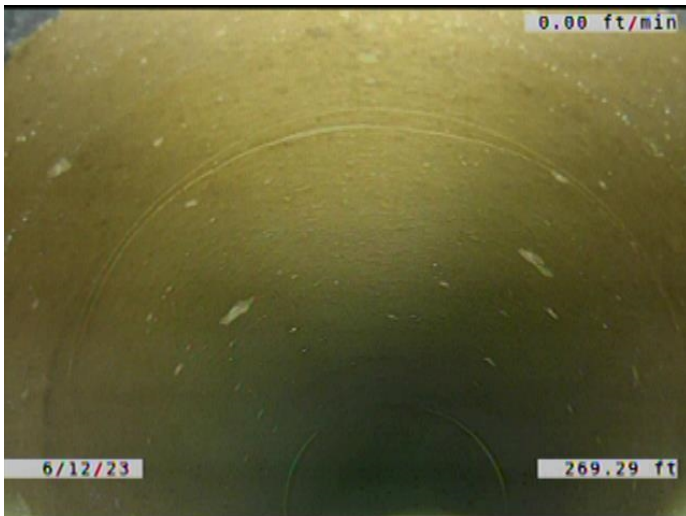
Code: **RFJ**
Description: **Roots Fine Joint**

Distance (ft): **269.3**
Structural Grade: **0**
O&M Grade: **1**
Clock Start/From: **8**
Clock To: **4**
1st Value:
2nd Value:
Value Percent:
Continuous Index: **F02**
Within 8" of Joint: **YES**
Remarks:
