Profile/Photo Observation Report

Street:	N UNION ST	Flow Control:	Not Controlled
City:	Hobart, IN	Year Renewed:	
Location:	Other	Tape/Media #:	
Purpose:	Not Known	Dia/Height:	10"
Use:	Sanitary	Material:	VCP
Drain Area:	NA	Lining:	
Category:	NA		
Comment:

Location Details:		Direction of Survey:	Downstream
US MH:	M-903-006	DS MH:	M-903-011
		Total Length Surveyed (ft):	18.2

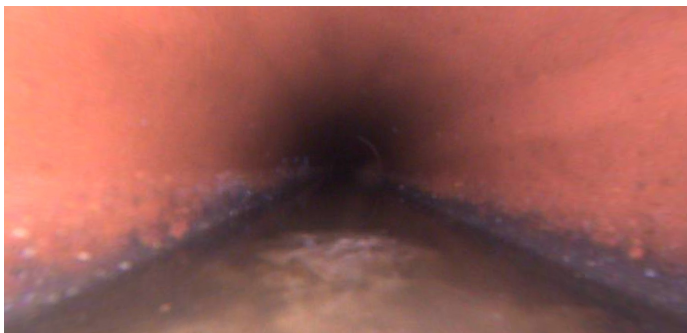
Code: **AMH**
Description: **Manhole**

Distance (ft): **.0**
Structural Grade: **0**
O&M Grade: **0**
Clock Start/From:
Clock To:
1st Value:
2nd Value:
Value Percent:
Continuous Index:
Within 8" of Joint: **NO**
Remarks: **M-903-006**

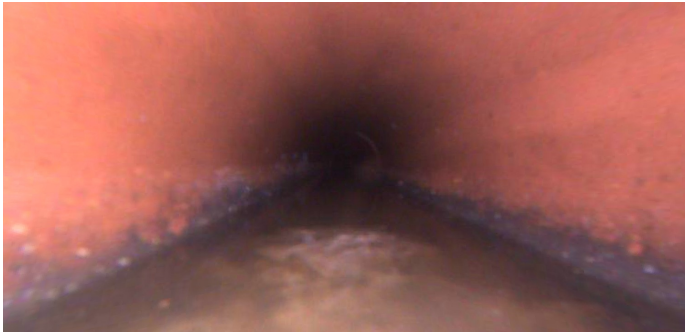
Code:	MWL
Description:	Water Level

Distance (ft):	.0
Structural Grade:	0
O&M Grade:	0
Clock Start/From:	
Clock To:	
1st Value:	
2nd Value:	
Value Percent:	30.000
Continuous Index:	
Within 8" of Joint:	NO
Remarks:

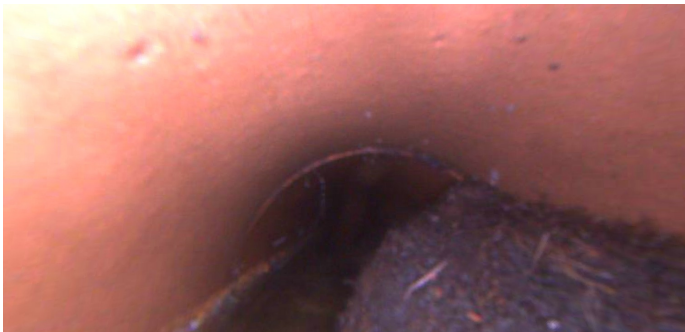
Code:	RMJ
Description:	Roots Medium Joint

Distance (ft):	18.2
Structural Grade:	0
O&M Grade:	3
Clock Start/From:	1
Clock To:	6
1st Value:	
2nd Value:	
Value Percent:	40.000
Continuous Index:	
Within 8" of Joint:	YES
Remarks:

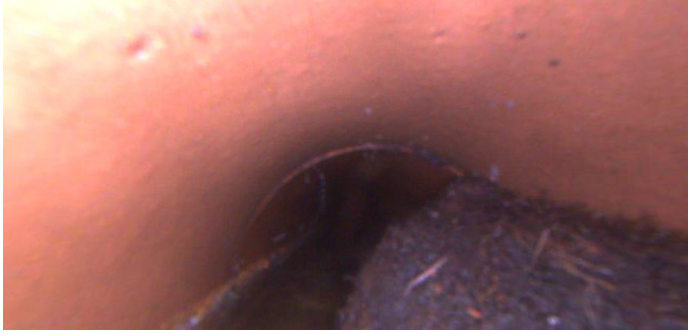
Code:	MSA
Description:	Abandoned Survey
Distance (ft):	18.2
Structural Grade:	0
O&M Grade:	0
Clock Start/From:	
Clock To:	
1st Value:	
2nd Value:	
Value Percent:	
Continuous Index:	
Within 8" of Joint:	NO
Remarks:	roots
