Profile/Photo Observation Report

Street:	E 38TH AVE & SPENCER PL	Flow Control:	Not Controlled
City:	Hobart, IN	Year Renewed:	
Location:	Other	Tape/Media #:	
Purpose:	Not Known	Dia/Height:	10"
Use:	Sanitary	Material:	VCP
Drain Area:	NA	Lining:	
Category:	NA		
Comment:

Location Details:		Direction of Survey:	Downstream
US MH:	M-903-006	DS MH:	M-903-011
		Total Length Surveyed (ft):	4.7

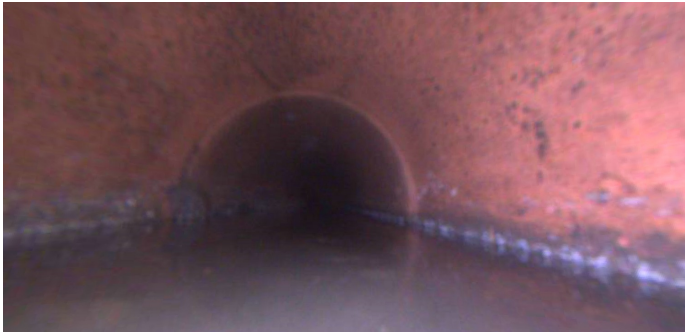
Code:	MWL
Description:	Water Level

Distance (ft):	.0
Structural Grade:	0
O&M Grade:	0
Clock Start/From:	
Clock To:	
1st Value:	
2nd Value:	
Value Percent:	40.000
Continuous Index:	
Within 8" of Joint:	NO
Remarks:

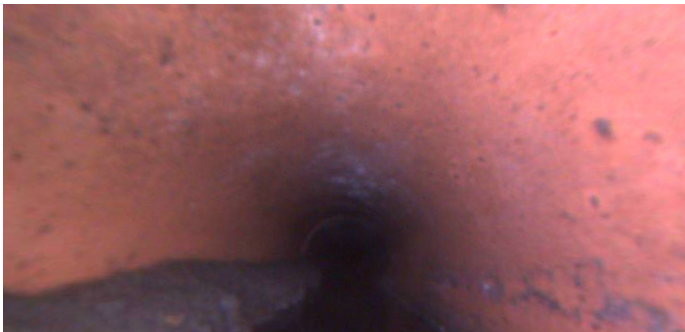
Code:	DAZ
Description:	Deposits Attached Other

Distance (ft):	4.7
Structural Grade:	0
O&M Grade:	2
Clock Start/From:	7
Clock To:	9
1st Value:	
2nd Value:	
Value Percent:	10.000
Continuous Index:	
Within 8" of Joint:	NO
Remarks:

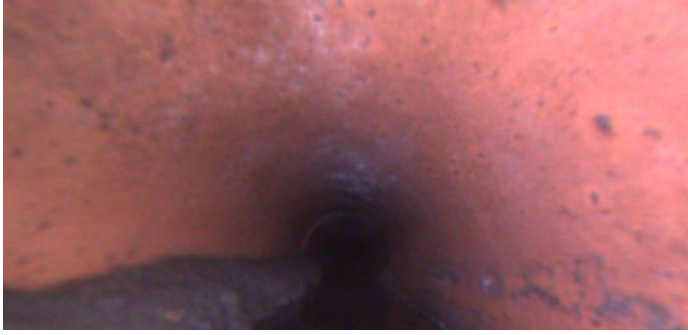
Code:	MSA
Description:	Abandoned Survey
Distance (ft):	4.7
Structural Grade:	0
O&M Grade:	0
Clock Start/From:	
Clock To:	
1st Value:	
2nd Value:	
Value Percent:	
Continuous Index:	
Within 8" of Joint:	NO
Remarks:	daz
