Profile/Photo Observation Report

| Street: | E 38TH AVE & SPENCER PL | Flow Control: | Not Controlled |
| City: | Hobart, IN | Year Renewed: | |
| US MH: | M-903-006 | DS MH: | M-903-011 |

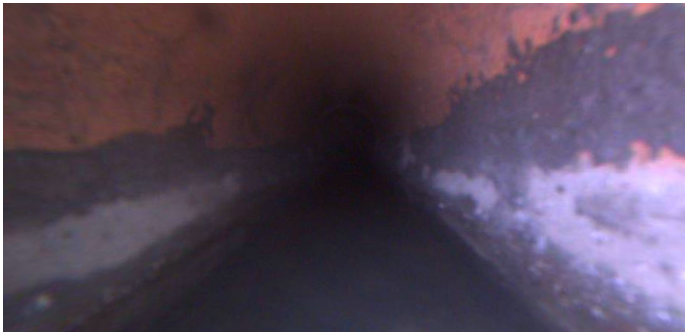
| Code: | DAGS |
| Description: | Deposits Attached Grease |

| O&M Grade: | 2 |
| Value Percent: | 5.000 |

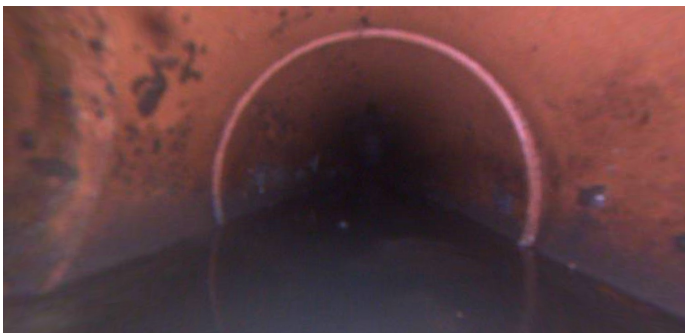
Code: **DAGS**
Description: **Deposits Attached Grease**

Distance (ft): **36.5**
Structural Grade: **0**
O&M Grade: **2**
Clock Start/From: **8**
Clock To: **4**
1st Value:
2nd Value:
Value Percent: **5.000**
Continuous Index: **F01**
Within 8" of Joint: **NO**
Remarks:

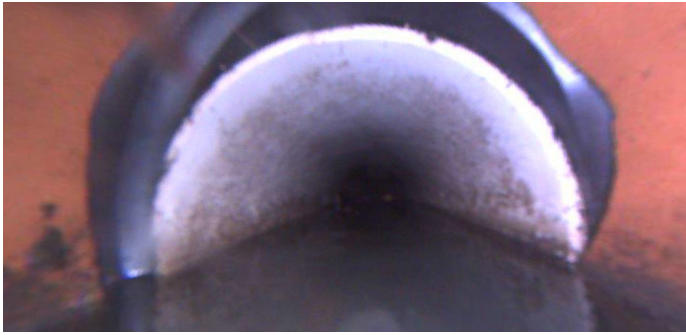
Code: **JOL**
Description: **Joint Offset Large**

Distance (ft): **57.6**
Structural Grade: **2**
O&M Grade: **0**
Clock Start/From:
Clock To:
1st Value:
2nd Value:
Value Percent:
Continuous Index:
Within 8" of Joint: **NO**
Remarks:

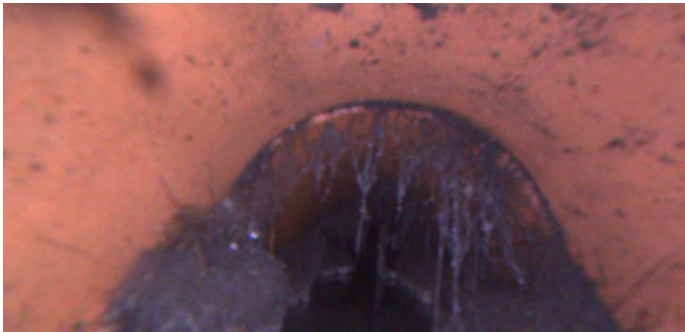
Code: **RMJ**
Description: **Roots Medium Joint**

Distance (ft): **72.1**
Structural Grade: **0**
O&M Grade: **3**
Clock Start/From: **8**
Clock To: **4**
1st Value:
2nd Value:
Value Percent: **20.000**
Continuous Index:
Within 8" of Joint: **YES**
Remarks:

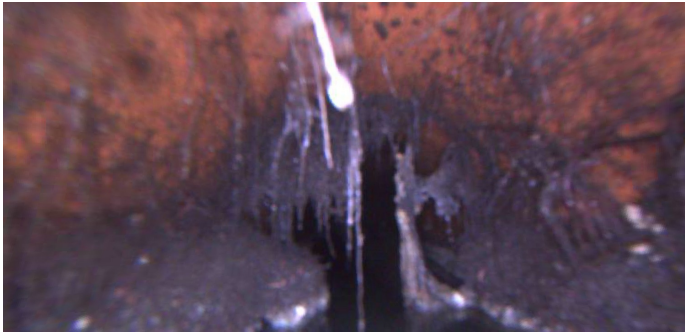
Code: **RBJ**
Description: **Roots Ball Joint**

Distance (ft): **74.0**
Structural Grade: **0**
O&M Grade: **4**
Clock Start/From: **8**
Clock To: **4**
1st Value:
2nd Value:
Value Percent: **60.000**
Continuous Index:
Within 8" of Joint: **YES**
Remarks:

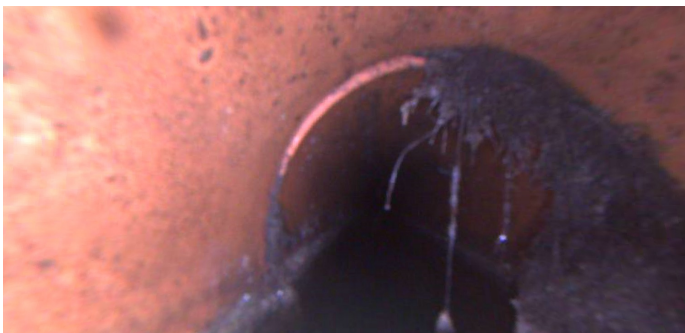
Code: **RMJ**
Description: **Roots Medium Joint**

Distance (ft): **79.9**
Structural Grade: **0**
O&M Grade: **3**
Clock Start/From: **8**
Clock To: **4**
1st Value:
2nd Value:
Value Percent: **20.000**
Continuous Index:
Within 8" of Joint: **YES**
Remarks:

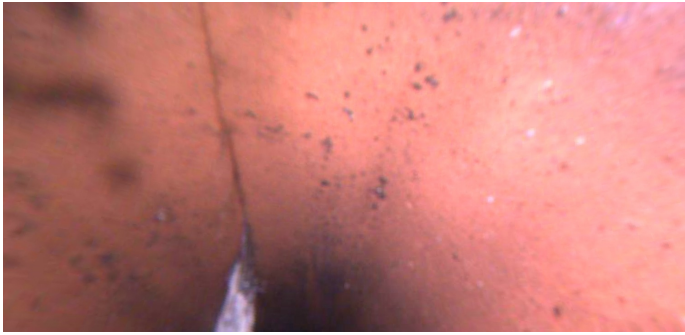
Code: **FL**
Description: **Fracture Longitudinal**

Distance (ft): **89.0**
Structural Grade: **3**
O&M Grade: **0**
Clock Start/From: **12**
Clock To:
1st Value:
2nd Value:
Value Percent:
Continuous Index:
Within 8" of Joint: **YES**
Remarks:

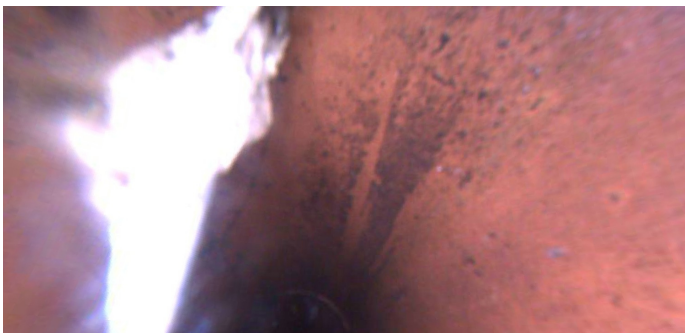
Code: **DAR**
Description: **Deposits Attached Ragging**

Distance (ft): **89.7**
Structural Grade: **0**
O&M Grade: **2**
Clock Start/From: **12**
Clock To:
1st Value:
2nd Value:
Value Percent: **10.000**
Continuous Index:
Within 8" of Joint: **NO**
Remarks:

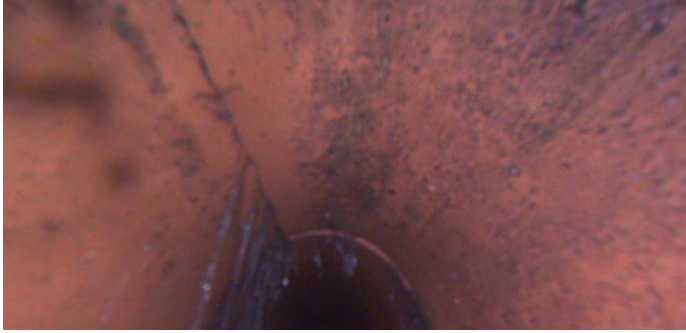
Code: **RFB**
Description: **Roots Fine Barrel**

Distance (ft): **91.0**
Structural Grade: **0**
O&M Grade: **2**
Clock Start/From: **12**
Clock To:
1st Value:
2nd Value:
Value Percent:
Continuous Index:
Within 8" of Joint: **NO**
Remarks:

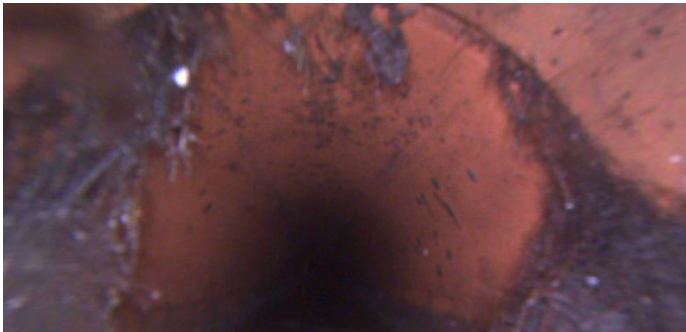
Code: **RMJ**
Description: **Roots Medium Joint**

Distance (ft): **92.0**
Structural Grade: **0**
O&M Grade: **3**
Clock Start/From: **8**
Clock To: **4**
1st Value:
2nd Value:
Value Percent: **20.000**
Continuous Index:
Within 8" of Joint: **YES**
Remarks:

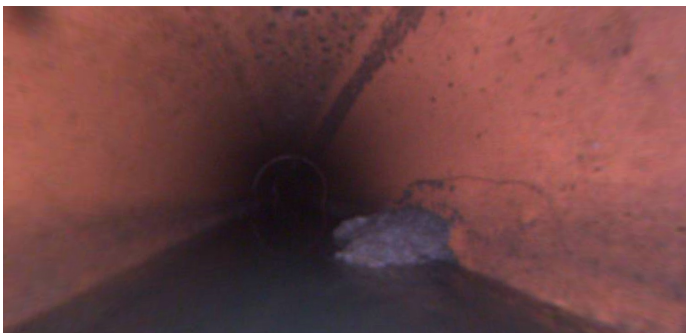
Code: **FL**
Description: **Fracture Longitudinal**

Distance (ft): **203.2**
Structural Grade: **3**
O&M Grade: **0**
Clock Start/From: **3**
Clock To:
1st Value:
2nd Value:
Value Percent:
Continuous Index:
Within 8" of Joint:
Remarks:

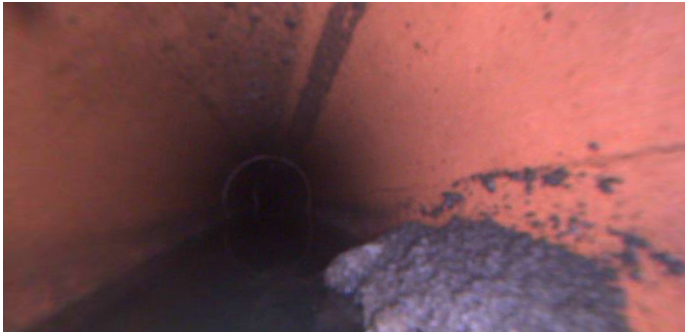
Code: **DAZ**
Description: **Deposits Attached Other**

Distance (ft): **203.8**
Structural Grade: **0**
O&M Grade: **2**
Clock Start/From: **3**
Clock To: **4**
1st Value:
2nd Value:
Value Percent: **10.000**
Continuous Index:
Within 8" of Joint: **NO**
Remarks:

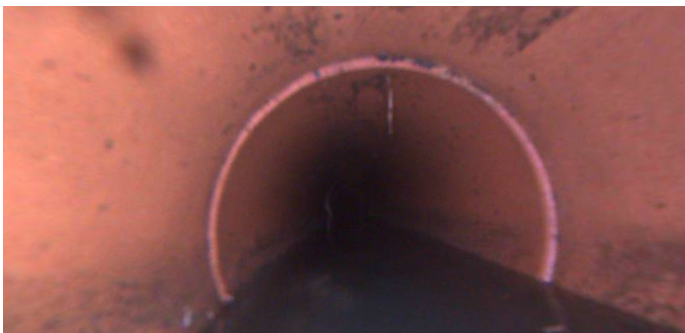
Code: **RFJ**
Description: **Roots Fine Joint**

Distance (ft): **206.5**
Structural Grade: **0**
O&M Grade: **1**
Clock Start/From: **12**
Clock To:
1st Value:
2nd Value:
Value Percent:
Continuous Index:
Within 8" of Joint: **YES**
Remarks:

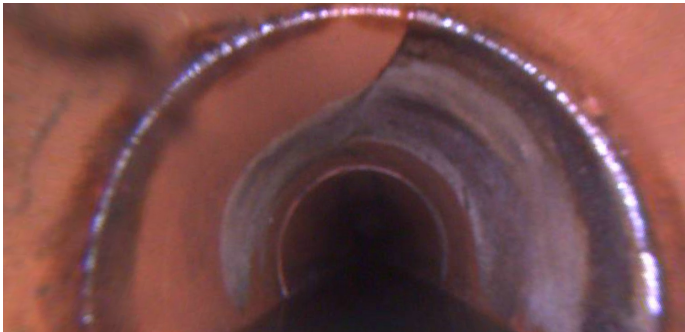
Code: **IW**
Description: **Infil Weeper**

Distance (ft): **214.7**
Structural Grade: **0**
O&M Grade: **2**
Clock Start/From: **8**
Clock To: **4**
1st Value:
2nd Value:
Value Percent:
Continuous Index:
Within 8" of Joint: **YES**
Remarks:

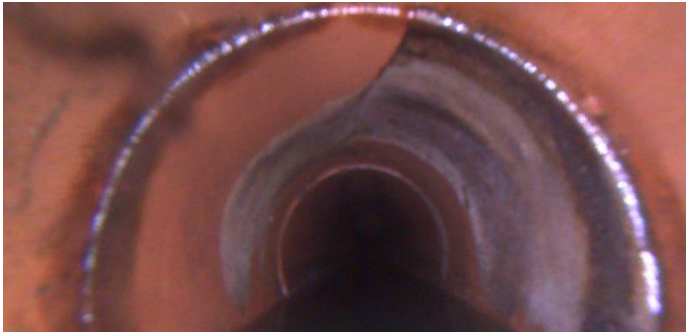
Code: **FL**
Description: **Fracture Longitudinal**

Distance (ft): **214.7**
Structural Grade: **3**
O&M Grade: **0**
Clock Start/From: **12**
Clock To:
1st Value:
2nd Value:
Value Percent:
Continuous Index:
Within 8" of Joint: **YES**
Remarks:

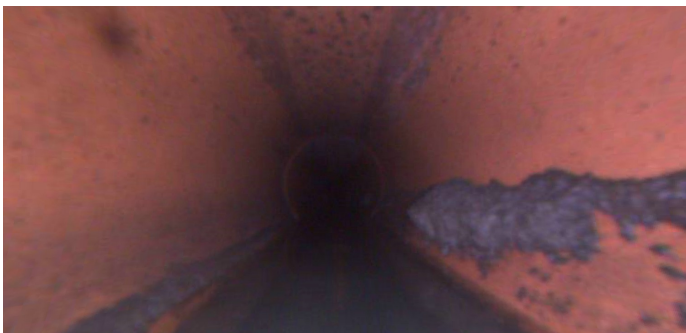
Code: **DAGS**
Description: **Deposits Attached Grease**

Distance (ft): **248.0**
Structural Grade: **0**
O&M Grade: **2**
Clock Start/From: **3**
Clock To: **4**
1st Value:
2nd Value:
Value Percent: **5.000**
Continuous Index: **S02**
Within 8" of Joint: **NO**
Remarks:

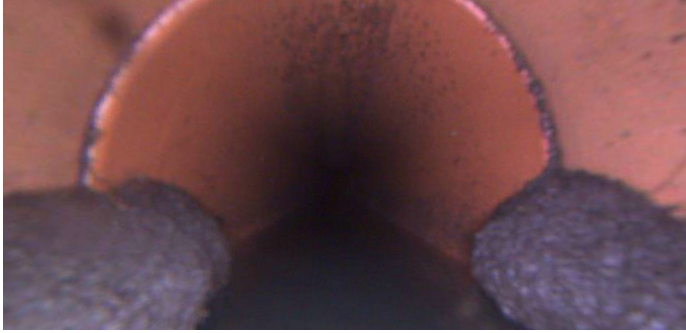
Code: **DAZ**
Description: **Deposits Attached Other**

Distance (ft): **256.1**
Structural Grade: **0**
O&M Grade: **2**
Clock Start/From: **7**
Clock To: **5**
1st Value:
2nd Value:
Value Percent: **10.000**
Continuous Index:
Within 8" of Joint: **YES**
Remarks:

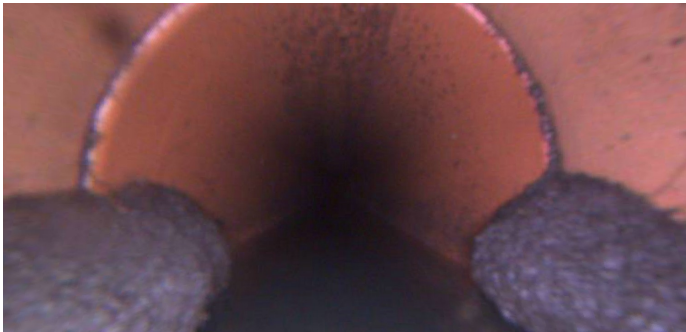
Code: **DAGS**
Description: **Deposits Attached Grease**

Distance (ft): **256.1**
Structural Grade: **0**
O&M Grade: **2**
Clock Start/From: **3**
Clock To: **4**
1st Value:
2nd Value:
Value Percent: **5.000**
Continuous Index: **F02**
Within 8" of Joint: **NO**
Remarks:

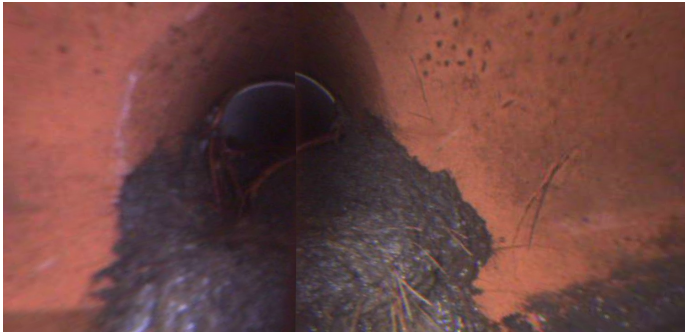
Code: **TFD**
Description: **Tap Factory Defective**

Distance (ft): **264.0**
Structural Grade: **0**
O&M Grade: **2**
Clock Start/From: **3**
Clock To:
1st Value: **4.000**
2nd Value:
Value Percent:
Continuous Index:
Within 8" of Joint:
Remarks: **RML**

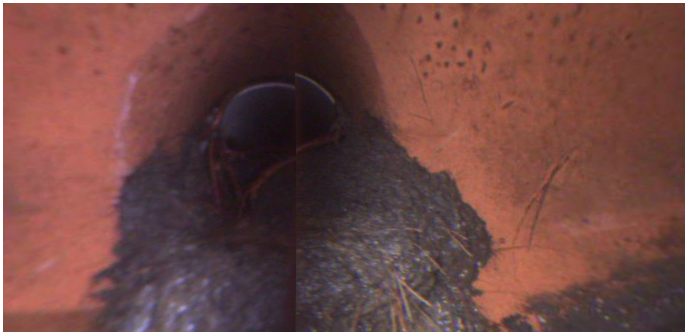
Code: **RML**
Description: **Roots Medium Lateral**

Distance (ft): **264.0**
Structural Grade: **0**
O&M Grade: **3**
Clock Start/From: **3**
Clock To: **4**
1st Value:
2nd Value:
Value Percent: **10.000**
Continuous Index:
Within 8" of Joint: **NO**
Remarks:

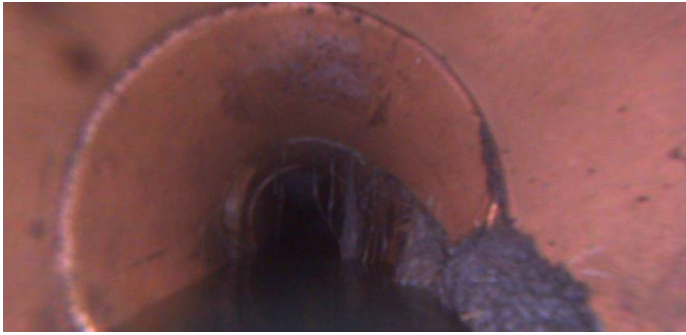
Code: **FM**
Description: **Fracture Multiple**

Distance (ft): **270.0**
Structural Grade: **4**
O&M Grade: **0**
Clock Start/From: **8**
Clock To: **2**
1st Value:
2nd Value:
Value Percent:
Continuous Index:
Within 8" of Joint: **YES**
Remarks:

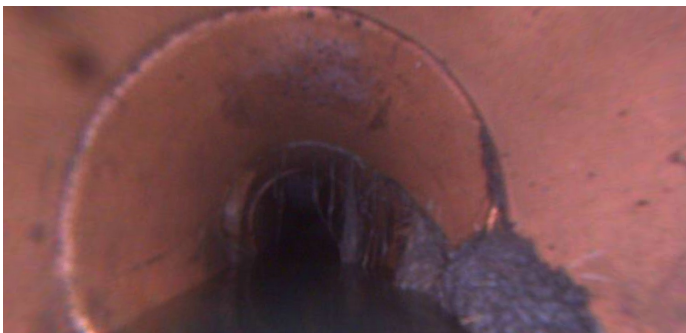
Code: **RMJ**
Description: **Roots Medium Joint**

Distance (ft): **270.0**
Structural Grade: **0**
O&M Grade: **3**
Clock Start/From: **3**
Clock To: **4**
1st Value:
2nd Value:
Value Percent: **5.000**
Continuous Index:
Within 8" of Joint: **YES**
Remarks:

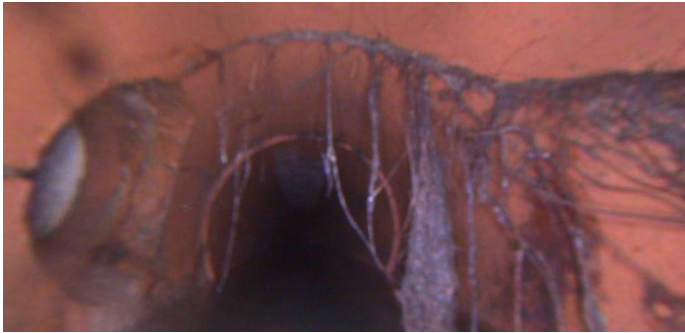
Code: **FS**
Description: **Fracture Spiral**

Distance (ft): **271.2**
Structural Grade: **3**
O&M Grade: **0**
Clock Start/From: **11**
Clock To: **4**
1st Value:
2nd Value:
Value Percent:
Continuous Index:
Within 8" of Joint:
Remarks:

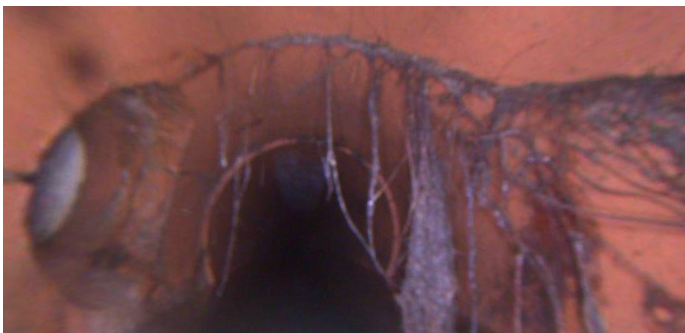
Code: **RMB**
Description: **Roots Medium Barrel**

Distance (ft): **271.2**
Structural Grade: **0**
O&M Grade: **4**
Clock Start/From: **11**
Clock To: **4**
1st Value:
2nd Value:
Value Percent: **10.000**
Continuous Index:
Within 8" of Joint: **NO**
Remarks:

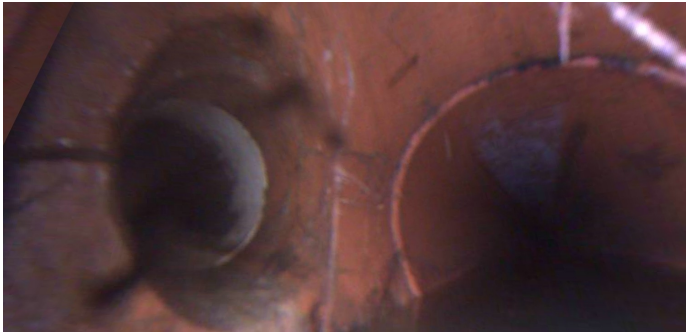
Code: **TFD**
Description: **Tap Factory Defective**

Distance (ft): **271.6**
Structural Grade: **0**
O&M Grade: **2**
Clock Start/From: **9**
Clock To:
1st Value: **4.000**
2nd Value:
Value Percent:
Continuous Index:
Within 8" of Joint:
Remarks: **ROOTS**

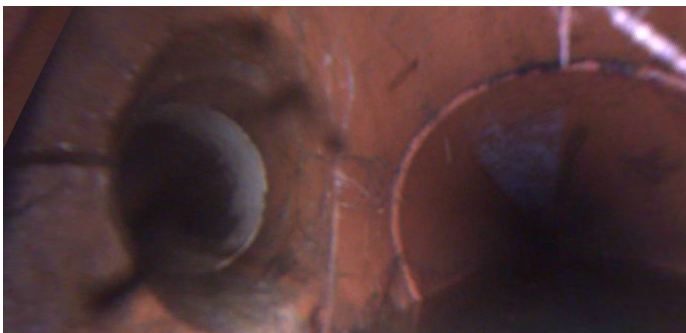
Code: **RFL**
Description: **Roots Fine Lateral**

Distance (ft): **271.6**
Structural Grade: **0**
O&M Grade: **1**
Clock Start/From: **8**
Clock To: **10**
1st Value:
2nd Value:
Value Percent:
Continuous Index:
Within 8" of Joint: **NO**
Remarks:

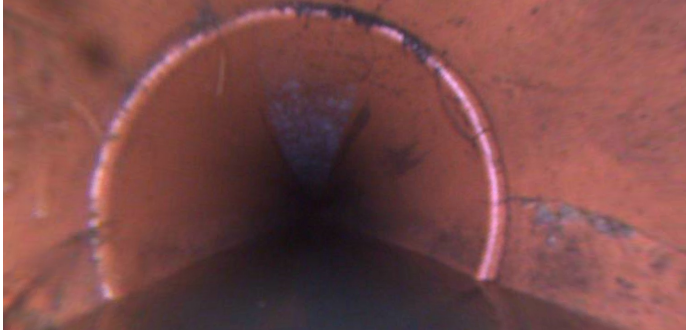
Code: **FM**
Description: **Fracture Multiple**

Distance (ft): **271.9**
Structural Grade: **4**
O&M Grade: **0**
Clock Start/From: **8**
Clock To: **4**
1st Value:
2nd Value:
Value Percent:
Continuous Index:
Within 8" of Joint: **YES**
Remarks:

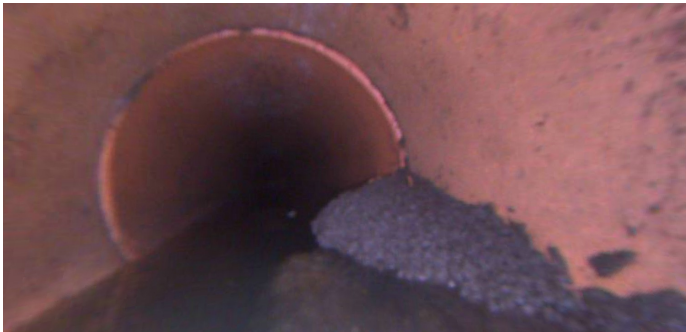
Code: **DAZ**
Description: **Deposits Attached Other**

Distance (ft): **277.6**
Structural Grade: **0**
O&M Grade: **2**
Clock Start/From: **3**
Clock To: **4**
1st Value:
2nd Value:
Value Percent: **10.000**
Continuous Index:
Within 8" of Joint: **YES**
Remarks:

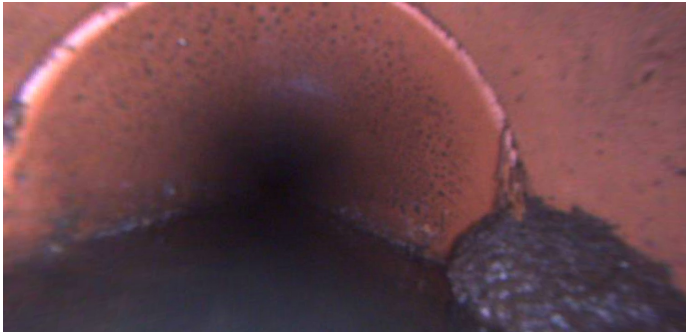
Code: **RFJ**
Description: **Roots Fine Joint**

Distance (ft): **290.2**
Structural Grade: **0**
O&M Grade: **1**
Clock Start/From: **3**
Clock To:
1st Value:
2nd Value:
Value Percent:
Continuous Index:
Within 8" of Joint: **YES**
Remarks:

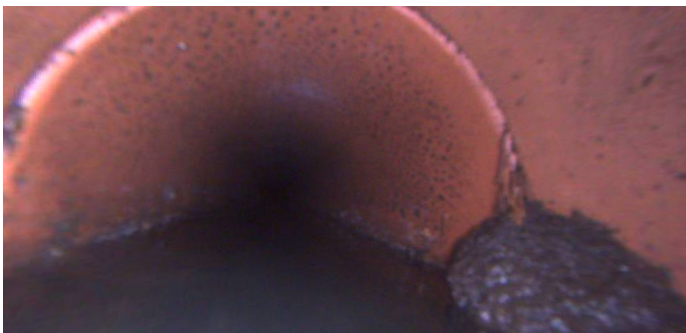
Code: **DAZ**
Description: **Deposits Attached Other**

Distance (ft): **290.2**
Structural Grade: **0**
O&M Grade: **2**
Clock Start/From: **3**
Clock To: **4**
1st Value:
2nd Value:
Value Percent: **5.000**
Continuous Index:
Within 8" of Joint: **YES**
Remarks:

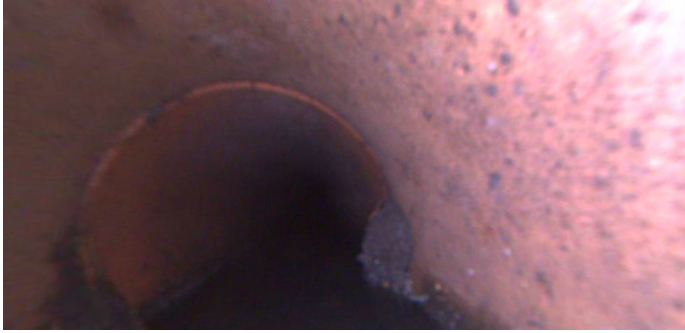
Code: **DAZ**
Description: **Deposits Attached Other**

Distance (ft): **295.6**
Structural Grade: **0**
O&M Grade: **2**
Clock Start/From: **8**
Clock To: **4**
1st Value:
2nd Value:
Value Percent: **5.000**
Continuous Index:
Within 8" of Joint: **YES**
Remarks:

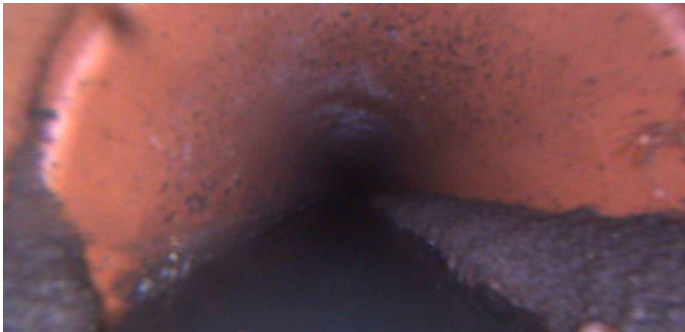
Code: **DAZ**
Description: **Deposits Attached Other**

Distance (ft): **302.0**
Structural Grade: **0**
O&M Grade: **2**
Clock Start/From: **7**
Clock To: **5**
1st Value:
2nd Value:
Value Percent: **10.000**
Continuous Index: **S03**
Within 8" of Joint: **NO**
Remarks:

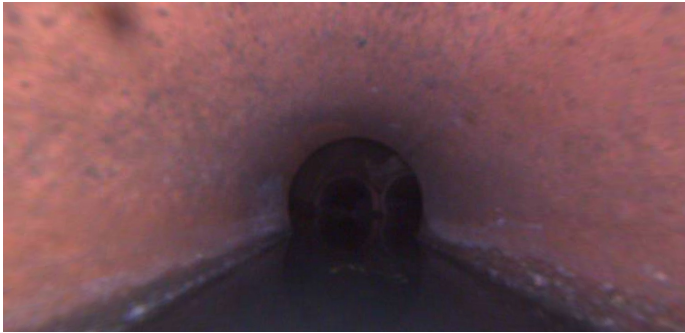
Code: **DAZ**
Description: **Deposits Attached Other**

Distance (ft): **309.3**
Structural Grade: **0**
O&M Grade: **2**
Clock Start/From: **7**
Clock To: **5**
1st Value:
2nd Value:
Value Percent: **10.000**
Continuous Index: **F03**
Within 8" of Joint: **NO**
Remarks:
