## Profile/Photo Observation Report

Date:	<b>03/23/2018</b>	Weather:		Coding:	<b>PACP 6.0</b>
Pipe Length (ft):	<b>145.1</b>	Owner:	<b>NA</b>	Pre Clean:	<b>Not Known</b>
P.O.#:		Surveyor:	<b>Jen Costello</b>	PSR:	<b>P-903-008-007</b>
Customer:		Clean Date:	<b>01/01/1900</b>	Shape:	<b>C</b>

Street:	<b>E 38TH AVE</b>	Flow Control:	<b>Not Controlled</b>
City:	<b>Hobart, IN</b>	Year Renewed:	
Location:	<b>Other</b>	Tape/Media #:	
Purpose:	<b>Not Known</b>	Dia/Height:	<b>10"</b>
Use:	<b>Sanitary</b>	Material:	<b>PVC</b>
Drain Area:	<b>NA</b>	Lining:	
Category:	<b>NA</b>		
Comment:			
Location Details:		Direction of Survey:	<b>Downstream</b>
US MH:	<b>M-903-007</b>	DS MH:	<b>M-903-008</b>
		Total Length Surveyed (ft):	<b>5.4</b>

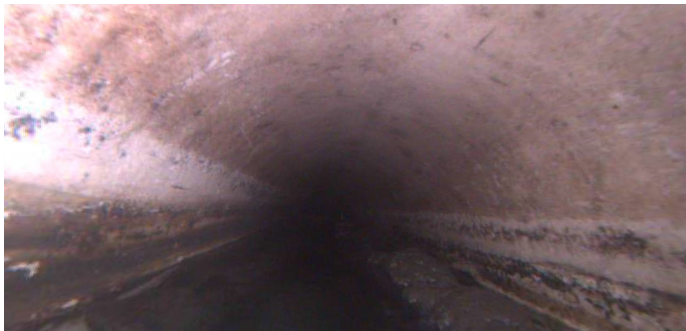
Code: **AMH**  
Description: **Manhole**

Distance (ft): **.0**  
Structural Grade: **0**  
O&M Grade: **0**  
Clock Start/From:  
Clock To:  
1st Value:  
2nd Value:  
Value Percent:  
Continuous Index:  
Within 8" of Joint: **NO**  
Remarks: **M-903-007**

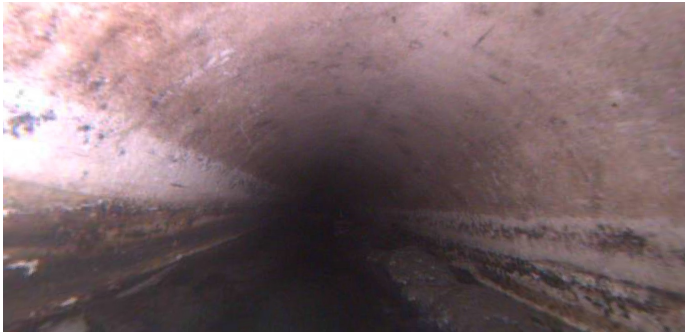
Code:	<b>MWL</b>
Description:	<b>Water Level</b>

Distance (ft):	<b>.0</b>
Structural Grade:	<b>0</b>
O&M Grade:	<b>0</b>
Clock Start/From:	
Clock To:	
1st Value:	
2nd Value:	
Value Percent:	<b>30.000</b>
Continuous Index:	
Within 8" of Joint:	<b>NO</b>
Remarks:

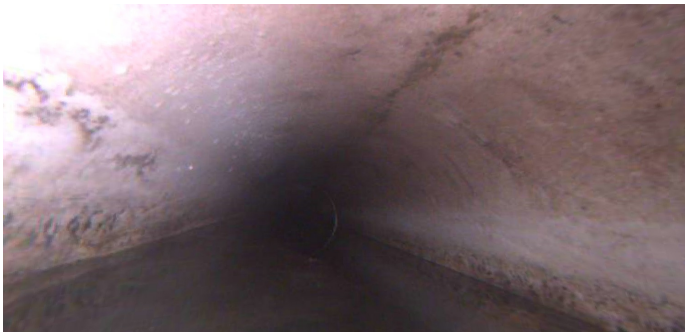
Code:	<b>MSA</b>
Description:	<b>Abandoned Survey</b>

Distance (ft):	<b>5.4</b>
Structural Grade:	<b>0</b>
O&M Grade:	<b>0</b>
Clock Start/From:	
Clock To:	
1st Value:	
2nd Value:	
Value Percent:	
Continuous Index:	
Within 8" of Joint:	<b>NO</b>
Remarks:	<b>OVERTURNED</b>
