## Profile/Photo Observation Report

Date:	<b>06/12/2023</b>	Weather:		Coding:	<b>PACP 7.0</b>
Pipe Length (ft):	<b>134.3</b>	Owner:	<b>City of Hobart</b>	Pre Clean:	<b>Heavy Cleaning</b>
P.O.#:	<b>YES502259</b>	Surveyor:	<b>S. Bucklin</b>	PSR:	<b>P-903-008-007</b>
Customer:	<b>City of Hobart</b>	Clean Date:	<b>06/11/2023</b>	Shape:	<b>C</b>

Street:	<b>East 38th Street</b>	Flow Control:	<b>Not Controlled</b>
City:	<b>Hobart, IN</b>	Year Renewed:	
Location:	<b>Easement/Right of Way</b>	Tape/Media #:	
Purpose:	<b>Routine Assessment</b>	Dia/Height:	<b>12"</b>
Use:	<b>Sanitary Sewage Pipe</b>	Material:	<b>PVC</b>
Drain Area:		Lining:	<b>None</b>
Category:	<b>NA</b>		
Comment:			
Location Details:		Direction of Survey:	<b>Upstream</b>
US MH:	<b>M-903-007</b>	DS MH:	<b>M-903-008</b>
		Total Length Surveyed (ft):	<b>134.3</b>

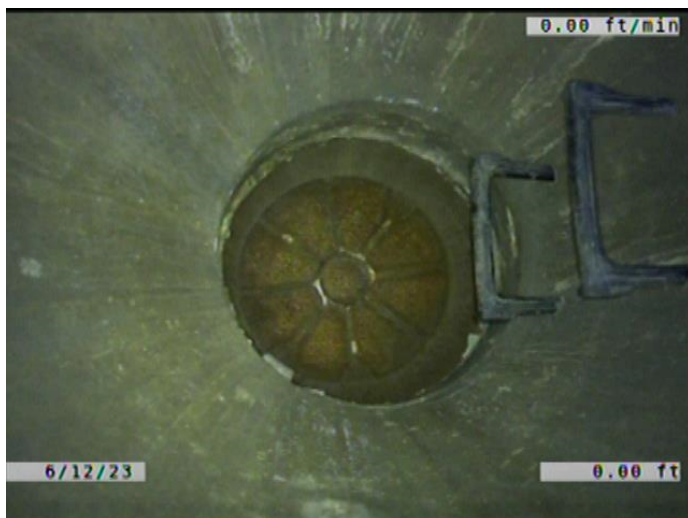
Code: **AMH**  
Description: **Manhole**

Distance (ft): **.0**  
Structural Grade: **0**  
O&M Grade: **0**  
Clock Start/From:  
Clock To:  
1st Value:  
2nd Value:  
Value Percent:  
Continuous Index:  
Within 8" of Joint: **NO**  
Remarks: **M-903-008**

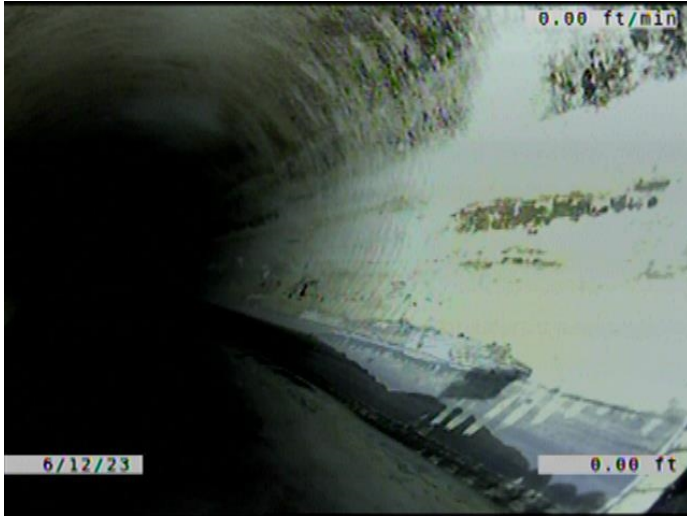
Code: **MWL**  
Description: **Miscellaneous Water Level**

Distance (ft): **.0**  
Structural Grade: **0**  
O&M Grade: **0**  
Clock Start/From:  
Clock To:  
1st Value:  
2nd Value:  
Value Percent: **15.000**  
Continuous Index:  
Within 8" of Joint: **NO**  
Remarks:

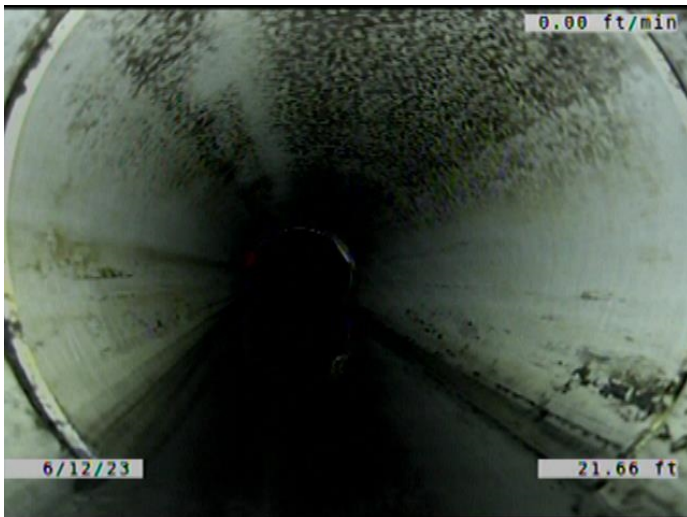
Code: **LL**  
Description: **Line Left**

Distance (ft): **21.7**  
Structural Grade: **0**  
O&M Grade: **1**  
Clock Start/From:  
Clock To:  
1st Value:  
2nd Value:  
Value Percent: **5.000**  
Continuous Index:  
Within 8" of Joint: **NO**  
Remarks:

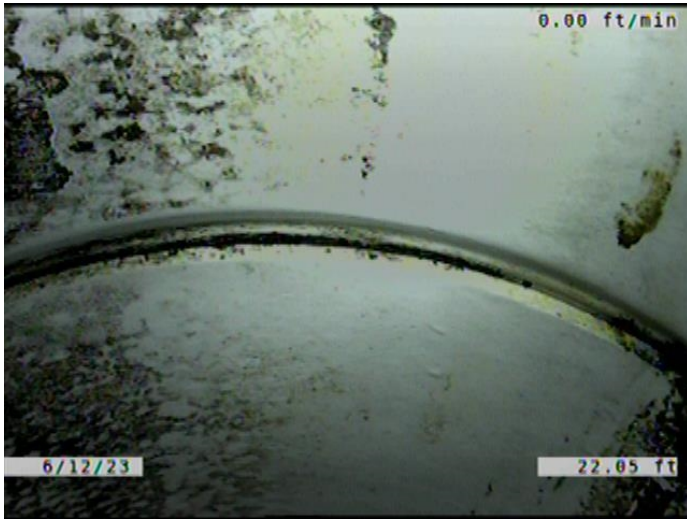
Code: **JAM**  
Description: **Joint Angular Medium**

Distance (ft): **22.0**  
Structural Grade: **3**  
O&M Grade: **0**  
Clock Start/From:  
Clock To:  
1st Value:  
2nd Value:  
Value Percent:  
Continuous Index:  
Within 8" of Joint: **NO**  
Remarks:

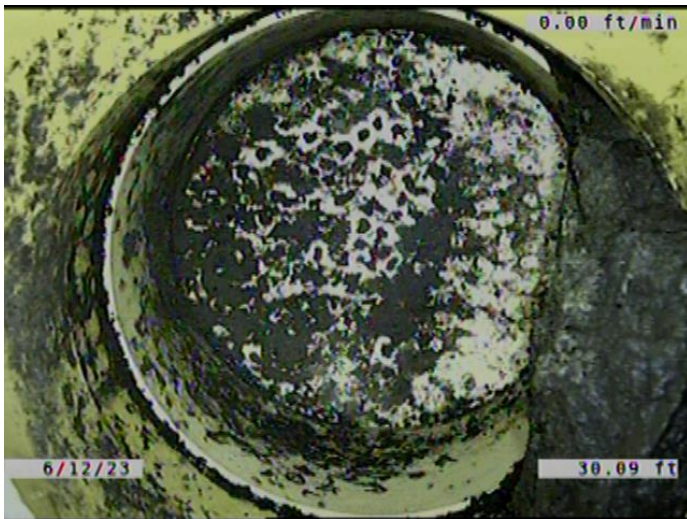
Code: **TFC**  
Description: **Tap Factory Capped**

Distance (ft): **30.1**  
Structural Grade: **0**  
O&M Grade: **0**  
Clock Start/From: **2**  
Clock To:  
1st Value: **6.000**  
2nd Value:  
Value Percent:  
Continuous Index:  
Within 8" of Joint: **YES**  
Remarks:

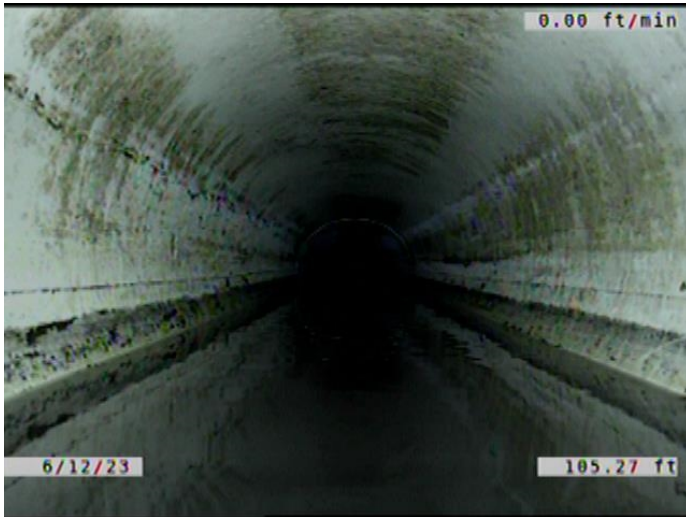
Code: **MWLS**  
Description: **Miscellaneous Water Level Sag**

Distance (ft): **105.3**  
Structural Grade: **3**  
O&M Grade: **0**  
Clock Start/From:  
Clock To:  
1st Value:  
2nd Value:  
Value Percent: **45.000**  
Continuous Index: **S01**  
Within 8" of Joint: **NO**  
Remarks:

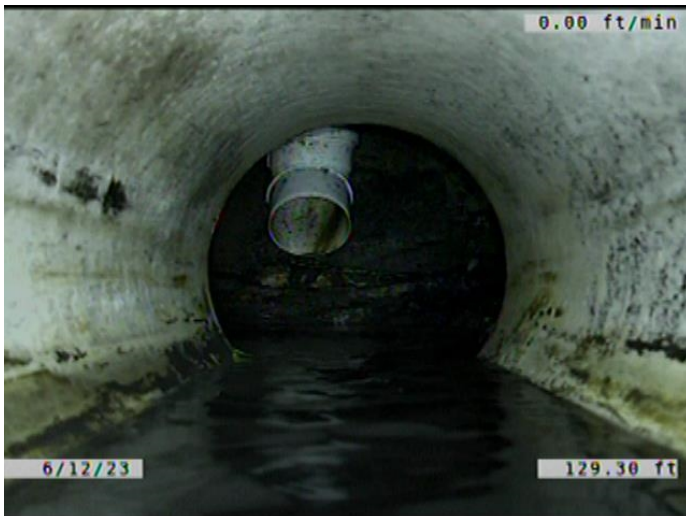
Code: **MWLS**  
Description: **Miscellaneous Water Level Sag**

Distance (ft): **129.3**  
Structural Grade: **3**  
O&M Grade: **0**  
Clock Start/From:  
Clock To:  
1st Value:  
2nd Value:  
Value Percent: **45.000**  
Continuous Index: **F01**  
Within 8" of Joint: **NO**  
Remarks:

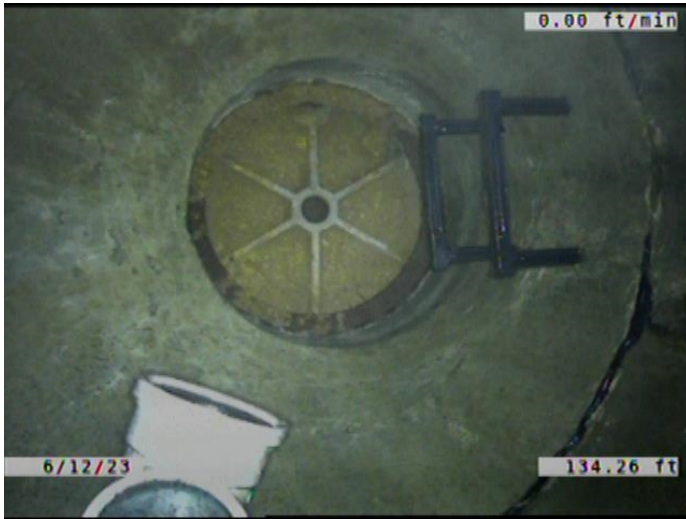
Code:	AMH
Description:	Manhole
Distance (ft):	134.3
Structural Grade:	0
O&M Grade:	0
Clock Start/From:	
Clock To:	
1st Value:	
2nd Value:	
Value Percent:	
Continuous Index:	
Within 8" of Joint:	NO
Remarks:	M-903-007
