Profile/Photo Observation Report

Street:	N UNION ST	Flow Control:	Not Controlled
City:	Hobart, IN	Year Renewed:	
Location:	Other	Tape/Media #:	
Purpose:	Not Known	Dia/Height:	10"
Use:	Sanitary	Material:	VCP
Drain Area:	NA	Lining:	
Category:	NA		
Comment:	NULL-REV-CNL M-902-062

Location Details:		Direction of Survey:	Downstream
US MH:	M-903-009	DS MH:	M-903-010
		Total Length Surveyed (ft):	156.2

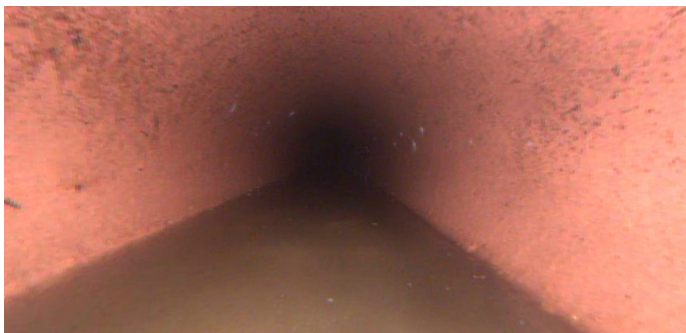
Code: **AMH**
Description: **Manhole**

Distance (ft): **.0**
Structural Grade: **0**
O&M Grade: **0**
Clock Start/From:
Clock To:
1st Value:
2nd Value:
Value Percent:
Continuous Index:
Within 8" of Joint: **NO**
Remarks: **M-903-009**

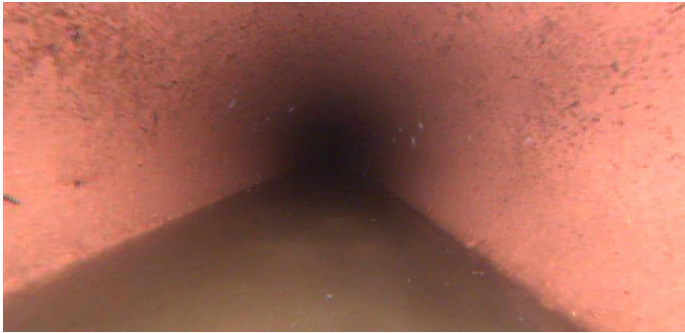
Code:	MWL
Description:	Water Level

Distance (ft):	.0
Structural Grade:	0
O&M Grade:	0
Clock Start/From:	
Clock To:	
1st Value:	
2nd Value:	
Value Percent:	5.000
Continuous Index:	
Within 8" of Joint:	NO
Remarks:

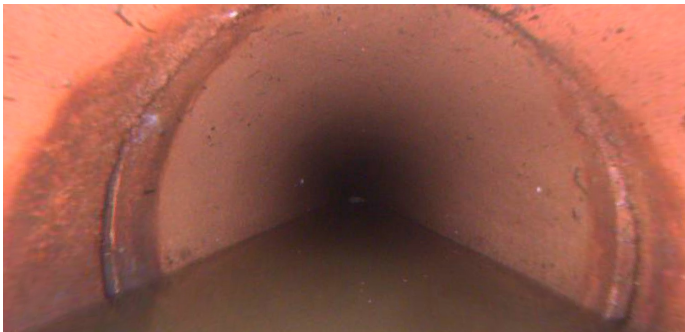
Code:	IS
Description:	Infil Stain

Distance (ft):	129.1
Structural Grade:	0
O&M Grade:	0
Clock Start/From:	8
Clock To:	4
1st Value:	
2nd Value:	
Value Percent:	
Continuous Index:	
Within 8" of Joint:	YES
Remarks:

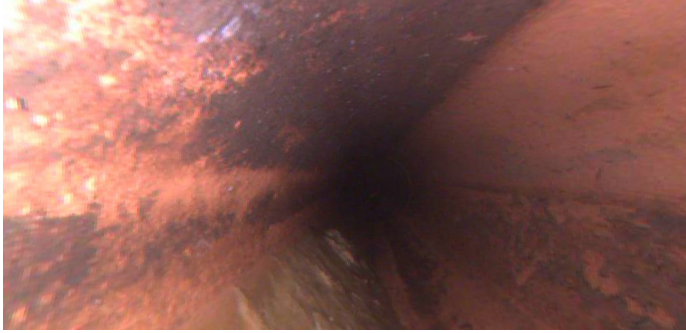
Code:	MSA
Description:	Abandoned Survey
Distance (ft):	156.2
Structural Grade:	0
O&M Grade:	0
Clock Start/From:	
Clock To:	
1st Value:	
2nd Value:	
Value Percent:	
Continuous Index:	
Within 8" of Joint:	NO
Remarks:	camera stopped
