## Profile/Photo Observation Report

Street:	<b>OFF N UNION ST</b>	Flow Control:	<b>Not Controlled</b>
City:	<b>Hobart, IN</b>	Year Renewed:	
Location:	<b>Other</b>	Tape/Media #:	
Purpose:	<b>Not Known</b>	Dia/Height:	<b>10"</b>
Use:	<b>Sanitary</b>	Material:	<b>VCP</b>
Drain Area:	<b>NA</b>	Lining:	
Category:	<b>NA</b>		
Comment:	<b>NULL-REV-CNL M-902-062</b>

Location Details:		Direction of Survey:	<b>Upstream</b>
US MH:	<b>M-903-009</b>	DS MH:	<b>M-903-010</b>
		Total Length Surveyed (ft):	<b>122.0</b>

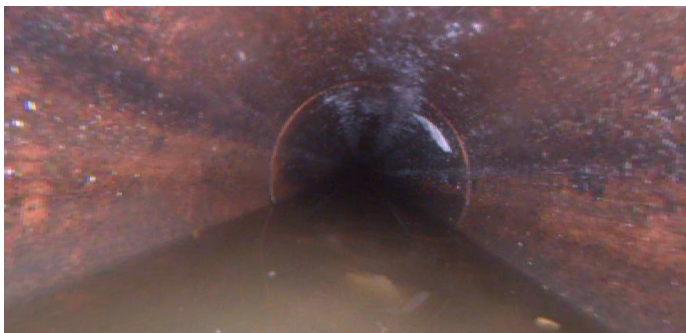
Code: **AMH**  
Description: **Manhole**

Distance (ft): **.0**  
Structural Grade: **0**  
O&M Grade: **0**  
Clock Start/From:  
Clock To:  
1st Value:  
2nd Value:  
Value Percent:  
Continuous Index:  
Within 8" of Joint: **NO**  
Remarks: **M-903-009**

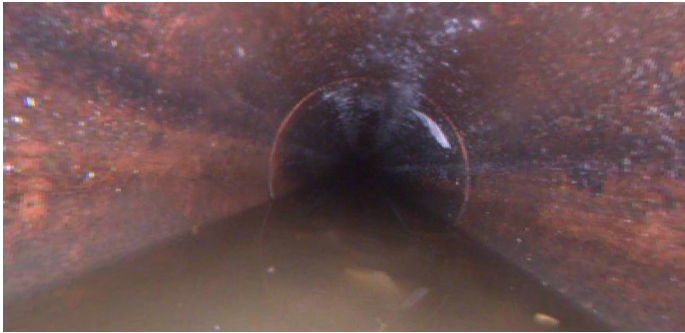
Code:	<b>MWL</b>
Description:	<b>Water Level</b>

Distance (ft):	<b>.0</b>
Structural Grade:	<b>0</b>
O&M Grade:	<b>0</b>
Clock Start/From:	
Clock To:	
1st Value:	
2nd Value:	
Value Percent:	<b>5.000</b>
Continuous Index:	
Within 8" of Joint:	<b>NO</b>
Remarks:

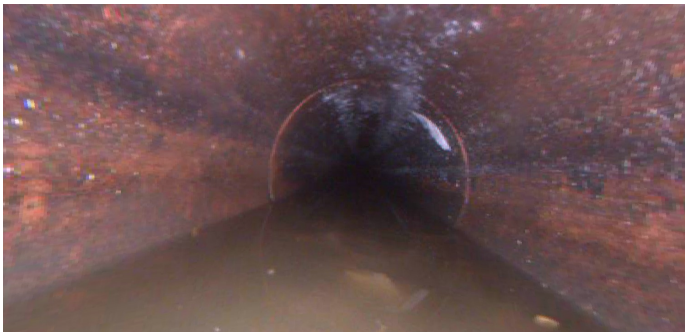
Code:	<b>DAGS</b>
Description:	<b>Deposits Attached Grease</b>

Distance (ft):	<b>.0</b>
Structural Grade:	<b>0</b>
O&M Grade:	<b>2</b>
Clock Start/From:	<b>7</b>
Clock To:	<b>5</b>
1st Value:	
2nd Value:	
Value Percent:	<b>5.000</b>
Continuous Index:	<b>S01</b>
Within 8" of Joint:	<b>YES</b>
Remarks:	<b>WANDER</b>

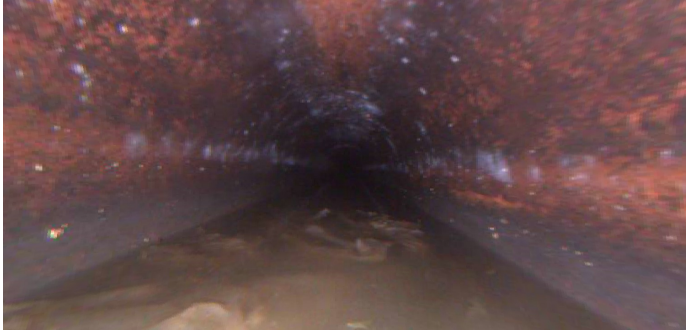
Code: **MGO**  
Description: **General Observation**

Distance (ft): **8.3**  
Structural Grade: **0**  
O&M Grade: **0**  
Clock Start/From:  
Clock To:  
1st Value:  
2nd Value:  
Value Percent:  
Continuous Index:  
Within 8" of Joint: **NO**  
Remarks: **TOILET TISSUE**

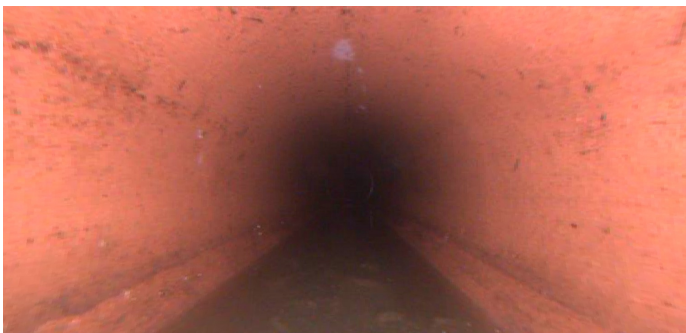
Code: **MSA**  
Description: **Abandoned Survey**

Distance (ft): **122.0**  
Structural Grade: **0**  
O&M Grade: **0**  
Clock Start/From:  
Clock To:  
1st Value:  
2nd Value:  
Value Percent:  
Continuous Index:  
Within 8" of Joint: **NO**  
Remarks: **ROBOT HAS STOPPED**

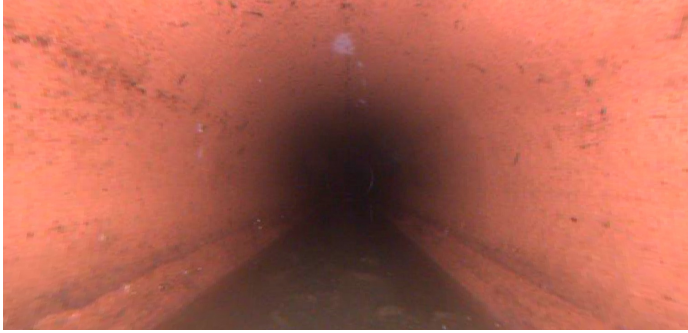
Code:	<b>DAGS</b>
Description:	<b>Deposits Attached Grease</b>
Distance (ft):	<b>122.0</b>
Structural Grade:	<b>0</b>
O&M Grade:	<b>2</b>
Clock Start/From:	<b>7</b>
Clock To:	<b>5</b>
1st Value:	
2nd Value:	
Value Percent:	<b>5.000</b>
Continuous Index:	<b>F01</b>
Within 8" of Joint:	<b>YES</b>
Remarks:	<b>WANDER</b>
