Profile/Photo Observation Report

Street:	OFF N UNION ST	Flow Control:	Not Controlled
City:	Hobart, IN	Year Renewed:	
Location:	Other	Tape/Media #:	
Purpose:	Not Known	Dia/Height:	10"
Use:	Sanitary	Material:	VCP
Drain Area:	NA	Lining:	
Category:	NA		
Comment:

Location Details:		Direction of Survey:	Downstream
US MH:	M-903-010	DS MH:	M-903-067
		Total Length Surveyed (ft):	102.1

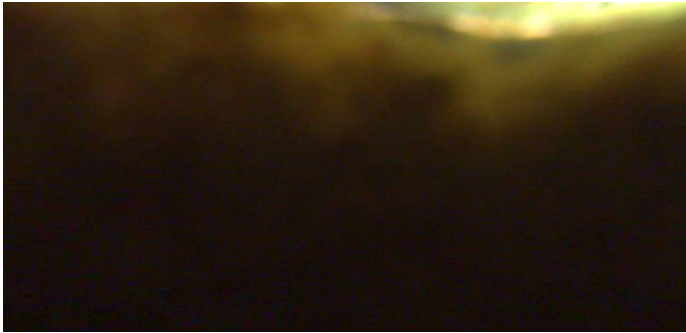
Code:	AMH
Description:	Manhole

Distance (ft):	.0
Structural Grade:	0
O&M Grade:	0
Clock Start/From:	
Clock To:	
1st Value:	
2nd Value:	
Value Percent:	
Continuous Index:	
Within 8" of Joint:	NO
Remarks:	M-903-010

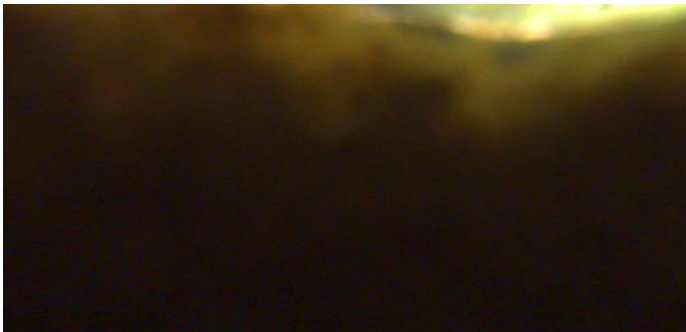
Code:	MWL
Description:	Water Level

Distance (ft):	.0
Structural Grade:	0
O&M Grade:	0
Clock Start/From:	
Clock To:	
1st Value:	
2nd Value:	
Value Percent:	5.000
Continuous Index:	
Within 8" of Joint:	NO
Remarks:

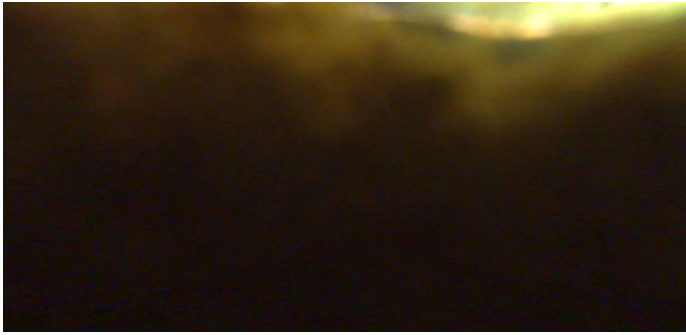
Code: **MWLS**
Description: **Water Level Sag**

Distance (ft): **.0**
Structural Grade: **2**
O&M Grade: **3**
Clock Start/From:
Clock To:
1st Value:
2nd Value:
Value Percent: **10.000**
Continuous Index: **S01**
Within 8" of Joint: **NO**
Remarks:
