Profile/Photo Observation Report

Street:	N UNION ST	Flow Control:	Not Controlled
City:	Hobart, IN	Year Renewed:	
Location:	Other	Tape/Media #:	
Purpose:	Not Known	Dia/Height:	10"
Use:	Sanitary	Material:	VCP
Drain Area:	NA	Lining:	
Category:	NA		
Comment:

Location Details:		Direction of Survey:	Downstream
US MH:	M-903-010	DS MH:	M-903-067
		Total Length Surveyed (ft):	102.1

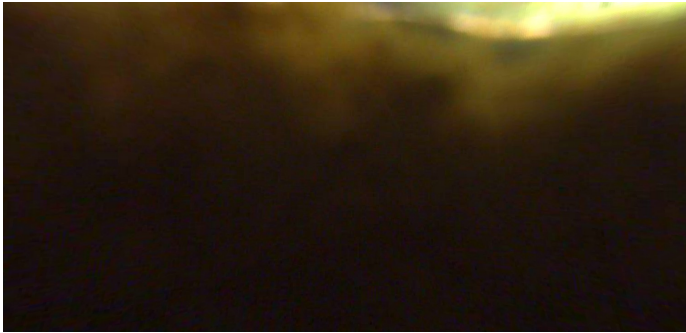
Code:	AMH
Description:	Manhole

Distance (ft):	.0
Structural Grade:	0
O&M Grade:	0
Clock Start/From:	
Clock To:	
1st Value:	
2nd Value:	
Value Percent:	
Continuous Index:	
Within 8" of Joint:	NO
Remarks:	M-903-010

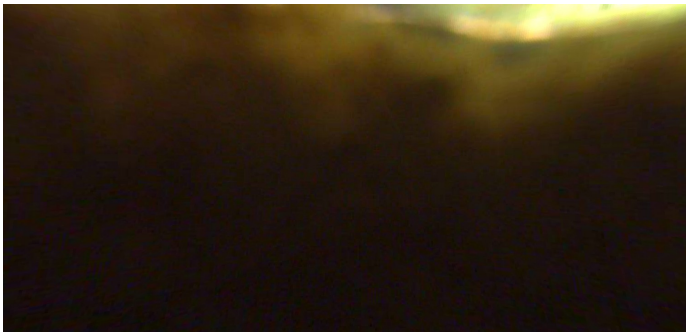
Code:	MWL
Description:	Water Level

Distance (ft):	.0
Structural Grade:	0
O&M Grade:	0
Clock Start/From:	
Clock To:	
1st Value:	
2nd Value:	
Value Percent:	5.000
Continuous Index:	
Within 8" of Joint:	NO
Remarks:

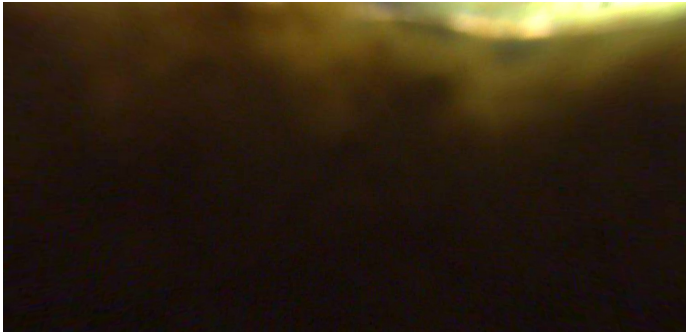
Code: **MWLS**
Description: **Water Level Sag**

Distance (ft): **.0**
Structural Grade: **2**
O&M Grade: **3**
Clock Start/From:
Clock To:
1st Value:
2nd Value:
Value Percent: **10.000**
Continuous Index: **S01**
Within 8" of Joint: **NO**
Remarks:
