## Profile/Photo Observation Report

Street:	<b>OFF N UNION ST</b>	Flow Control:	<b>Not Controlled</b>
City:	<b>Hobart, IN</b>	Year Renewed:	
Location:	<b>Other</b>	Tape/Media #:	
Purpose:	<b>Not Known</b>	Dia/Height:	<b>10"</b>
Use:	<b>Sanitary</b>	Material:	<b>VCP</b>
Drain Area:	<b>NA</b>	Lining:	
Category:	<b>NA</b>		
Comment:

Location Details:		Direction of Survey:	<b>Upstream</b>
US MH:	<b>M-903-010</b>	DS MH:	<b>M-903-067</b>
		Total Length Surveyed (ft):	<b>35.1</b>

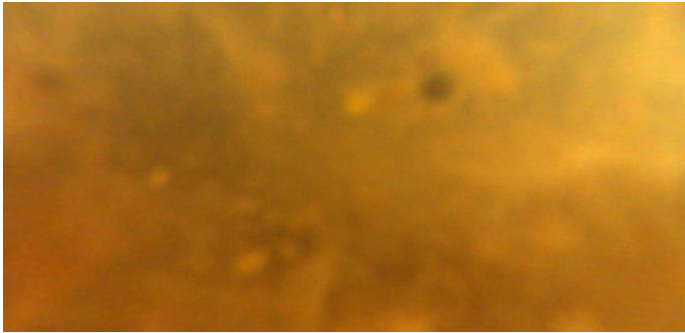
Code:	<b>MWL</b>
Description:	<b>Water Level</b>

Distance (ft):	<b>.0</b>
Structural Grade:	<b>0</b>
O&M Grade:	<b>0</b>
Clock Start/From:	
Clock To:	
1st Value:	
2nd Value:	
Value Percent:	<b>100.000</b>
Continuous Index:	
Within 8" of Joint:	<b>NO</b>
Remarks:
