Profile/Photo Observation Report

Street:	N UNION ST	Flow Control:	Not Controlled
City:	Hobart, IN	Year Renewed:	
Location:	Other	Tape/Media #:	
Purpose:	Not Known	Dia/Height:	10"
Use:	Sanitary	Material:	VCP
Drain Area:	NA	Lining:	
Category:	NA		
Comment:

Location Details:		Direction of Survey:	Upstream
US MH:	M-903-010	DS MH:	M-903-067
		Total Length Surveyed (ft):	35.1

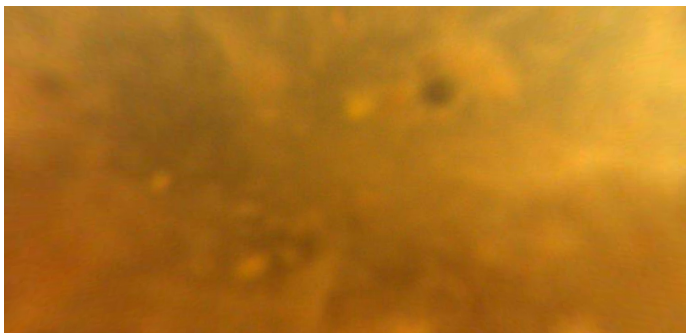
Code: **AMH**
Description: **Manhole**

Distance (ft): **.0**
Structural Grade: **0**
O&M Grade: **0**
Clock Start/From:
Clock To:
1st Value:
2nd Value:
Value Percent:
Continuous Index:
Within 8" of Joint: **NO**
Remarks: **M-903-067**

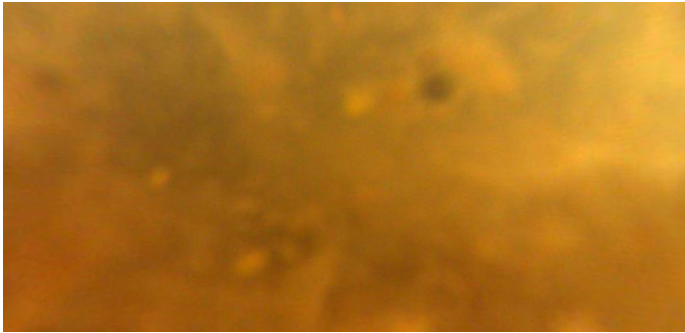
Code:	MWL
Description:	Water Level

Distance (ft):	.0
Structural Grade:	0
O&M Grade:	0
Clock Start/From:	
Clock To:	
1st Value:	
2nd Value:	
Value Percent:	100.000
Continuous Index:	
Within 8" of Joint:	NO
Remarks:
