## Profile/Photo Observation Report

Date:	<b>03/25/2018</b>	Weather:		Coding:	<b>PACP 6.0</b>
Pipe Length (ft):	<b>359.0</b>	Owner:	<b>NA</b>	Pre Clean:	<b>Not Known</b>
P.O.#:		Surveyor:	<b>Byrd Fitzgerald</b>	PSR:	<b>P-903-011-012</b>
Customer:		Clean Date:	<b>01/01/1900</b>	Shape:	<b>C</b>

Street:	<b>SPENCER PL</b>	Flow Control:	<b>Not Controlled</b>
City:	<b>Hobart, IN</b>	Year Renewed:	
Location:	<b>Other</b>	Tape/Media #:	
Purpose:	<b>Not Known</b>	Dia/Height:	<b>10"</b>
Use:	<b>Sanitary</b>	Material:	<b>VCP</b>
Drain Area:	<b>NA</b>	Lining:	
Category:	<b>NA</b>		
Comment:

Location Details:		Direction of Survey:	<b>Downstream</b>
US MH:	<b>M-903-011</b>	DS MH:	<b>M-903-012</b>
		Total Length Surveyed (ft):	<b>350.1</b>

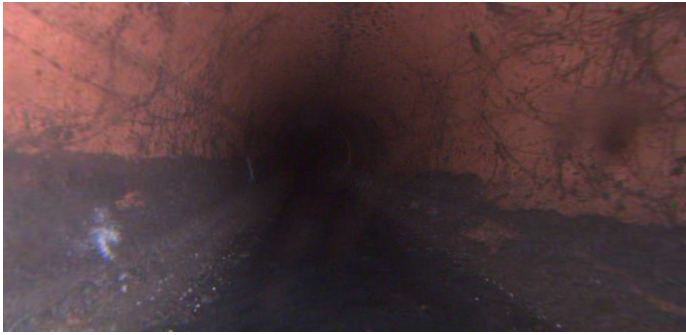
Code: **DAZ**  
Description: **Deposits Attached Other**

Distance (ft): **.0**  
Structural Grade: **0**  
O&M Grade: **2**  
Clock Start/From: **7**  
Clock To: **5**  
1st Value:  
2nd Value:  
Value Percent: **5.000**  
Continuous Index: **S02**  
Within 8" of Joint: **NO**  
Remarks:

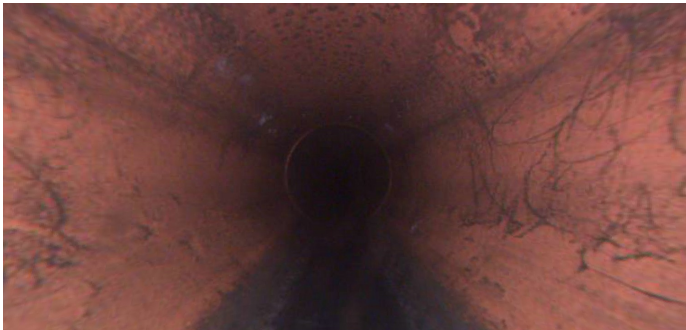
Code: **DAZ**  
Description: **Deposits Attached Other**

Distance (ft): **48.3**  
Structural Grade: **0**  
O&M Grade: **2**  
Clock Start/From: **7**  
Clock To: **5**  
1st Value:  
2nd Value:  
Value Percent: **5.000**  
Continuous Index: **F02**  
Within 8" of Joint: **NO**  
Remarks:

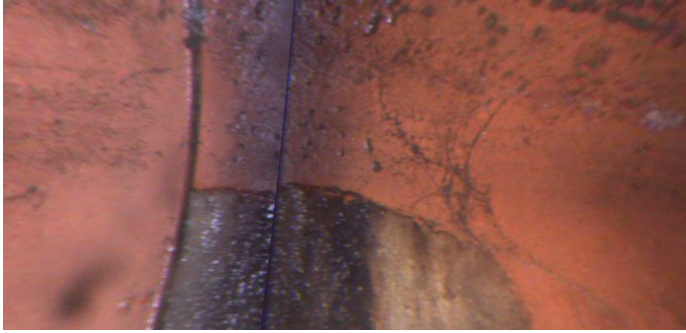
Code: **FL**  
Description: **Fracture Longitudinal**

Distance (ft): **100.8**  
Structural Grade: **3**  
O&M Grade: **0**  
Clock Start/From: **2**  
Clock To:  
1st Value:  
2nd Value:  
Value Percent:  
Continuous Index:  
Within 8" of Joint: **YES**  
Remarks:

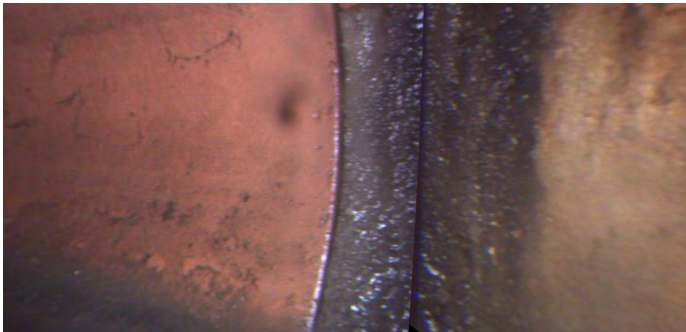
Code: **IW**  
Description: **Infil Weeper**

Distance (ft): **100.8**  
Structural Grade: **0**  
O&M Grade: **2**  
Clock Start/From: **2**  
Clock To: **4**  
1st Value:  
2nd Value:  
Value Percent:  
Continuous Index:  
Within 8" of Joint: **YES**  
Remarks:

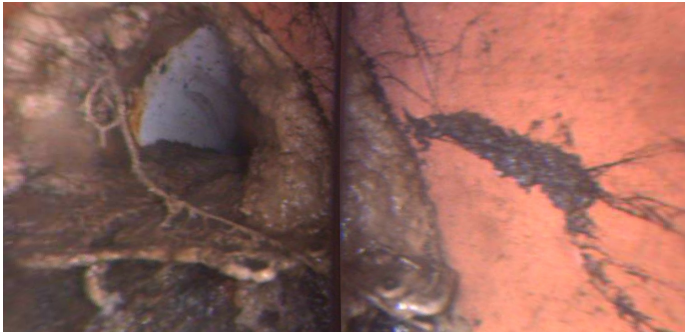
Code: **DAE**  
Description: **Deposits Attached Encrustation**

Distance (ft): **119.8**  
Structural Grade: **0**  
O&M Grade: **2**  
Clock Start/From: **8**  
Clock To: **10**  
1st Value:  
2nd Value:  
Value Percent: **10.000**  
Continuous Index:  
Within 8" of Joint: **NO**  
Remarks:

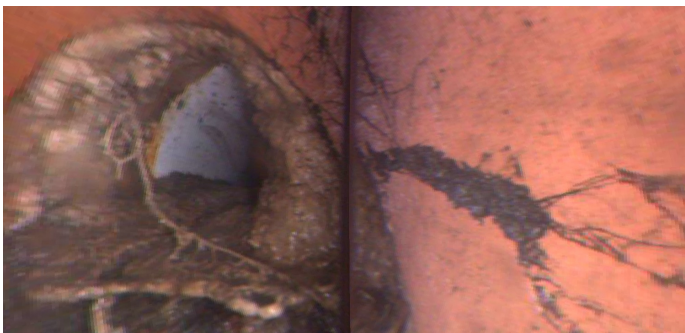
Code: **TFD**  
Description: **Tap Factory Defective**

Distance (ft): **119.8**  
Structural Grade: **0**  
O&M Grade: **2**  
Clock Start/From: **9**  
Clock To:  
1st Value: **4.000**  
2nd Value:  
Value Percent:  
Continuous Index:  
Within 8" of Joint:  
Remarks: **blocked by unknown deposits**

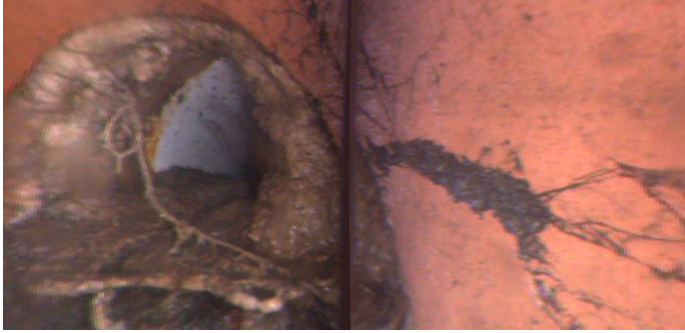
Code: **RFC**  
Description: **Roots Fine Connection**

Distance (ft): **119.8**  
Structural Grade: **0**  
O&M Grade: **1**  
Clock Start/From: **12**  
Clock To: **12**  
1st Value:  
2nd Value:  
Value Percent:  
Continuous Index:  
Within 8" of Joint: **NO**  
Remarks: **around tap**

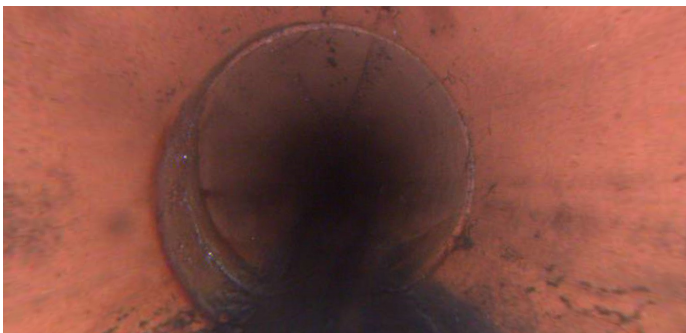
Code: **IW**  
Description: **Infil Weeper**

Distance (ft): **169.7**  
Structural Grade: **0**  
O&M Grade: **2**  
Clock Start/From: **7**  
Clock To: **11**  
1st Value:  
2nd Value:  
Value Percent:  
Continuous Index:  
Within 8" of Joint: **YES**  
Remarks:

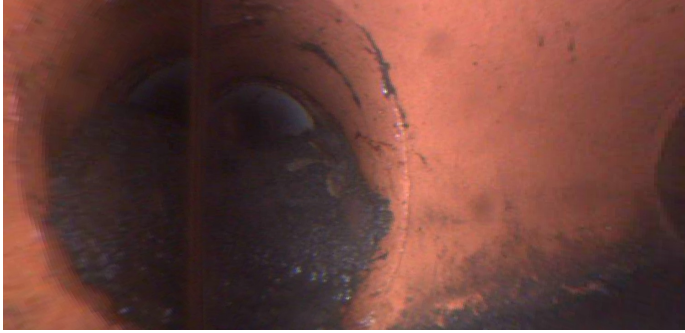
Code: **TFD**  
Description: **Tap Factory Defective**

Distance (ft): **189.2**  
Structural Grade: **0**  
O&M Grade: **2**  
Clock Start/From: **9**  
Clock To:  
1st Value: **4.000**  
2nd Value:  
Value Percent:  
Continuous Index:  
Within 8" of Joint:  
Remarks: **blocked**

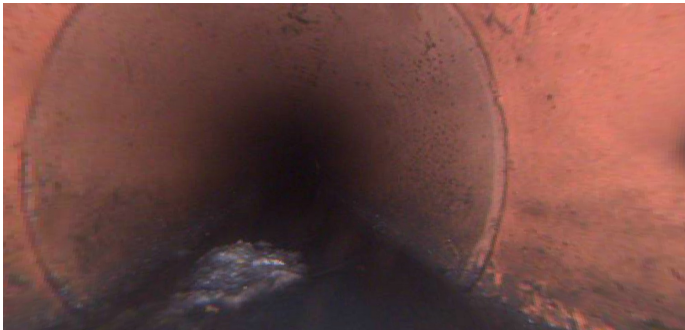
Code: **DSZ**  
Description: **Deposits Settled Other**

Distance (ft): **189.9**  
Structural Grade: **0**  
O&M Grade: **2**  
Clock Start/From: **6**  
Clock To:  
1st Value:  
2nd Value:  
Value Percent: **5.000**  
Continuous Index:  
Within 8" of Joint: **NO**  
Remarks: **tissue**

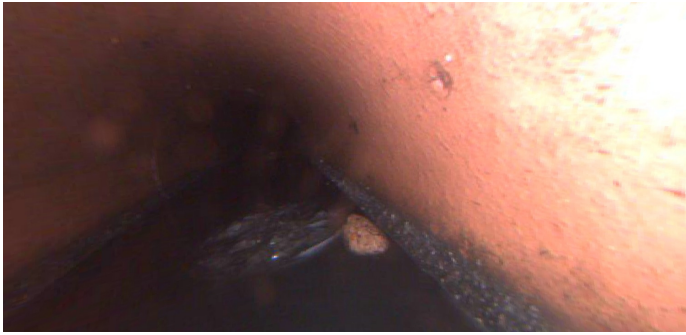
Code: **DSZ**  
Description: **Deposits Settled Other**

Distance (ft): **232.4**  
Structural Grade: **0**  
O&M Grade: **2**  
Clock Start/From: **6**  
Clock To:  
1st Value:  
2nd Value:  
Value Percent: **5.000**  
Continuous Index:  
Within 8" of Joint: **NO**  
Remarks: **tissue/debris**

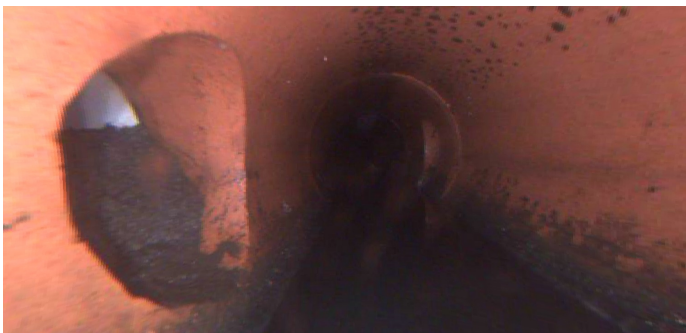
Code: **TFD**  
Description: **Tap Factory Defective**

Distance (ft): **252.2**  
Structural Grade: **0**  
O&M Grade: **2**  
Clock Start/From: **9**  
Clock To:  
1st Value: **4.000**  
2nd Value:  
Value Percent:  
Continuous Index:  
Within 8" of Joint:  
Remarks: **blocked**

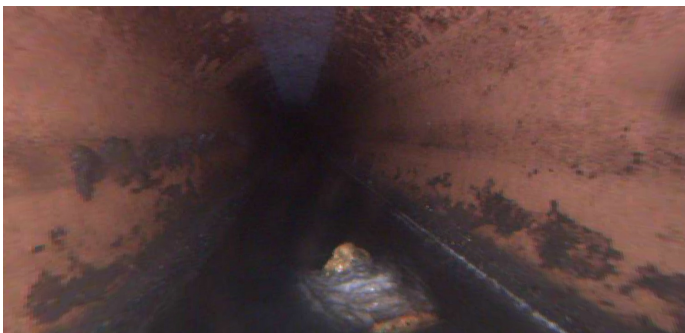
Code: **DSZ**  
Description: **Deposits Settled Other**

Distance (ft): **256.3**  
Structural Grade: **0**  
O&M Grade: **2**  
Clock Start/From: **6**  
Clock To:  
1st Value:  
2nd Value:  
Value Percent: **5.000**  
Continuous Index: **S01**  
Within 8" of Joint: **NO**  
Remarks: **tissue**

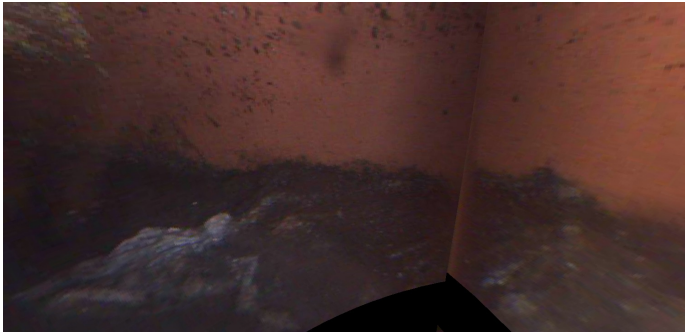
Code: **DAZ**  
Description: **Deposits Attached Other**

Distance (ft): **332.8**  
Structural Grade: **0**  
O&M Grade: **2**  
Clock Start/From: **4**  
Clock To: **5**  
1st Value:  
2nd Value:  
Value Percent: **5.000**  
Continuous Index:  
Within 8" of Joint: **NO**  
Remarks: **mud**

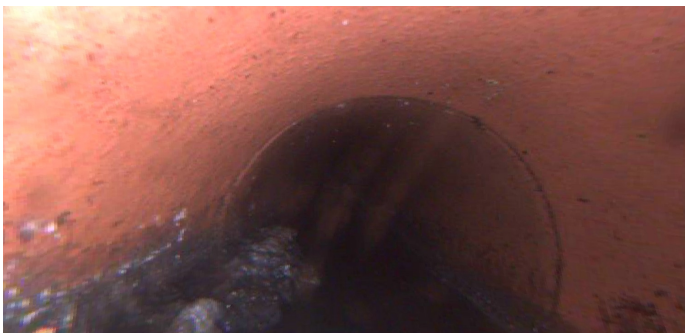
Code: **DAZ**  
Description: **Deposits Attached Other**

Distance (ft): **342.8**  
Structural Grade: **0**  
O&M Grade: **2**  
Clock Start/From: **7**  
Clock To: **8**  
1st Value:  
2nd Value:  
Value Percent: **5.000**  
Continuous Index:  
Within 8" of Joint: **NO**  
Remarks: **mud**

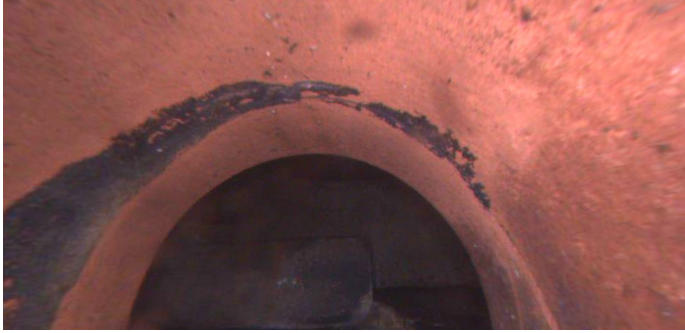
Code: **FC**  
Description: **Fracture Circumferential**

Distance (ft): **348.6**  
Structural Grade: **2**  
O&M Grade: **0**  
Clock Start/From: **8**  
Clock To: **4**  
1st Value:  
2nd Value:  
Value Percent:  
Continuous Index:  
Within 8" of Joint:  
Remarks:

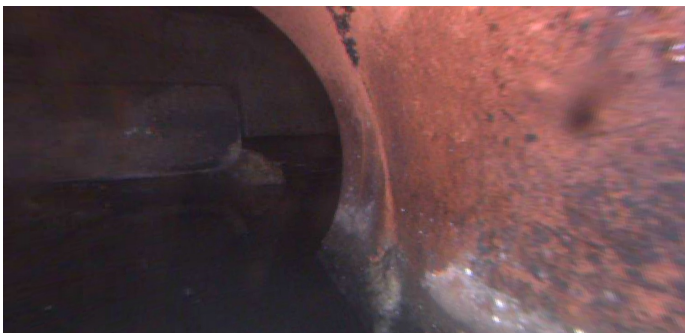
Code: **DSZ**  
Description: **Deposits Settled Other**

Distance (ft): **348.7**  
Structural Grade: **0**  
O&M Grade: **2**  
Clock Start/From: **6**  
Clock To:  
1st Value:  
2nd Value:  
Value Percent: **5.000**  
Continuous Index: **F01**  
Within 8" of Joint: **NO**  
Remarks: **tissue**
