Profile/Photo Observation Report

Date:	03/25/2018	Weather:		Coding:	PACP 6.0
Pipe Length (ft):	359.0	Owner:	NA	Pre Clean:	Not Known
P.O.#:		Surveyor:	Byrd Fitzgerald	PSR:	P-903-011-012
Customer:		Clean Date:	01/01/1900	Shape:	C

Street:	SPENCER PL	Flow Control:	Not Controlled
City:	Hobart, IN	Year Renewed:	
Location:	Other	Tape/Media #:	
Purpose:	Not Known	Dia/Height:	10"
Use:	Sanitary	Material:	VCP
Drain Area:	NA	Lining:	
Category:	NA		
Comment:

Location Details:		Direction of Survey:	Downstream
US MH:	M-903-011	DS MH:	M-903-012
		Total Length Surveyed (ft):	350.1

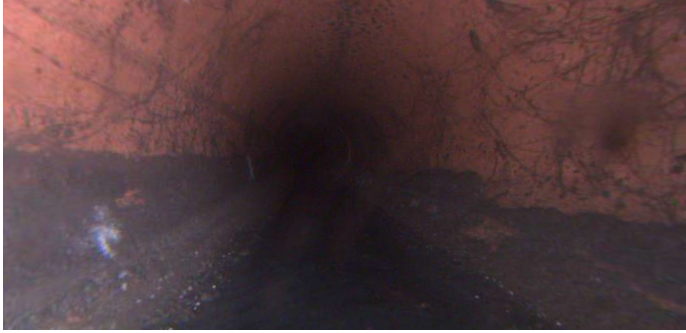
Code: **DAZ**
Description: **Deposits Attached Other**

Distance (ft): **.0**
Structural Grade: **0**
O&M Grade: **2**
Clock Start/From: **7**
Clock To: **5**
1st Value:
2nd Value:
Value Percent: **5.000**
Continuous Index: **S02**
Within 8" of Joint: **NO**
Remarks:

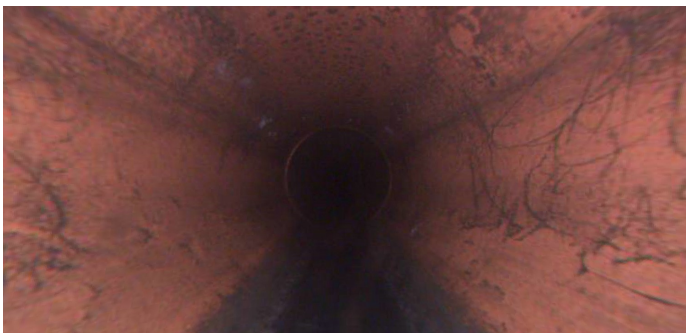
Code: **DAZ**
Description: **Deposits Attached Other**

Distance (ft): **48.3**
Structural Grade: **0**
O&M Grade: **2**
Clock Start/From: **7**
Clock To: **5**
1st Value:
2nd Value:
Value Percent: **5.000**
Continuous Index: **F02**
Within 8" of Joint: **NO**
Remarks:

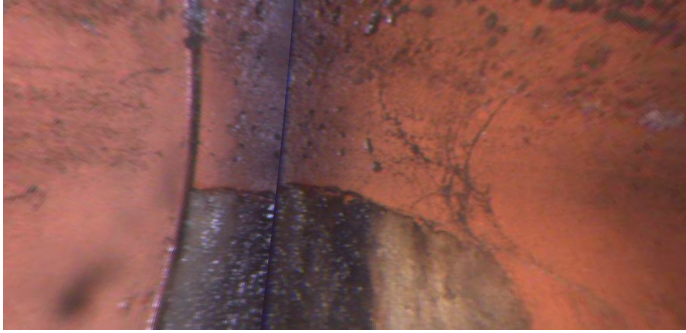
Code: **FL**
Description: **Fracture Longitudinal**

Distance (ft): **100.8**
Structural Grade: **3**
O&M Grade: **0**
Clock Start/From: **2**
Clock To:
1st Value:
2nd Value:
Value Percent:
Continuous Index:
Within 8" of Joint: **YES**
Remarks:

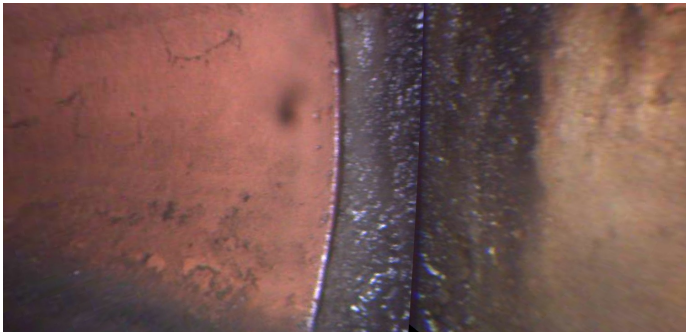
Code: **IW**
Description: **Infil Weeper**

Distance (ft): **100.8**
Structural Grade: **0**
O&M Grade: **2**
Clock Start/From: **2**
Clock To: **4**
1st Value:
2nd Value:
Value Percent:
Continuous Index:
Within 8" of Joint: **YES**
Remarks:

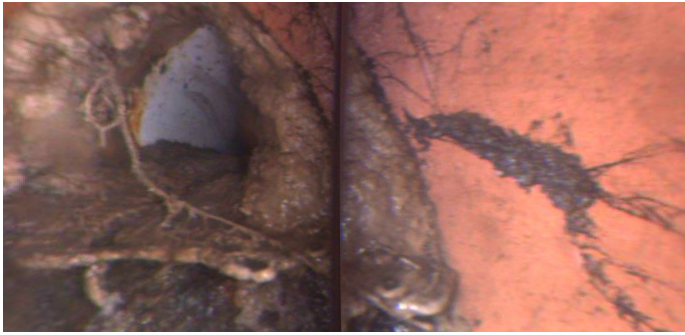
Code: **DAE**
Description: **Deposits Attached Encrustation**

Distance (ft): **119.8**
Structural Grade: **0**
O&M Grade: **2**
Clock Start/From: **8**
Clock To: **10**
1st Value:
2nd Value:
Value Percent: **10.000**
Continuous Index:
Within 8" of Joint: **NO**
Remarks:

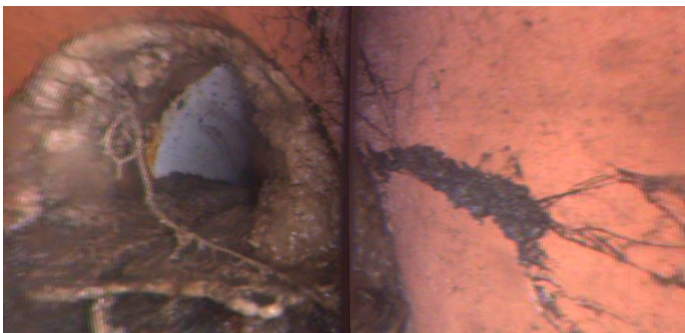
Code: **TFD**
Description: **Tap Factory Defective**

Distance (ft): **119.8**
Structural Grade: **0**
O&M Grade: **2**
Clock Start/From: **9**
Clock To:
1st Value: **4.000**
2nd Value:
Value Percent:
Continuous Index:
Within 8" of Joint:
Remarks: **blocked by unknown deposits**

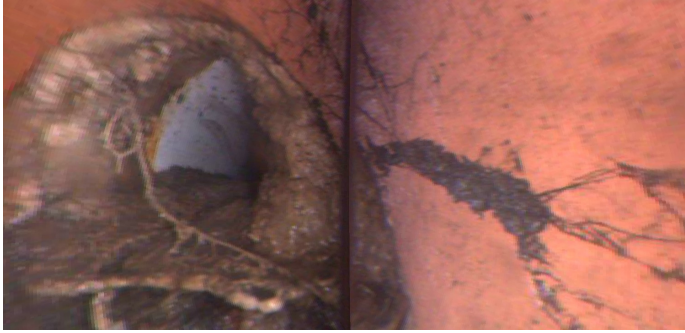
Code: **RFC**
Description: **Roots Fine Connection**

Distance (ft): **119.8**
Structural Grade: **0**
O&M Grade: **1**
Clock Start/From: **12**
Clock To: **12**
1st Value:
2nd Value:
Value Percent:
Continuous Index:
Within 8" of Joint: **NO**
Remarks: **around tap**

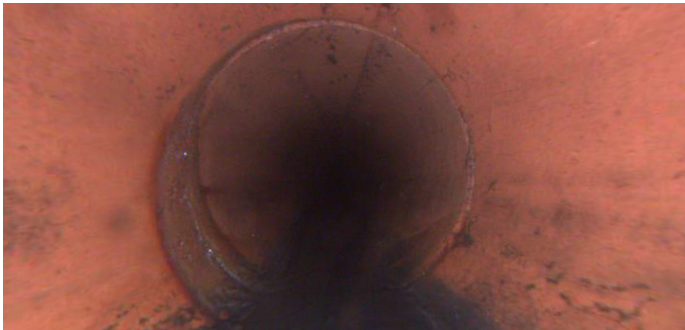
Code: **IW**
Description: **Infil Weeper**

Distance (ft): **169.7**
Structural Grade: **0**
O&M Grade: **2**
Clock Start/From: **7**
Clock To: **11**
1st Value:
2nd Value:
Value Percent:
Continuous Index:
Within 8" of Joint: **YES**
Remarks:

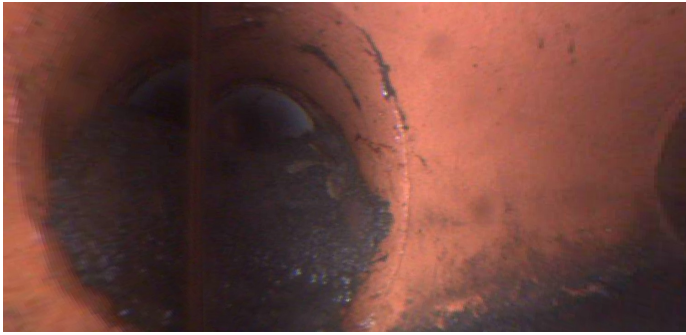
Code: **TFD**
Description: **Tap Factory Defective**

Distance (ft): **189.2**
Structural Grade: **0**
O&M Grade: **2**
Clock Start/From: **9**
Clock To:
1st Value: **4.000**
2nd Value:
Value Percent:
Continuous Index:
Within 8" of Joint:
Remarks: **blocked**

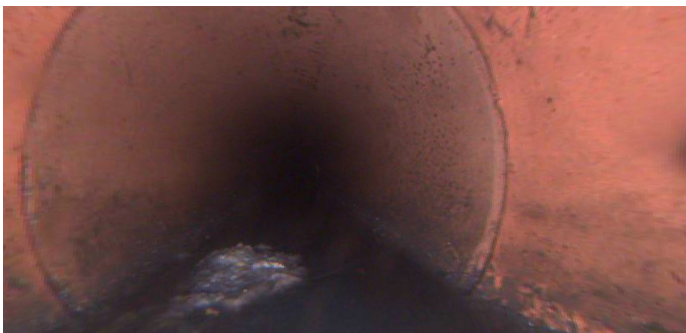
Code: **DSZ**
Description: **Deposits Settled Other**

Distance (ft): **189.9**
Structural Grade: **0**
O&M Grade: **2**
Clock Start/From: **6**
Clock To:
1st Value:
2nd Value:
Value Percent: **5.000**
Continuous Index:
Within 8" of Joint: **NO**
Remarks: **tissue**

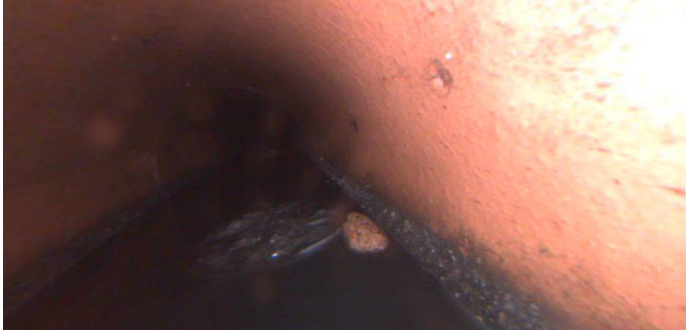
Code: **DSZ**
Description: **Deposits Settled Other**

Distance (ft): **232.4**
Structural Grade: **0**
O&M Grade: **2**
Clock Start/From: **6**
Clock To:
1st Value:
2nd Value:
Value Percent: **5.000**
Continuous Index:
Within 8" of Joint: **NO**
Remarks: **tissue/debris**

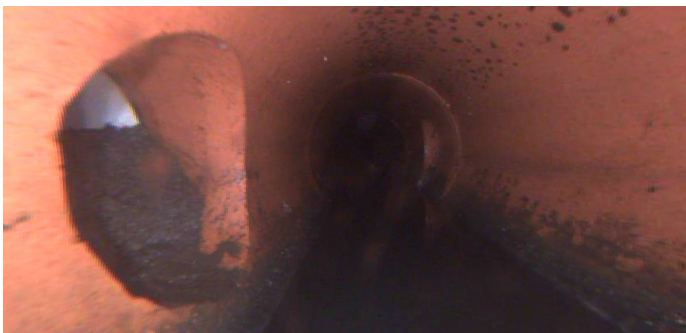
Code: **TFD**
Description: **Tap Factory Defective**

Distance (ft): **252.2**
Structural Grade: **0**
O&M Grade: **2**
Clock Start/From: **9**
Clock To:
1st Value: **4.000**
2nd Value:
Value Percent:
Continuous Index:
Within 8" of Joint:
Remarks: **blocked**

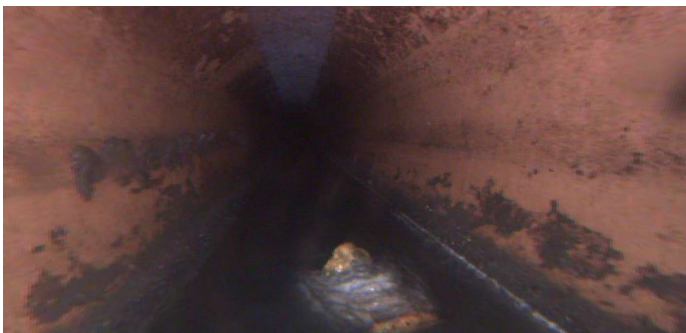
Code: **DSZ**
Description: **Deposits Settled Other**

Distance (ft): **256.3**
Structural Grade: **0**
O&M Grade: **2**
Clock Start/From: **6**
Clock To:
1st Value:
2nd Value:
Value Percent: **5.000**
Continuous Index: **S01**
Within 8" of Joint: **NO**
Remarks: **tissue**

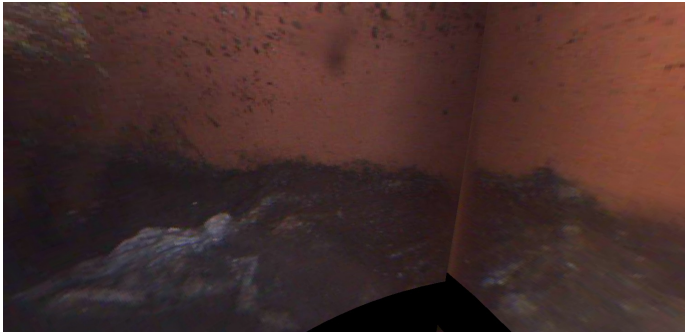
Code: **DAZ**
Description: **Deposits Attached Other**

Distance (ft): **332.8**
Structural Grade: **0**
O&M Grade: **2**
Clock Start/From: **4**
Clock To: **5**
1st Value:
2nd Value:
Value Percent: **5.000**
Continuous Index:
Within 8" of Joint: **NO**
Remarks: **mud**

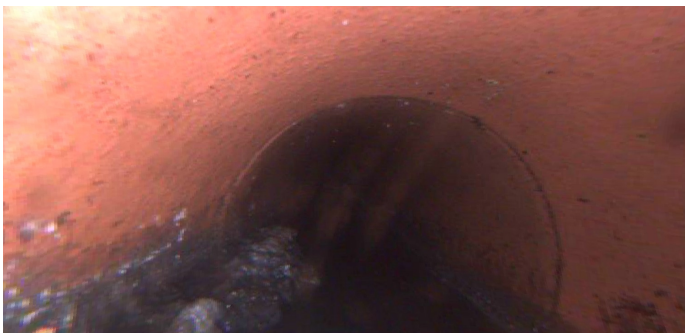
Code: **DAZ**
Description: **Deposits Attached Other**

Distance (ft): **342.8**
Structural Grade: **0**
O&M Grade: **2**
Clock Start/From: **7**
Clock To: **8**
1st Value:
2nd Value:
Value Percent: **5.000**
Continuous Index:
Within 8" of Joint: **NO**
Remarks: **mud**

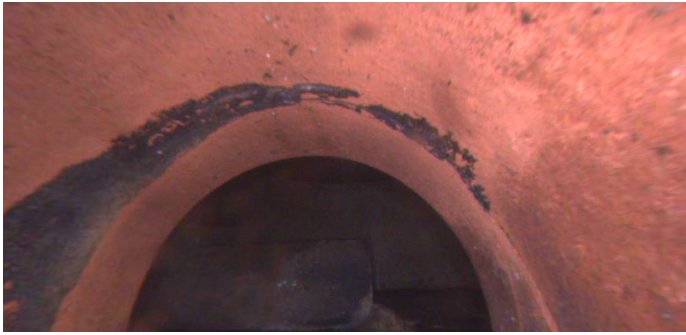
Code: **FC**
Description: **Fracture Circumferential**

Distance (ft): **348.6**
Structural Grade: **2**
O&M Grade: **0**
Clock Start/From: **8**
Clock To: **4**
1st Value:
2nd Value:
Value Percent:
Continuous Index:
Within 8" of Joint:
Remarks:

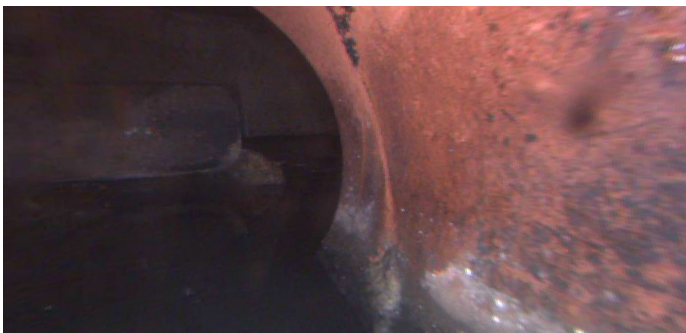
Code: **DSZ**
Description: **Deposits Settled Other**

Distance (ft): **348.7**
Structural Grade: **0**
O&M Grade: **2**
Clock Start/From: **6**
Clock To:
1st Value:
2nd Value:
Value Percent: **5.000**
Continuous Index: **F01**
Within 8" of Joint: **NO**
Remarks: **tissue**
