## Profile/Photo Observation Report

| Street: | <b>E RAND ST</b> | Flow Control: | <b>Not Controlled</b> |

| US MH: | <b>M-903-012</b> | DS MH: | <b>M-903-015</b> |

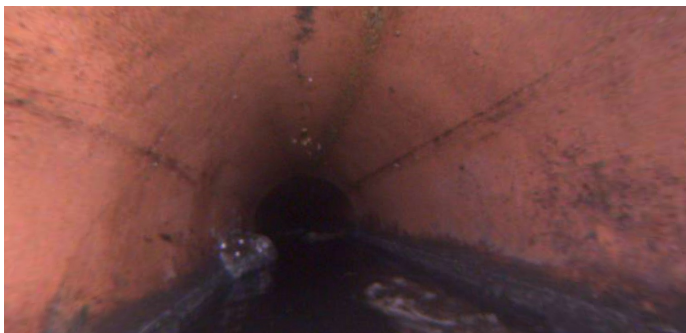
Code: **AMH**  
Description: **Manhole**

Distance (ft): **.0**  
Structural Grade: **0**  
O&M Grade: **0**  
Clock Start/From:  
Clock To:  
1st Value:  
2nd Value:  
Value Percent:  
Continuous Index:  
Within 8" of Joint: **NO**  
Remarks: **M-903-012**

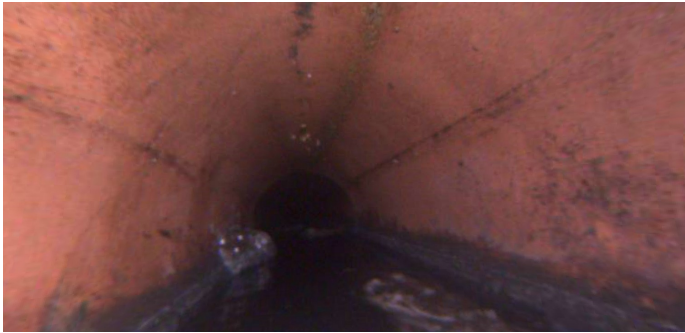
| Code: | <b>MWL</b> |
| Description: | <b>Water Level</b> |

| Value Percent: | <b>20.000</b> |

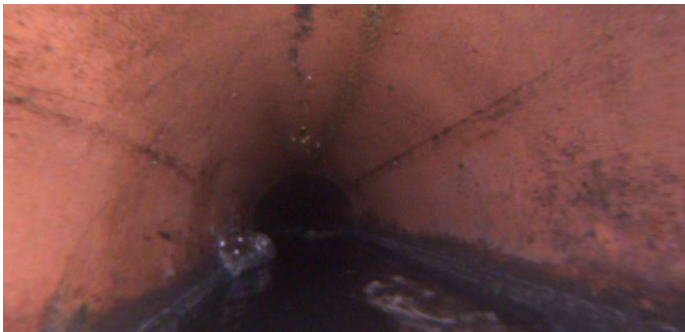
| Code: | <b>FC</b> |
| Description: | <b>Fracture Circumferential</b> |

| Structural Grade: | <b>2</b> |
| Clock Start/From: | <b>8</b> |
| Clock To: | <b>9</b> |

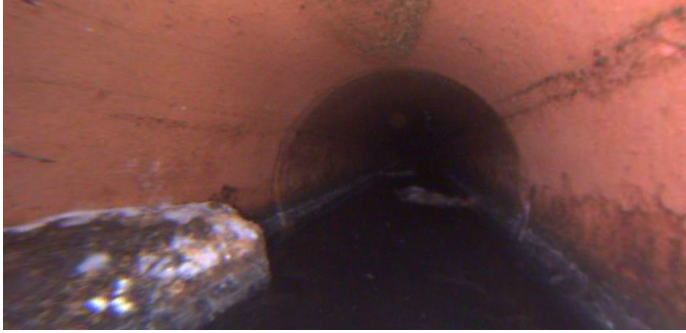
Code: **DAE**  
Description: **Deposits Attached Encrustation**

Distance (ft): **2.8**  
Structural Grade: **0**  
O&M Grade: **2**  
Clock Start/From: **7**  
Clock To: **9**  
1st Value:  
2nd Value:  
Value Percent: **10.000**  
Continuous Index:  
Within 8" of Joint: **NO**  
Remarks:

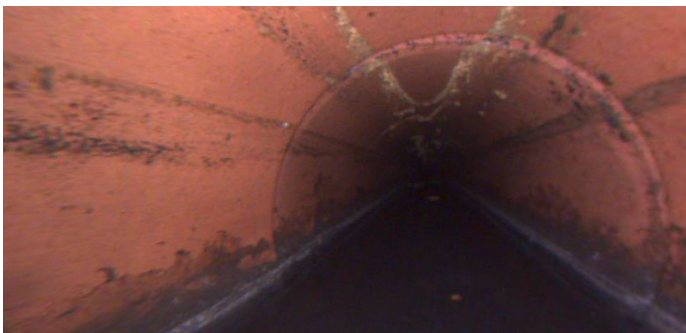
Code: **MSA**  
Description: **Abandoned Survey**

Distance (ft): **9.1**  
Structural Grade: **0**  
O&M Grade: **0**  
Clock Start/From:  
Clock To:  
1st Value:  
2nd Value:  
Value Percent:  
Continuous Index:  
Within 8" of Joint: **NO**  
Remarks: **dae**
