Profile/Photo Observation Report

Street:	E RAND ST	Flow Control:	Not Controlled
City:	Hobart, IN	Year Renewed:	
Location:	Other	Tape/Media #:	
Purpose:	Not Known	Dia/Height:	12"
Use:	Sanitary	Material:	VCP
Drain Area:	NA	Lining:	
Category:	NA		
Comment:

Location Details:		Direction of Survey:	Upstream
US MH:	M-903-012	DS MH:	M-903-015
		Total Length Surveyed (ft):	102.1

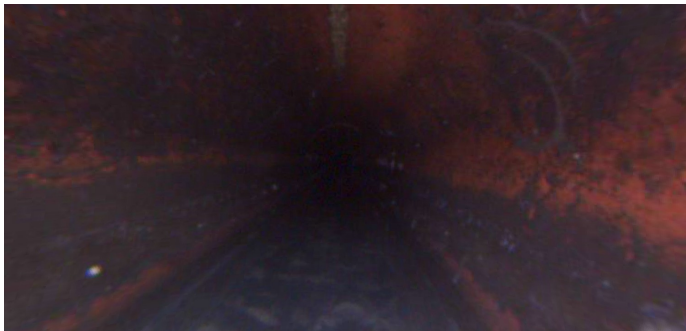
Code: **AMH**
Description: **Manhole**

Distance (ft): **.0**
Structural Grade: **0**
O&M Grade: **0**
Clock Start/From:
Clock To:
1st Value:
2nd Value:
Value Percent:
Continuous Index:
Within 8" of Joint: **NO**
Remarks: **M-903-015**

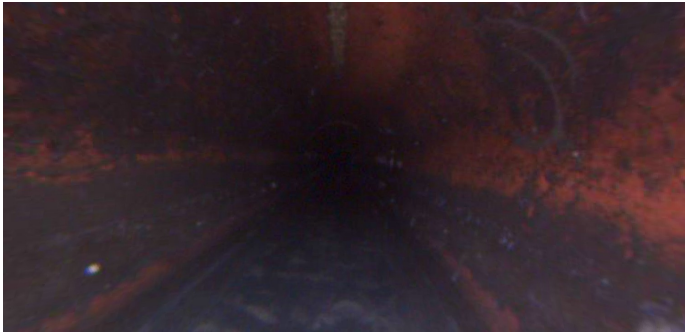
Code:	MWL
Description:	Water Level

Distance (ft):	.0
Structural Grade:	0
O&M Grade:	0
Clock Start/From:	
Clock To:	
1st Value:	
2nd Value:	
Value Percent:	5.000
Continuous Index:	
Within 8" of Joint:	NO
Remarks:

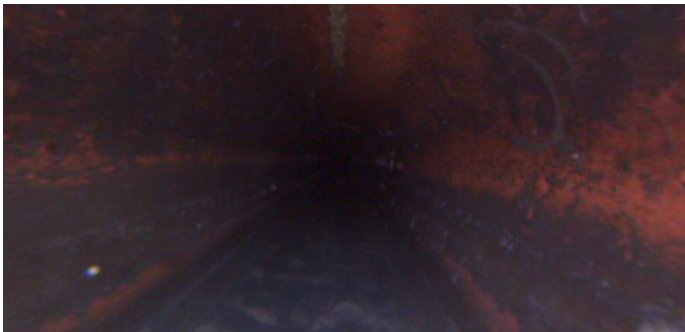
Code:	DAZ
Description:	Deposits Attached Other

Distance (ft):	.0
Structural Grade:	0
O&M Grade:	2
Clock Start/From:	8
Clock To:	4
1st Value:	
2nd Value:	
Value Percent:	5.000
Continuous Index:	S01
Within 8" of Joint:	NO
Remarks:

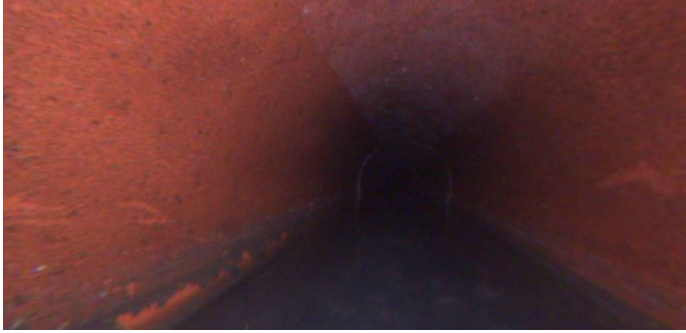
Code: **DAZ**
Description: **Deposits Attached Other**

Distance (ft): **102.1**
Structural Grade: **0**
O&M Grade: **2**
Clock Start/From: **8**
Clock To: **4**
1st Value:
2nd Value:
Value Percent: **5.000**
Continuous Index: **F01**
Within 8" of Joint: **NO**
Remarks:

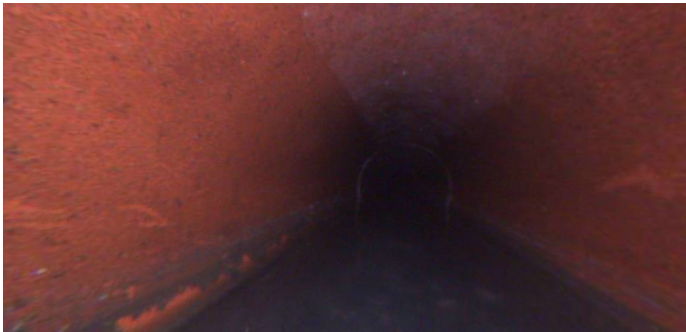
Code: **MSA**
Description: **Abandoned Survey**

Distance (ft): **102.1**
Structural Grade: **0**
O&M Grade: **0**
Clock Start/From:
Clock To:
1st Value:
2nd Value:
Value Percent:
Continuous Index:
Within 8" of Joint: **NO**
Remarks: **DEBRIS UNDER WATER**
