Profile/Photo Observation Report

Street:	Rand St.	Flow Control:	Not Controlled
City:	Hobart, IN	Year Renewed:	
Location:	Other	Tape/Media #:	
Purpose:	Not Known	Dia/Height:	12"
Use:	Sanitary	Material:	VCP
Drain Area:	NA	Lining:	
Category:	NA		
Comment:

Location Details:		Direction of Survey:	Upstream
US MH:	M-903-012	DS MH:	M-903-015
		Total Length Surveyed (ft):	102.1

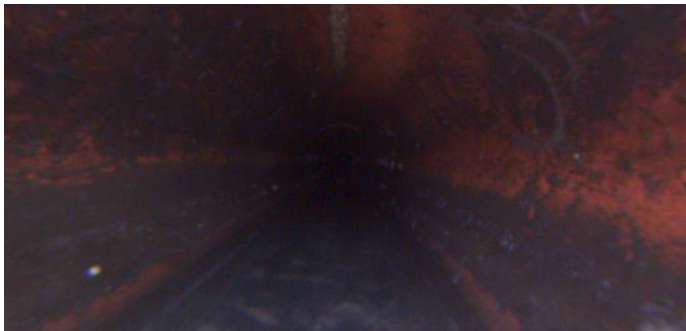
Code: **AMH**
Description: **Manhole**

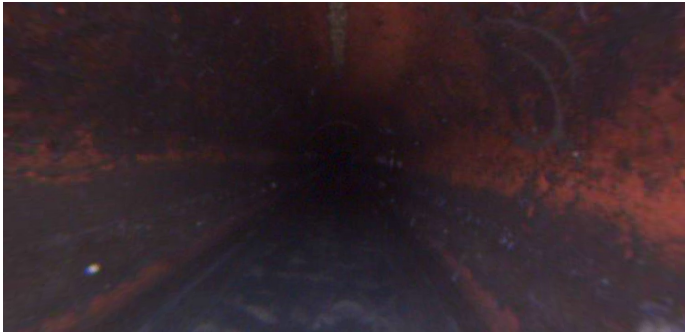
Code:	MWL
Description:	Water Level

Distance (ft):	.0
Structural Grade:	0
O&M Grade:	0
Clock Start/From:	
Clock To:	
1st Value:	
2nd Value:	
Value Percent:	5.000
Continuous Index:	
Within 8" of Joint:	NO
Remarks:

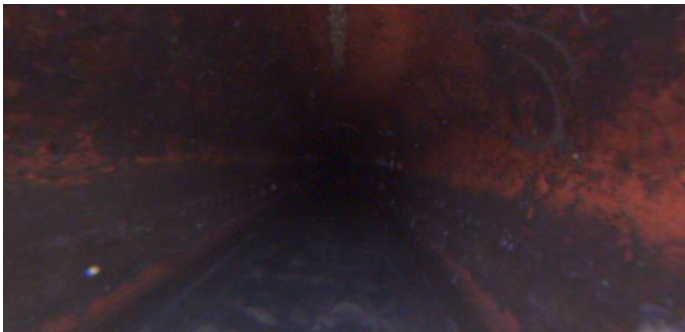
Code:	DAZ
Description:	Deposits Attached Other

Distance (ft):	.0
Structural Grade:	0
O&M Grade:	2
Clock Start/From:	8
Clock To:	4
1st Value:	
2nd Value:	
Value Percent:	5.000
Continuous Index:	S01
Within 8" of Joint:	NO
Remarks:

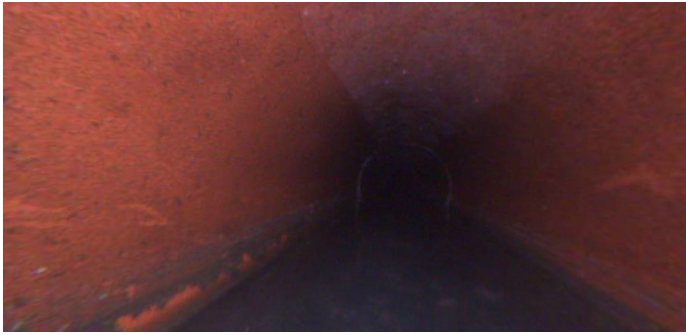
Code: **DAZ**
Description: **Deposits Attached Other**

Distance (ft): **102.1**
Structural Grade: **0**
O&M Grade: **2**
Clock Start/From: **8**
Clock To: **4**
1st Value:
2nd Value:
Value Percent: **5.000**
Continuous Index: **F01**
Within 8" of Joint: **NO**
Remarks:

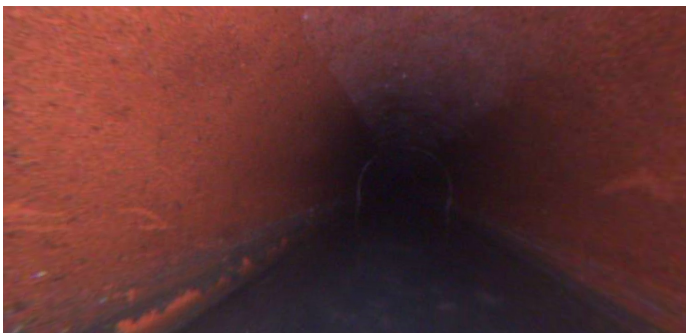
Code: **MSA**
Description: **Abandoned Survey**

Distance (ft): **102.1**
Structural Grade: **0**
O&M Grade: **0**
Clock Start/From:
Clock To:
1st Value:
2nd Value:
Value Percent:
Continuous Index:
Within 8" of Joint: **NO**
Remarks: **DEBRIS UNDER WATER**
