# Profile/Photo Observation Report

Street:	<b>E RAND ST</b>	Flow Control:	<b>Not Controlled</b>
City:	<b>Hobart, IN</b>	Year Renewed:	
Location:	<b>Light Highway</b>	Tape/Media #:	
Purpose:	<b>Routine Assessment</b>	Dia/Height:	<b>12"</b>
Use:	<b>Sanitary</b>	Material:	<b>VCP</b>
Drain Area:	<b>NA</b>	Lining:	
Category:	<b>NA</b>		
Comment:			
Location Details:		Direction of Survey:	<b>Upstream</b>
US MH:	<b>M-903-012</b>	DS MH:	<b>M-903-015</b>
		Total Length Surveyed (ft):	<b>294.7</b>

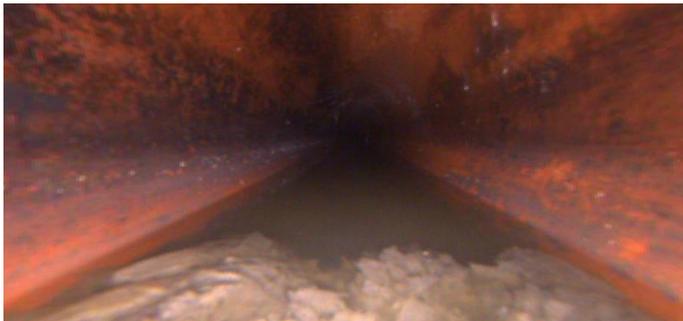
Code: **AMH**  
Description: **Manhole**

Distance (ft): **.0**  
Structural Grade: **0**  
O&M Grade: **0**  
Clock Start/From:  
Clock To:  
1st Value:  
2nd Value:  
Value Percent:  
Continuous Index:  
Within 8" of Joint: **NO**  
Remarks: **M-903-015**

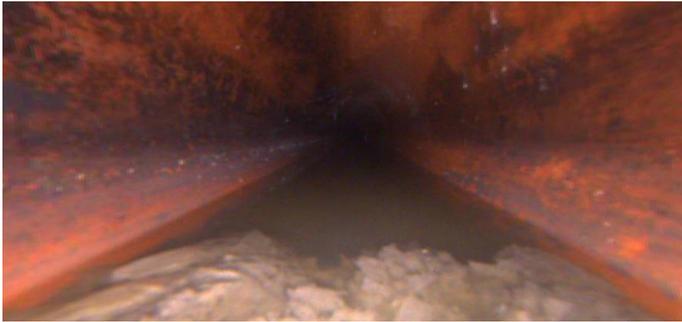
Code: **MWL**  
Description: **Water Level**

Distance (ft): **.0**  
Structural Grade: **0**  
O&M Grade: **0**  
Clock Start/From:  
Clock To:  
1st Value:  
2nd Value:  
Value Percent: **10.000**  
Continuous Index:  
Within 8" of Joint: **NO**  
Remarks:

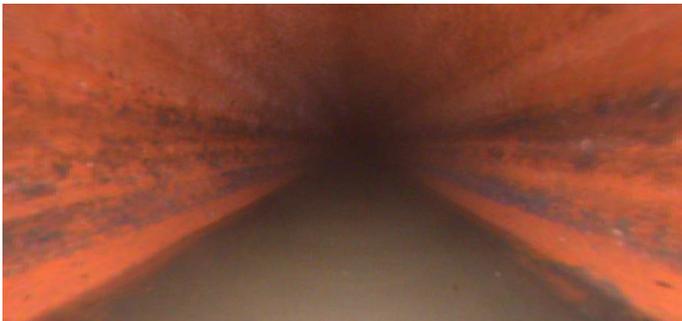
Code: **DAZ**  
Description: **Deposits Attached Other**

Distance (ft): **150.8**  
Structural Grade: **0**  
O&M Grade: **2**  
Clock Start/From: **7**  
Clock To: **5**  
1st Value:  
2nd Value:  
Value Percent: **5.000**  
Continuous Index: **S02**  
Within 8" of Joint: **YES**  
Remarks: **WANDER**

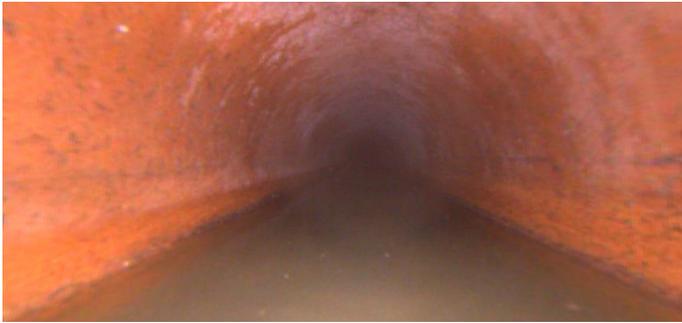
Code: **DAGS**  
Description: **Deposits Attached Grease**

Distance (ft): **287.6**  
Structural Grade: **0**  
O&M Grade: **2**  
Clock Start/From: **7**  
Clock To: **5**  
1st Value:  
2nd Value:  
Value Percent: **5.000**  
Continuous Index: **S01**  
Within 8" of Joint: **YES**  
Remarks:

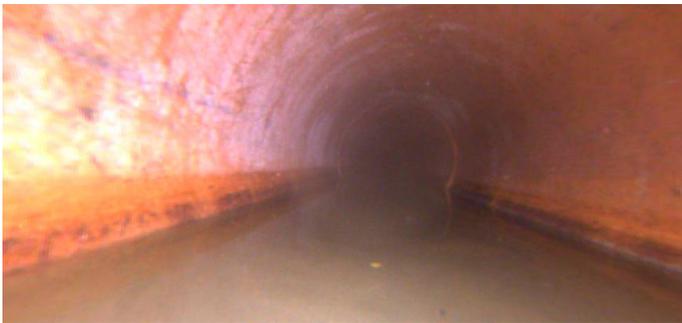
Code: **MSA**  
Description: **Abandoned Survey**

Distance (ft): **294.7**  
Structural Grade: **0**  
O&M Grade: **0**  
Clock Start/From:  
Clock To:  
1st Value:  
2nd Value:  
Value Percent:  
Continuous Index:  
Within 8" of Joint: **NO**  
Remarks: **ROBOT HAS STOPPED**

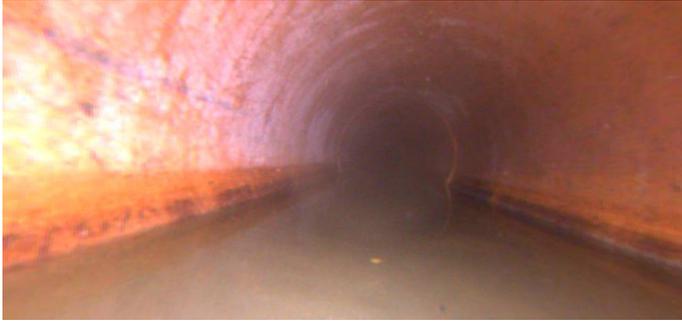
Code: **DAGS**  
Description: **Deposits Attached Grease**

Distance (ft): **294.7**  
Structural Grade: **0**  
O&M Grade: **2**  
Clock Start/From: **7**  
Clock To: **5**  
1st Value:  
2nd Value:  
Value Percent: **5.000**  
Continuous Index: **F01**  
Within 8" of Joint: **YES**  
Remarks:

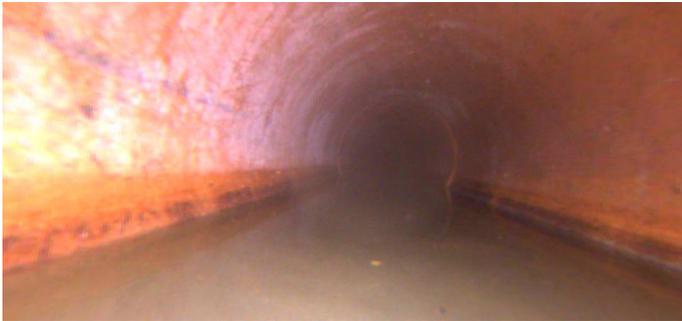
Code: **DAZ**  
Description: **Deposits Attached Other**

Distance (ft): **294.7**  
Structural Grade: **0**  
O&M Grade: **2**  
Clock Start/From: **7**  
Clock To: **5**  
1st Value:  
2nd Value:  
Value Percent: **5.000**  
Continuous Index: **F02**  
Within 8" of Joint: **YES**  
Remarks: **WANDER**
