Profile/Photo Observation Report

Street:	Rand St.	Flow Control:	Not Controlled
City:	Hobart, IN	Year Renewed:	
Location:	Light Highway	Tape/Media #:	
Purpose:	Routine Assessment	Dia/Height:	12"
Use:	Sanitary	Material:	VCP
Drain Area:	NA	Lining:	
Category:	NA		
Comment:

Location Details:		Direction of Survey:	Upstream
US MH:	M-903-012	DS MH:	M-903-015
		Total Length Surveyed (ft):	294.7

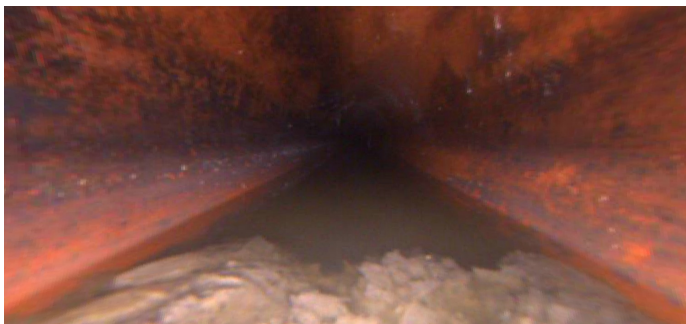
Code: **AMH**
Description: **Manhole**

Distance (ft): **.0**
Structural Grade: **0**
O&M Grade: **0**
Clock Start/From:
Clock To:
1st Value:
2nd Value:
Value Percent:
Continuous Index:
Within 8" of Joint: **NO**
Remarks: **M-903-015**

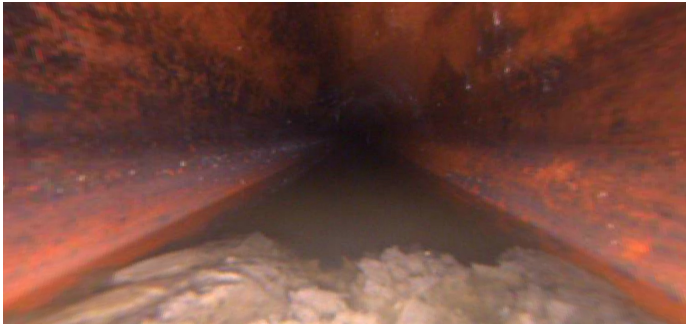
Code:	MWL
Description:	Water Level

Distance (ft):	.0
Structural Grade:	0
O&M Grade:	0
Clock Start/From:	
Clock To:	
1st Value:	
2nd Value:	
Value Percent:	10.000
Continuous Index:	
Within 8" of Joint:	NO
Remarks:

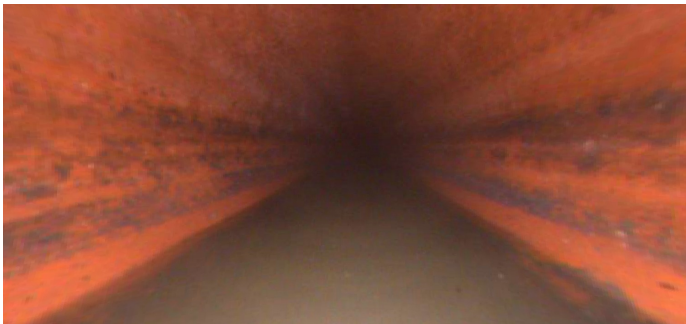
Code:	DAZ
Description:	Deposits Attached Other

Distance (ft):	150.8
Structural Grade:	0
O&M Grade:	2
Clock Start/From:	7
Clock To:	5
1st Value:	
2nd Value:	
Value Percent:	5.000
Continuous Index:	S02
Within 8" of Joint:	YES
Remarks:	WANDER

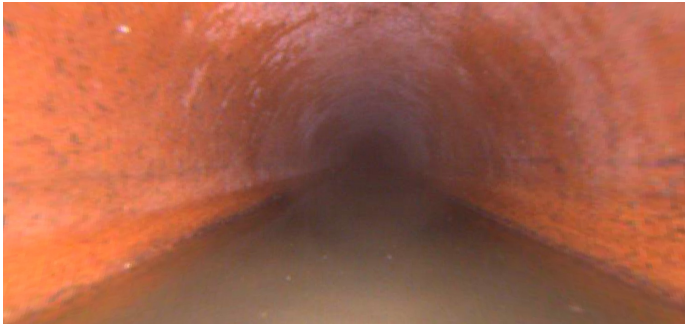
Code: **DAGS**
Description: **Deposits Attached Grease**

Distance (ft): **287.6**
Structural Grade: **0**
O&M Grade: **2**
Clock Start/From: **7**
Clock To: **5**
1st Value:
2nd Value:
Value Percent: **5.000**
Continuous Index: **S01**
Within 8" of Joint: **YES**
Remarks:

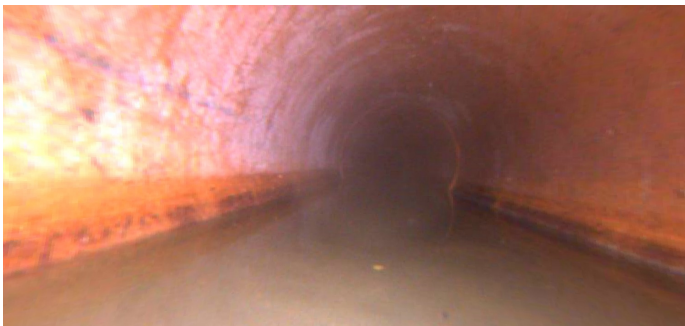
Code: **MSA**
Description: **Abandoned Survey**

Distance (ft): **294.7**
Structural Grade: **0**
O&M Grade: **0**
Clock Start/From:
Clock To:
1st Value:
2nd Value:
Value Percent:
Continuous Index:
Within 8" of Joint: **NO**
Remarks: **ROBOT HAS STOPPED**

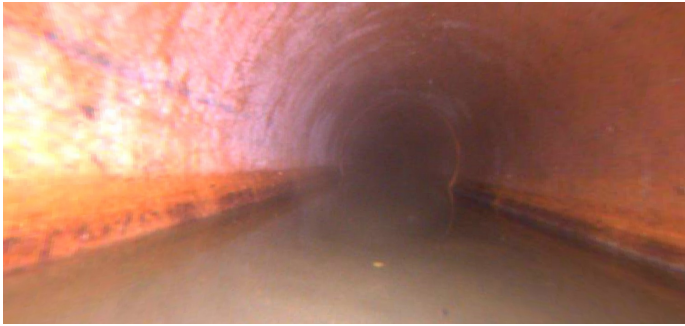
Code: **DAGS**
Description: **Deposits Attached Grease**

Distance (ft): **294.7**
Structural Grade: **0**
O&M Grade: **2**
Clock Start/From: **7**
Clock To: **5**
1st Value:
2nd Value:
Value Percent: **5.000**
Continuous Index: **F01**
Within 8" of Joint: **YES**
Remarks:

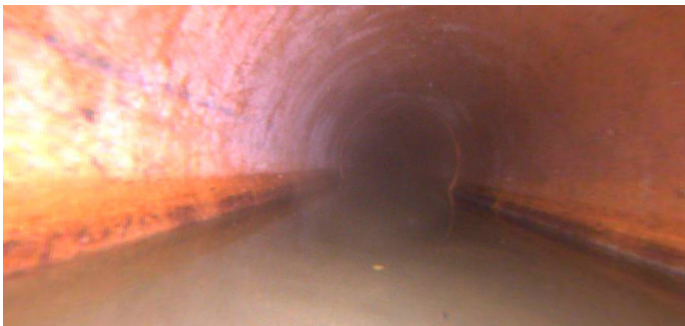
Code: **DAZ**
Description: **Deposits Attached Other**

Distance (ft): **294.7**
Structural Grade: **0**
O&M Grade: **2**
Clock Start/From: **7**
Clock To: **5**
1st Value:
2nd Value:
Value Percent: **5.000**
Continuous Index: **F02**
Within 8" of Joint: **YES**
Remarks: **WANDER**
