## Profile/Photo Observation Report

Street:	<b>E RAND ST</b>	Flow Control:	<b>Not Controlled</b>
City:	<b>Hobart, IN</b>	Year Renewed:	
Location:	<b>Light Highway</b>	Tape/Media #:	
Purpose:	<b>Routine Assessment</b>	Dia/Height:	<b>12"</b>
Use:	<b>Sanitary</b>	Material:	<b>VCP</b>
Drain Area:	<b>NA</b>	Lining:	
Category:	<b>NA</b>		
Comment:

Location Details:		Direction of Survey:	<b>Upstream</b>
US MH:	<b>M-903-012</b>	DS MH:	<b>M-903-015</b>
		Total Length Surveyed (ft):	<b>302.7</b>

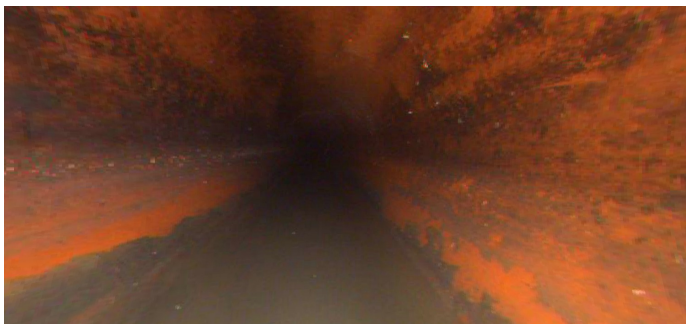
Code: **AMH**  
Description: **Manhole**

Distance (ft): **.0**  
Structural Grade: **0**  
O&M Grade: **0**  
Clock Start/From:  
Clock To:  
1st Value:  
2nd Value:  
Value Percent:  
Continuous Index:  
Within 8" of Joint: **NO**  
Remarks: **M-903-015**

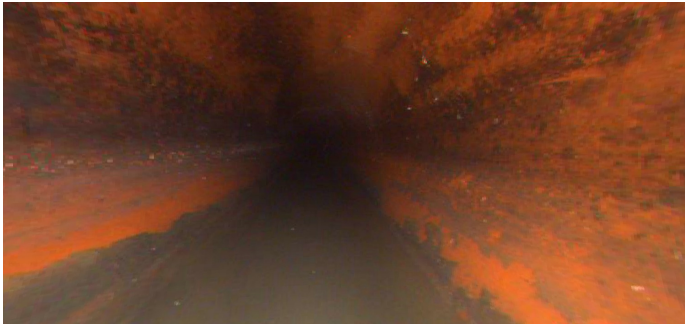
Code:	<b>MWL</b>
Description:	<b>Water Level</b>

Distance (ft):	<b>.0</b>
Structural Grade:	<b>0</b>
O&M Grade:	<b>0</b>
Clock Start/From:	
Clock To:	
1st Value:	
2nd Value:	
Value Percent:	<b>10.000</b>
Continuous Index:	
Within 8" of Joint:	<b>NO</b>
Remarks:

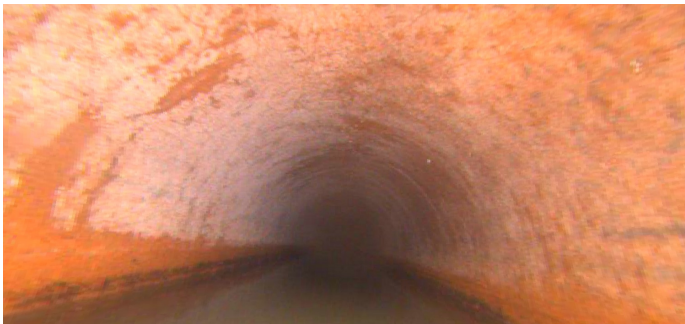
Code:	<b>DAGS</b>
Description:	<b>Deposits Attached Grease</b>

Distance (ft):	<b>291.6</b>
Structural Grade:	<b>0</b>
O&M Grade:	<b>2</b>
Clock Start/From:	<b>7</b>
Clock To:	<b>5</b>
1st Value:	
2nd Value:	
Value Percent:	<b>5.000</b>
Continuous Index:	
Within 8" of Joint:	<b>YES</b>
Remarks:

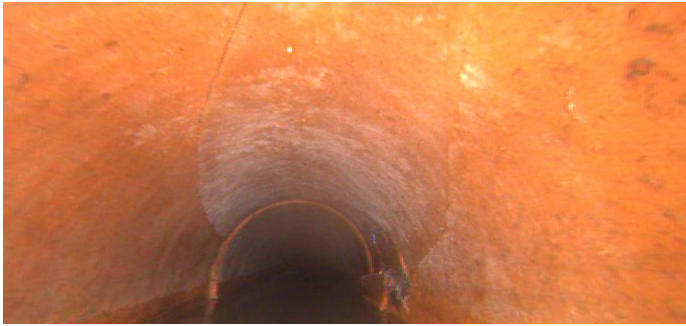
Code: **CM**  
Description: **Crack Multiple**

Distance (ft): **301.0**  
Structural Grade: **3**  
O&M Grade: **0**  
Clock Start/From: **10**  
Clock To: **4**  
1st Value:  
2nd Value:  
Value Percent:  
Continuous Index:  
Within 8" of Joint: **YES**  
Remarks:

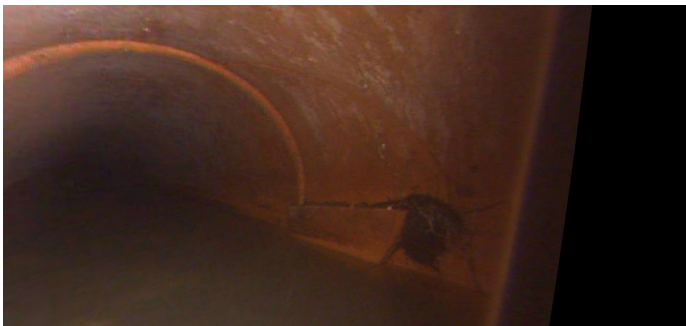
Code: **HSV**  
Description: **Hole Soil Visible**

Distance (ft): **302.0**  
Structural Grade: **5**  
O&M Grade: **0**  
Clock Start/From: **4**  
Clock To:  
1st Value:  
2nd Value:  
Value Percent:  
Continuous Index:  
Within 8" of Joint: **YES**  
Remarks:

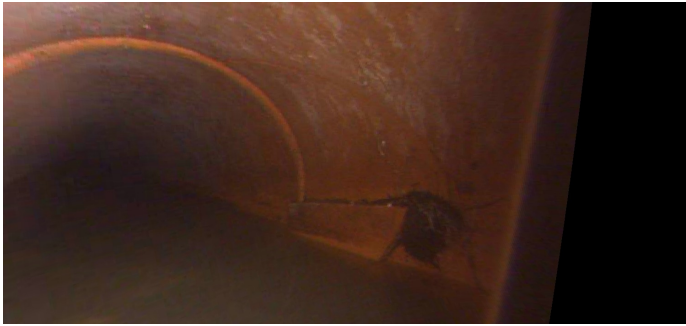
Code: **FM**  
Description: **Fracture Multiple**

Distance (ft): **302.0**  
Structural Grade: **4**  
O&M Grade: **0**  
Clock Start/From: **4**  
Clock To: **5**  
1st Value:  
2nd Value:  
Value Percent:  
Continuous Index:  
Within 8" of Joint: **YES**  
Remarks:

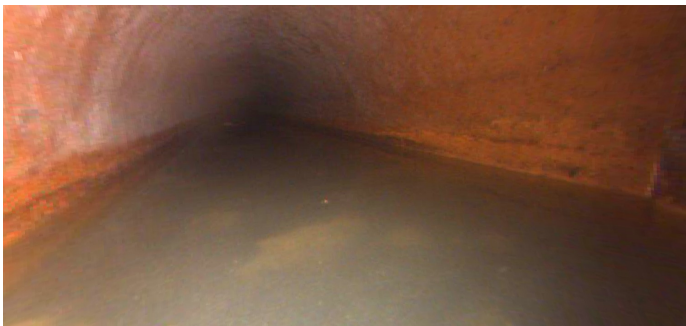
Code: **MSA**  
Description: **Abandoned Survey**

Distance (ft): **302.7**  
Structural Grade: **0**  
O&M Grade: **0**  
Clock Start/From:  
Clock To:  
1st Value:  
2nd Value:  
Value Percent:  
Continuous Index:  
Within 8" of Joint: **NO**  
Remarks: **ROBOT HAS STOPPED**
