## Profile/Photo Observation Report

Date:	<b>10/03/2018</b>	Weather:		Coding:	<b>PACP 6.0</b>
Pipe Length (ft):	<b>361.2</b>	Owner:	<b>NA</b>	Pre Clean:	<b>Not Known</b>
P.O.#:		Surveyor:	<b>Justin Gonzales</b>	PSR:	<b>P-903-012-015</b>
Customer:		Clean Date:	<b>01/01/1900</b>	Shape:	<b>C</b>

Street:	<b>Rand St.</b>	Flow Control:	<b>Not Controlled</b>
City:	<b>Hobart, IN</b>	Year Renewed:	
Location:	<b>Light Highway</b>	Tape/Media #:	
Purpose:	<b>Routine Assessment</b>	Dia/Height:	<b>12"</b>
Use:	<b>Sanitary</b>	Material:	<b>VCP</b>
Drain Area:	<b>NA</b>	Lining:	
Category:	<b>NA</b>		
Comment:

Location Details:		Direction of Survey:	<b>Upstream</b>
US MH:	<b>M-903-012</b>	DS MH:	<b>M-903-015</b>
		Total Length Surveyed (ft):	<b>302.7</b>

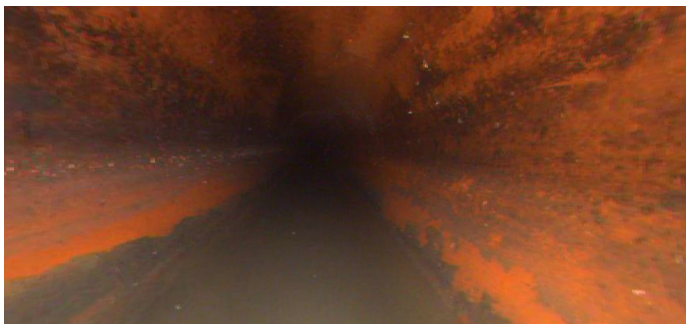
Code: **AMH**  
Description: **Manhole**

Distance (ft): **.0**  
Structural Grade: **0**  
O&M Grade: **0**  
Clock Start/From:  
Clock To:  
1st Value:  
2nd Value:  
Value Percent:  
Continuous Index:  
Within 8" of Joint: **NO**  
Remarks: **M-903-015**

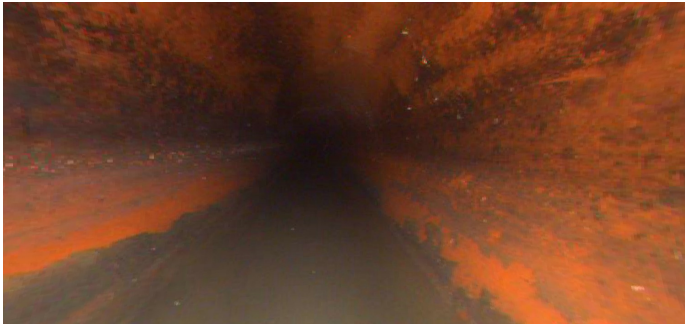
Code:	<b>MWL</b>
Description:	<b>Water Level</b>

Distance (ft):	<b>.0</b>
Structural Grade:	<b>0</b>
O&M Grade:	<b>0</b>
Clock Start/From:	
Clock To:	
1st Value:	
2nd Value:	
Value Percent:	<b>10.000</b>
Continuous Index:	
Within 8" of Joint:	<b>NO</b>
Remarks:

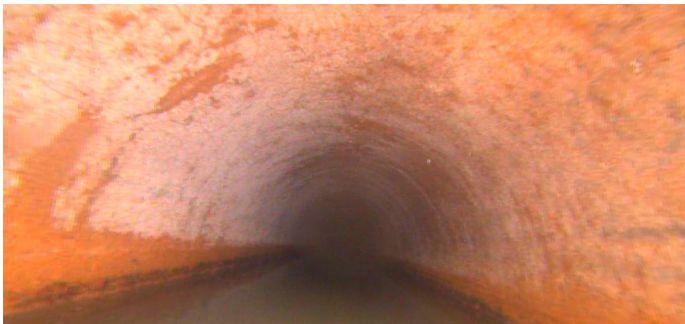
Code:	<b>DAGS</b>
Description:	<b>Deposits Attached Grease</b>

Distance (ft):	<b>291.6</b>
Structural Grade:	<b>0</b>
O&M Grade:	<b>2</b>
Clock Start/From:	<b>7</b>
Clock To:	<b>5</b>
1st Value:	
2nd Value:	
Value Percent:	<b>5.000</b>
Continuous Index:	
Within 8" of Joint:	<b>YES</b>
Remarks:

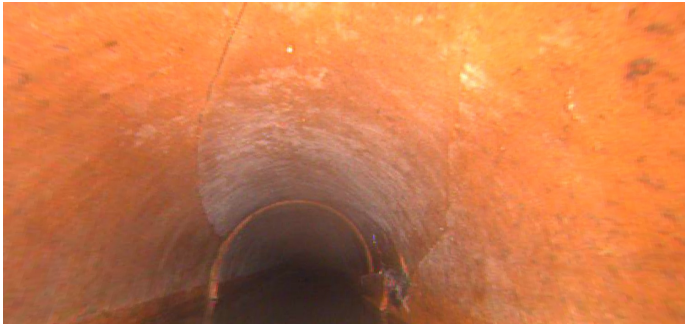
Code: **CM**  
Description: **Crack Multiple**

Distance (ft): **301.0**  
Structural Grade: **3**  
O&M Grade: **0**  
Clock Start/From: **10**  
Clock To: **4**  
1st Value:  
2nd Value:  
Value Percent:  
Continuous Index:  
Within 8" of Joint: **YES**  
Remarks:

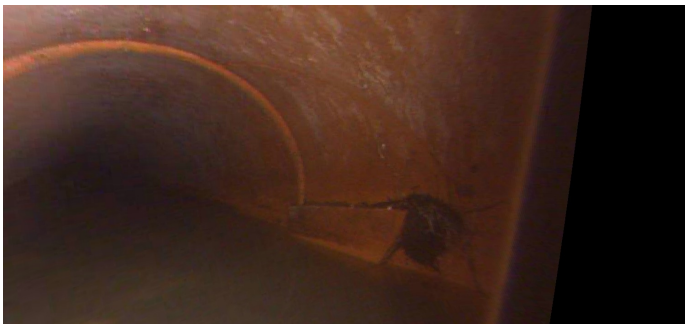
Code: **HSV**  
Description: **Hole Soil Visible**

Distance (ft): **302.0**  
Structural Grade: **5**  
O&M Grade: **0**  
Clock Start/From: **4**  
Clock To:  
1st Value:  
2nd Value:  
Value Percent:  
Continuous Index:  
Within 8" of Joint: **YES**  
Remarks:

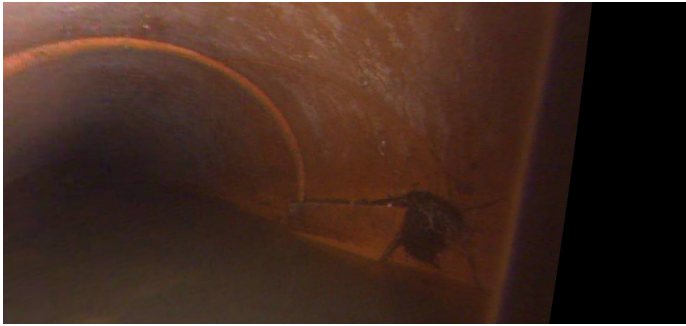
Code: **FM**  
Description: **Fracture Multiple**

Distance (ft): **302.0**  
Structural Grade: **4**  
O&M Grade: **0**  
Clock Start/From: **4**  
Clock To: **5**  
1st Value:  
2nd Value:  
Value Percent:  
Continuous Index:  
Within 8" of Joint: **YES**  
Remarks:

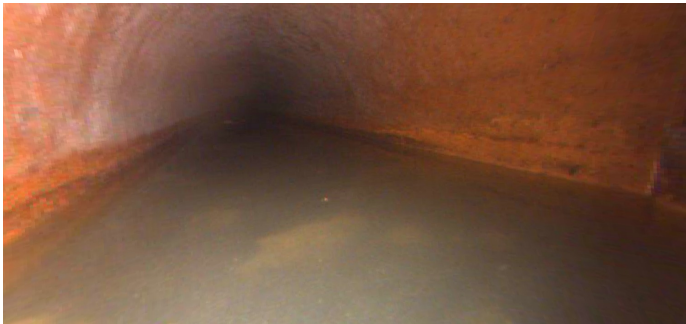
Code: **MSA**  
Description: **Abandoned Survey**

Distance (ft): **302.7**  
Structural Grade: **0**  
O&M Grade: **0**  
Clock Start/From:  
Clock To:  
1st Value:  
2nd Value:  
Value Percent:  
Continuous Index:  
Within 8" of Joint: **NO**  
Remarks: **ROBOT HAS STOPPED**
