## Profile/Photo Observation Report

Street:	<b>E RAND ST</b>	Flow Control:	<b>Not Controlled</b>
City:	<b>Hobart, IN</b>	Year Renewed:	
Location:	<b>Light Highway</b>	Tape/Media #:	
Purpose:	<b>Routine Assessment</b>	Dia/Height:	<b>12"</b>
Use:	<b>Sanitary</b>	Material:	<b>VCP</b>
Drain Area:	<b>NA</b>	Lining:	
Category:	<b>NA</b>		
Comment:

Location Details:		Direction of Survey:	<b>Downstream</b>
US MH:	<b>M-903-012</b>	DS MH:	<b>M-903-015</b>
		Total Length Surveyed (ft):	<b>39.4</b>

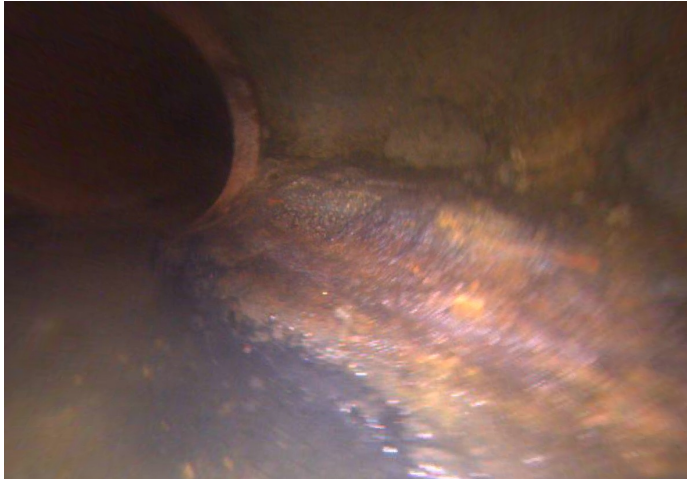
Code:	<b>MWL</b>
Description:	<b>Water Level</b>
Distance (ft):	<b>.0</b>
Structural Grade:	<b>0</b>
O&M Grade:	<b>0</b>
Clock Start/From:	
Clock To:	
1st Value:	
2nd Value:	
Value Percent:	<b>10.000</b>
Continuous Index:	
Within 8" of Joint:	<b>NO</b>
Remarks:

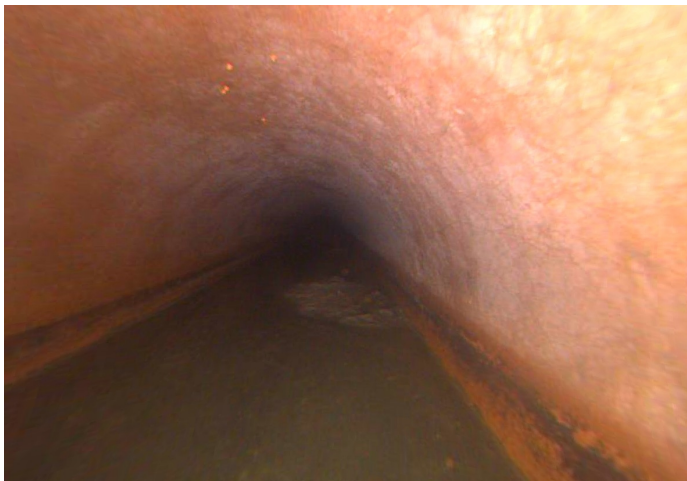
Code:	<b>MWL</b>
Description:	<b>Water Level</b>
Distance (ft):	<b>35.7</b>
Structural Grade:	<b>0</b>
O&M Grade:	<b>0</b>
Clock Start/From:	
Clock To:	
1st Value:	
2nd Value:	
Value Percent:	<b>20.000</b>
Continuous Index:	
Within 8" of Joint:	<b>NO</b>
Remarks:

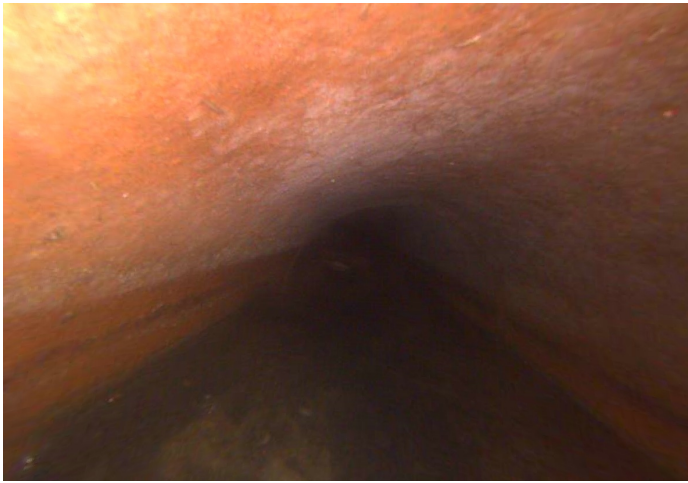
Code:	<b>MSA</b>
Description:	<b>Abandoned Survey</b>
Distance (ft):	<b>39.4</b>
Structural Grade:	<b>0</b>
O&M Grade:	<b>0</b>
Clock Start/From:	
Clock To:	
1st Value:	
2nd Value:	
Value Percent:	
Continuous Index:	
Within 8" of Joint:	<b>NO</b>
Remarks:	<b>Possible Debris</b>
