## Profile/Photo Observation Report

Street:	<b>Rand St.</b>	Flow Control:	<b>Not Controlled</b>
City:	<b>Hobart, IN</b>	Year Renewed:	
Location:	<b>Light Highway</b>	Tape/Media #:	
Purpose:	<b>Routine Assessment</b>	Dia/Height:	<b>12"</b>
Use:	<b>Sanitary</b>	Material:	<b>VCP</b>
Drain Area:	<b>NA</b>	Lining:	
Category:	<b>NA</b>		
Comment:

Location Details:		Direction of Survey:	<b>Downstream</b>
US MH:	<b>M-903-012</b>	DS MH:	<b>M-903-015</b>
		Total Length Surveyed (ft):	<b>39.4</b>

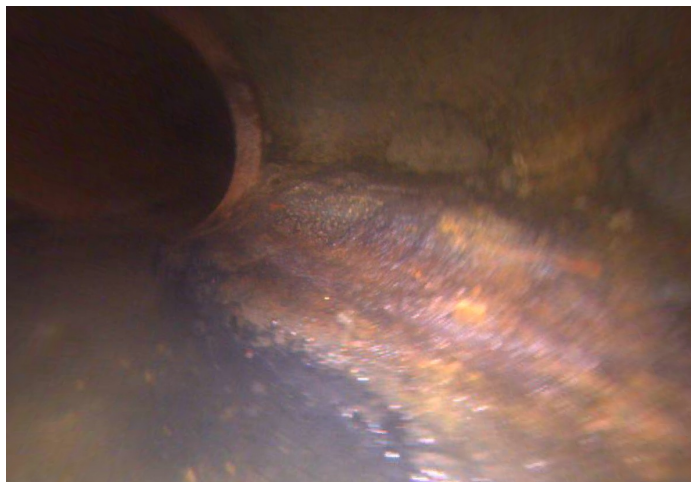
Code: **AMH**  
Description: **Manhole**

Distance (ft): **.0**  
Structural Grade: **0**  
O&M Grade: **0**  
Clock Start/From:  
Clock To:  
1st Value:  
2nd Value:  
Value Percent:  
Continuous Index:  
Within 8" of Joint: **NO**  
Remarks: **M-903-012**

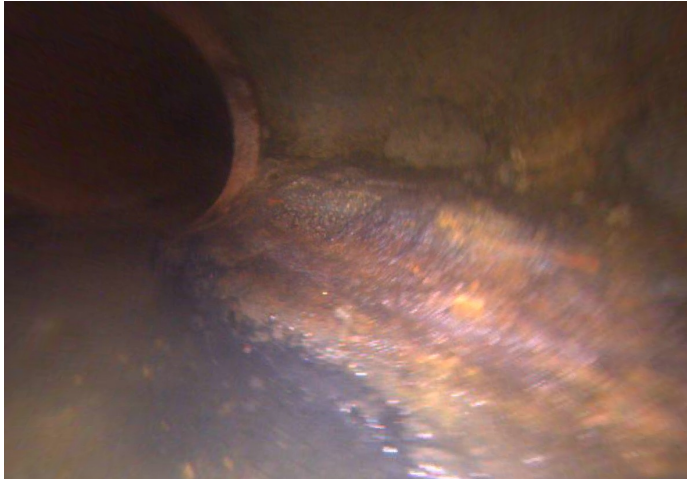
Code: **MWL**  
Description: **Water Level**

Distance (ft): **.0**  
Structural Grade: **0**  
O&M Grade: **0**  
Clock Start/From:  
Clock To:  
1st Value:  
2nd Value:  
Value Percent: **10.000**  
Continuous Index:  
Within 8" of Joint: **NO**  
Remarks:

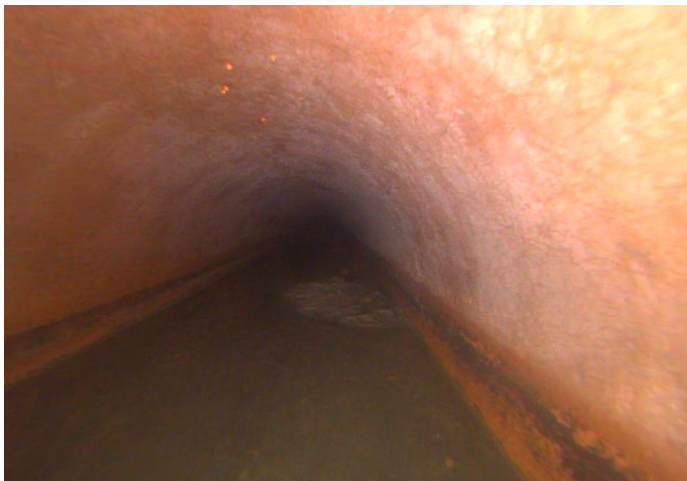
Code: **MWL**  
Description: **Water Level**

Distance (ft): **35.7**  
Structural Grade: **0**  
O&M Grade: **0**  
Clock Start/From:  
Clock To:  
1st Value:  
2nd Value:  
Value Percent: **20.000**  
Continuous Index:  
Within 8" of Joint: **NO**  
Remarks:

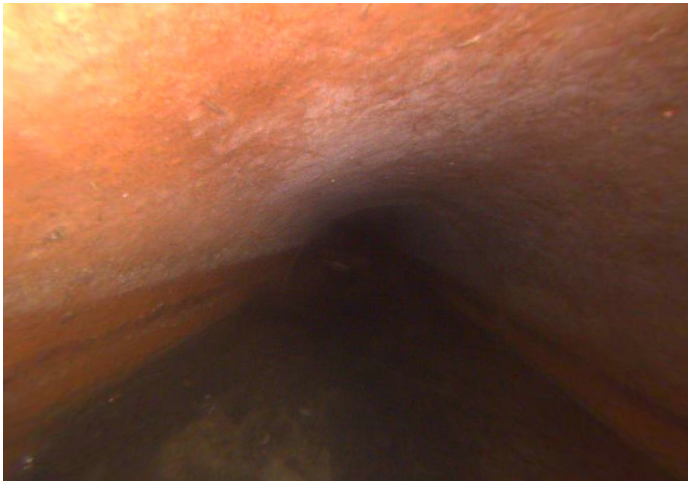
Code:	<b>MSA</b>
Description:	<b>Abandoned Survey</b>
Distance (ft):	<b>39.4</b>
Structural Grade:	<b>0</b>
O&M Grade:	<b>0</b>
Clock Start/From:	
Clock To:	
1st Value:	
2nd Value:	
Value Percent:	
Continuous Index:	
Within 8" of Joint:	<b>NO</b>
Remarks:	<b>Possible Debris</b>
