## Profile/Photo Observation Report

Date:	<b>04/02/2018</b>	Weather:		Coding:	<b>PACP 6.0</b>
Pipe Length (ft):	<b>199.1</b>	Owner:	<b>NA</b>	Pre Clean:	<b>Not Known</b>
P.O.#:		Surveyor:	<b>Jen Costello</b>	PSR:	<b>P-903-014-015</b>
Customer:		Clean Date:	<b>01/01/1900</b>	Shape:	<b>C</b>

Street:	<b>N Shelby St.</b>	Flow Control:	<b>Not Controlled</b>
City:	<b>Hobart, IN</b>	Year Renewed:	
Location:	<b>Other</b>	Tape/Media #:	
Purpose:	<b>Not Known</b>	Dia/Height:	<b>8"</b>
Use:	<b>Sanitary</b>	Material:	<b>VCP</b>
Drain Area:	<b>NA</b>	Lining:	
Category:	<b>NA</b>		
Comment:

Location Details:		Direction of Survey:	<b>Upstream</b>
US MH:	<b>M-903-015</b>	DS MH:	<b>M-903-014</b>
		Total Length Surveyed (ft):	<b>149.5</b>

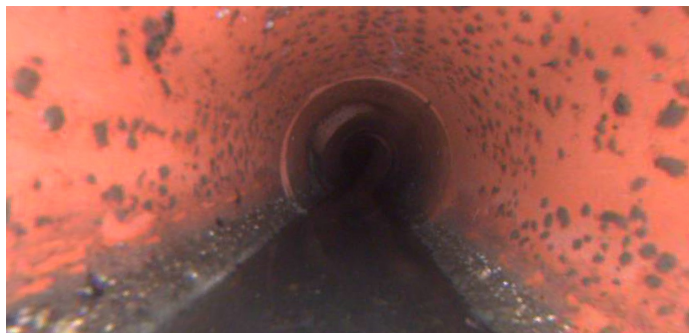
Code: **AMH**  
 Description: **Manhole**

Distance (ft): **.0**  
 Structural Grade: **0**  
 O&M Grade: **0**  
 Clock Start/From:  
 Clock To:  
 1st Value:  
 2nd Value:  
 Value Percent:  
 Continuous Index:  
 Within 8" of Joint: **NO**  
 Remarks: **M-903-014**

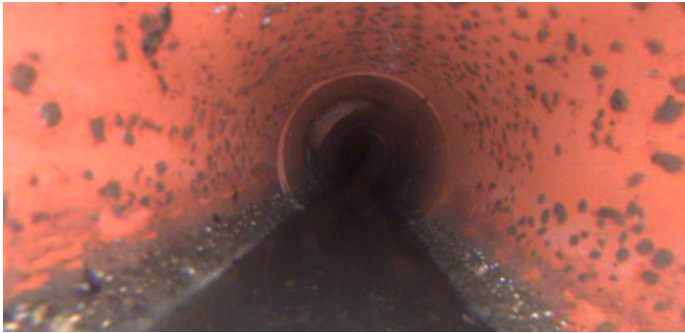
Code:	<b>MWL</b>
Description:	<b>Water Level</b>

Distance (ft):	<b>.0</b>
Structural Grade:	<b>0</b>
O&M Grade:	<b>0</b>
Clock Start/From:	
Clock To:	
1st Value:	
2nd Value:	
Value Percent:	<b>10.000</b>
Continuous Index:	
Within 8" of Joint:	<b>NO</b>
Remarks:

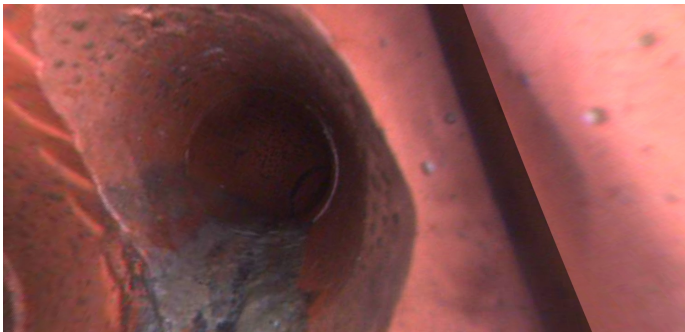
Code:	<b>TF</b>
Description:	<b>Tap Factory</b>

Distance (ft):	<b>3.3</b>
Structural Grade:	<b>0</b>
O&M Grade:	<b>0</b>
Clock Start/From:	<b>10</b>
Clock To:	
1st Value:	<b>4.000</b>
2nd Value:	
Value Percent:	
Continuous Index:	
Within 8" of Joint:	
Remarks:

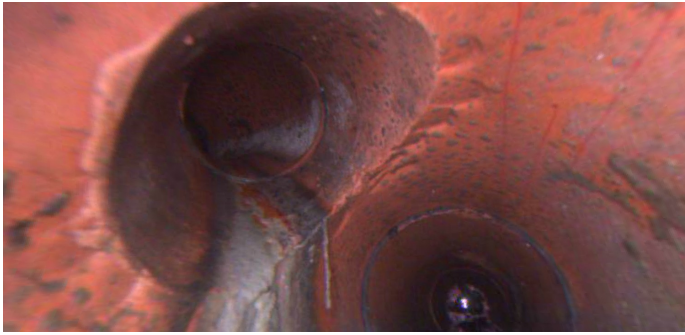
Code: **TB**  
Description: **Tap Break-in**

Distance (ft): **5.5**  
Structural Grade: **0**  
O&M Grade: **0**  
Clock Start/From: **2**  
Clock To:  
1st Value: **4.000**  
2nd Value:  
Value Percent:  
Continuous Index:  
Within 8" of Joint:  
Remarks:

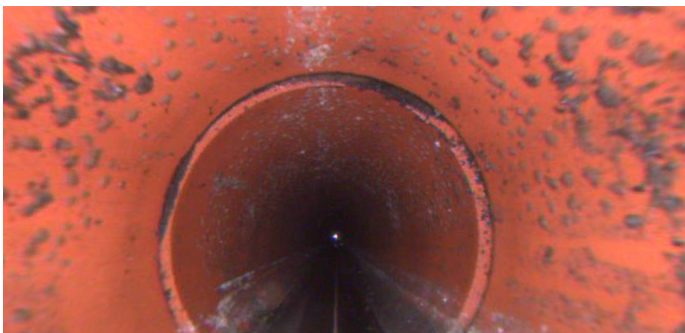
Code: **MGO**  
Description: **General Observation**

Distance (ft): **23.5**  
Structural Grade: **0**  
O&M Grade: **0**  
Clock Start/From:  
Clock To:  
1st Value:  
2nd Value:  
Value Percent:  
Continuous Index:  
Within 8" of Joint: **NO**  
Remarks: **REAR CAMERA**

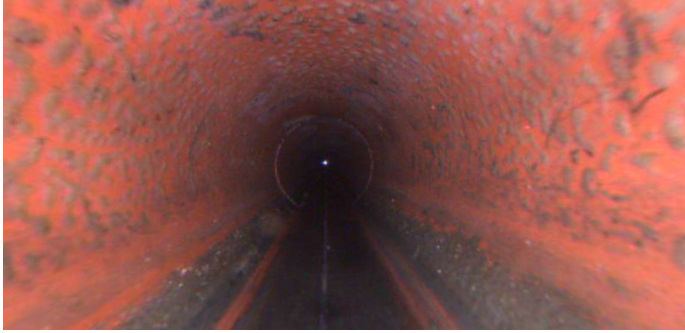
Code: **DAGS**  
Description: **Deposits Attached Grease**

Distance (ft): **36.0**  
Structural Grade: **0**  
O&M Grade: **2**  
Clock Start/From: **8**  
Clock To: **4**  
1st Value:  
2nd Value:  
Value Percent: **5.000**  
Continuous Index: **S01**  
Within 8" of Joint: **NO**  
Remarks:

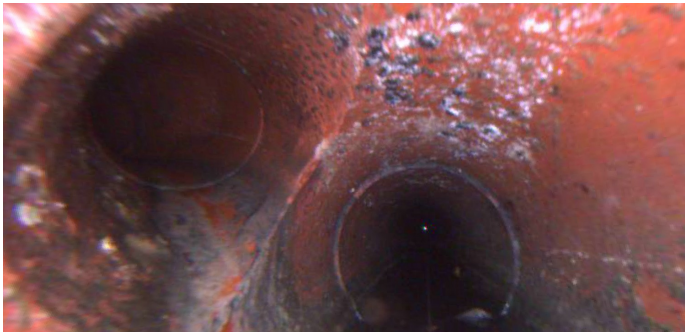
Code: **TF**  
Description: **Tap Factory**

Distance (ft): **79.0**  
Structural Grade: **0**  
O&M Grade: **0**  
Clock Start/From: **2**  
Clock To:  
1st Value: **4.000**  
2nd Value:  
Value Percent:  
Continuous Index:  
Within 8" of Joint:  
Remarks:

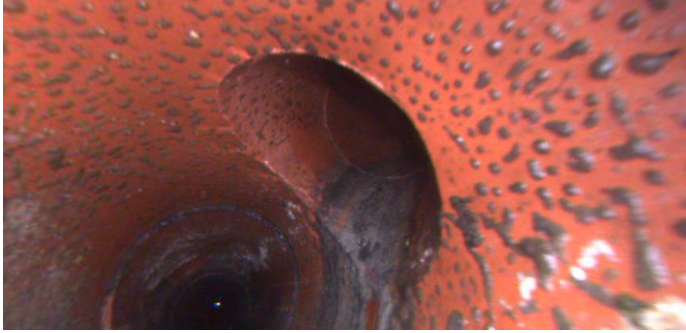
Code: **TF**  
Description: **Tap Factory**

Distance (ft): **81.3**  
Structural Grade: **0**  
O&M Grade: **0**  
Clock Start/From: **10**  
Clock To:  
1st Value: **4.000**  
2nd Value:  
Value Percent:  
Continuous Index:  
Within 8" of Joint:  
Remarks:

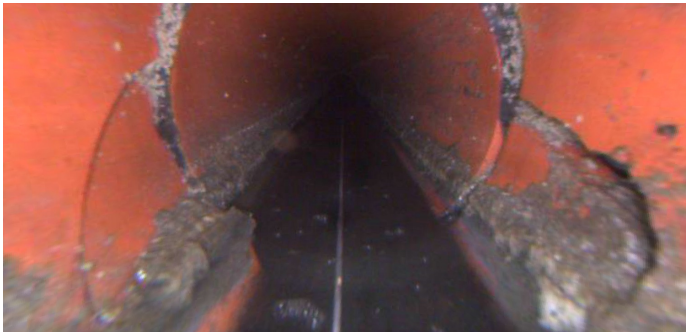
Code: **FM**  
Description: **Fracture Multiple**

Distance (ft): **121.1**  
Structural Grade: **4**  
O&M Grade: **0**  
Clock Start/From: **8**  
Clock To: **4**  
1st Value:  
2nd Value:  
Value Percent:  
Continuous Index:  
Within 8" of Joint: **YES**  
Remarks:

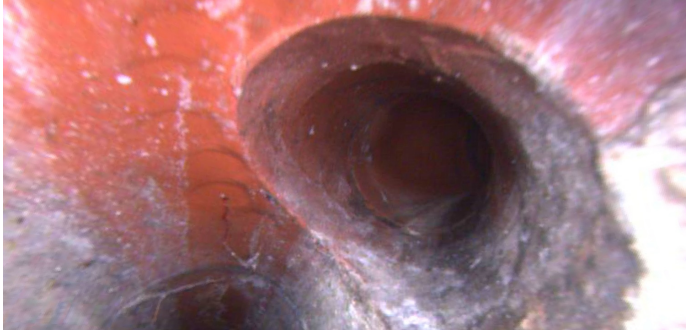
Code: **TF**  
Description: **Tap Factory**

Distance (ft): **138.3**  
Structural Grade: **0**  
O&M Grade: **0**  
Clock Start/From: **10**  
Clock To:  
1st Value: **4.000**  
2nd Value:  
Value Percent:  
Continuous Index:  
Within 8" of Joint:  
Remarks:
