## Profile/Photo Observation Report

Street:	<b>N SHELBY PL</b>	Flow Control:	<b>Not Controlled</b>
City:	<b>Hobart, IN</b>	Year Renewed:	
Location:	<b>Light Highway</b>	Tape/Media #:	
Purpose:	<b>Routine Assessment</b>	Dia/Height:	<b>8"</b>
Use:	<b>Sanitary</b>	Material:	<b>VCP</b>
Drain Area:	<b>NA</b>	Lining:	
Category:	<b>NA</b>		
Comment:

Location Details:		Direction of Survey:	<b>Downstream</b>
US MH:	<b>M-903-015</b>	DS MH:	<b>M-903-014</b>
		Total Length Surveyed (ft):	<b>192.8</b>

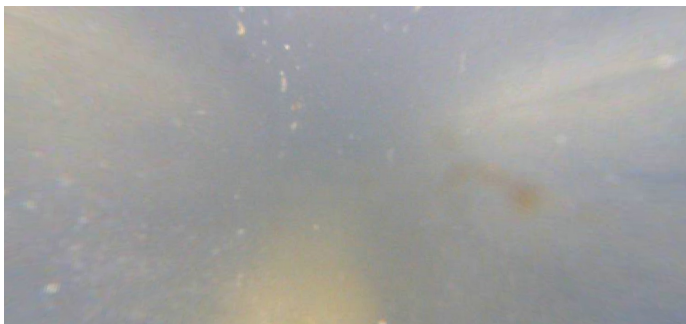
Code: **AMH**  
Description: **Manhole**

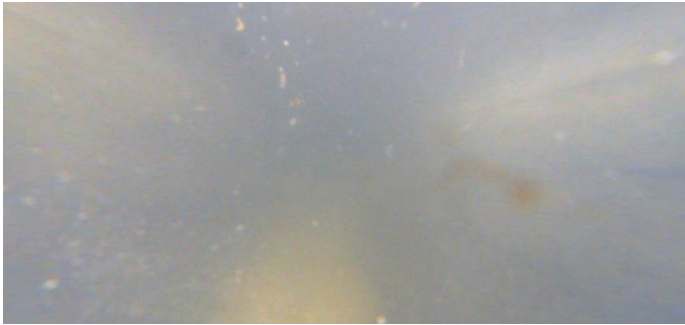
Code:	<b>MWL</b>
Description:	<b>Water Level</b>

Distance (ft):	<b>.0</b>
Structural Grade:	<b>0</b>
O&M Grade:	<b>0</b>
Clock Start/From:	
Clock To:	
1st Value:	
2nd Value:	
Value Percent:	<b>100.000</b>
Continuous Index:	
Within 8" of Joint:	<b>NO</b>
Remarks:

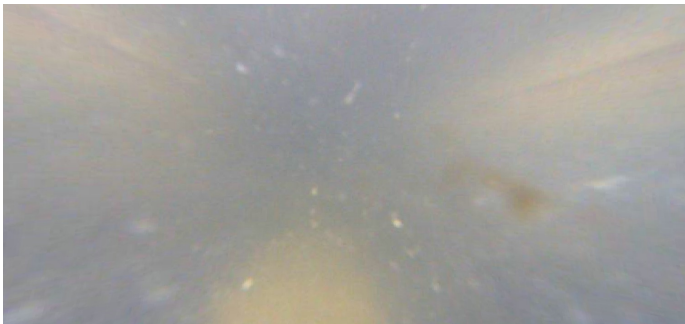
Code:	<b>MCU</b>
Description:	<b>Camera Underwater</b>

Distance (ft):	<b>1.8</b>
Structural Grade:	<b>0</b>
O&M Grade:	<b>4</b>
Clock Start/From:	
Clock To:	
1st Value:	
2nd Value:	
Value Percent:	
Continuous Index:	<b>S01</b>
Within 8" of Joint:	<b>NO</b>
Remarks:

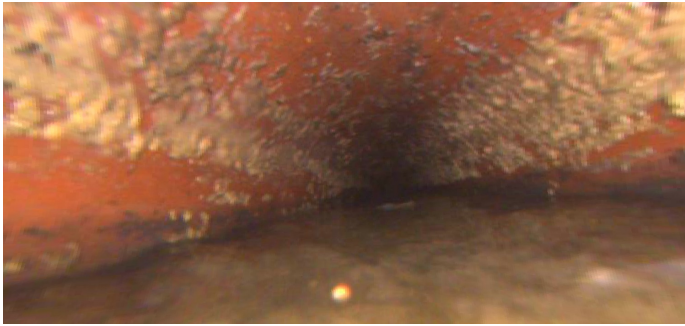
Code: **MCU**  
Description: **Camera Underwater**

Distance (ft): **35.4**  
Structural Grade: **0**  
O&M Grade: **4**  
Clock Start/From:  
Clock To:  
1st Value:  
2nd Value:  
Value Percent:  
Continuous Index: **F01**  
Within 8" of Joint: **NO**  
Remarks:

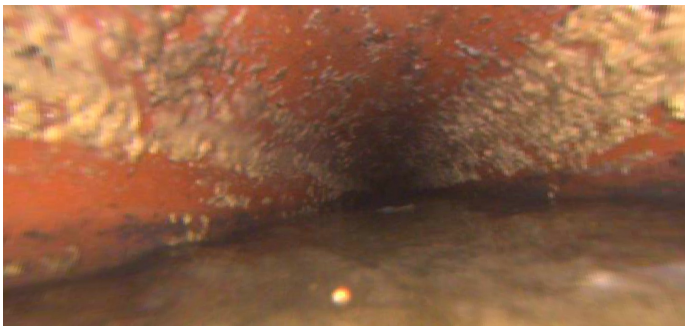
Code: **DAGS**  
Description: **Deposits Attached Grease**

Distance (ft): **35.4**  
Structural Grade: **0**  
O&M Grade: **2**  
Clock Start/From: **7**  
Clock To: **5**  
1st Value:  
2nd Value:  
Value Percent: **5.000**  
Continuous Index: **S02**  
Within 8" of Joint: **YES**  
Remarks: **WANDER**

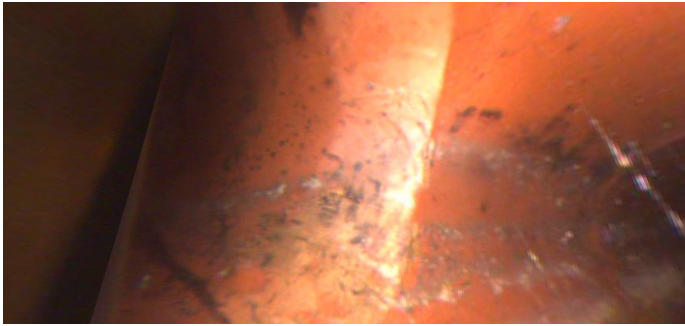
Code: **TF**  
Description: **Tap Factory**

Distance (ft): **55.3**  
Structural Grade: **0**  
O&M Grade: **0**  
Clock Start/From: **3**  
Clock To:  
1st Value: **4.000**  
2nd Value:  
Value Percent:  
Continuous Index:  
Within 8" of Joint:  
Remarks:

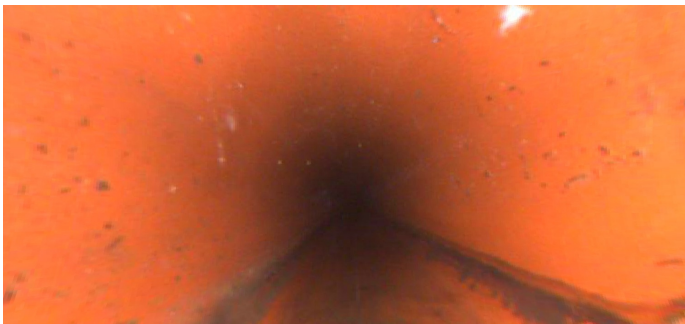
Code: **DAGS**  
Description: **Deposits Attached Grease**

Distance (ft): **72.3**  
Structural Grade: **0**  
O&M Grade: **2**  
Clock Start/From: **7**  
Clock To: **5**  
1st Value:  
2nd Value:  
Value Percent: **5.000**  
Continuous Index: **F02**  
Within 8" of Joint: **YES**  
Remarks: **WANDER**

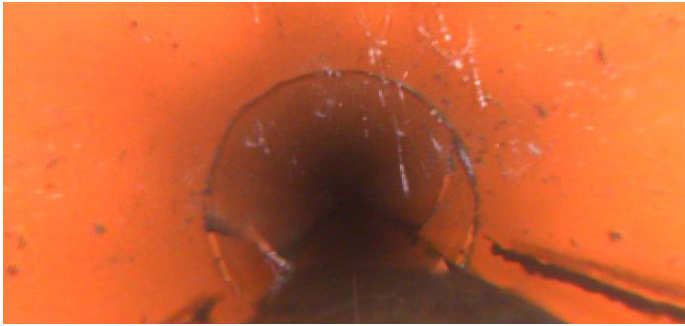
Code: **FM**  
Description: **Fracture Multiple**

Distance (ft): **73.1**  
Structural Grade: **4**  
O&M Grade: **0**  
Clock Start/From: **7**  
Clock To: **5**  
1st Value:  
2nd Value:  
Value Percent:  
Continuous Index:  
Within 8" of Joint: **YES**  
Remarks:

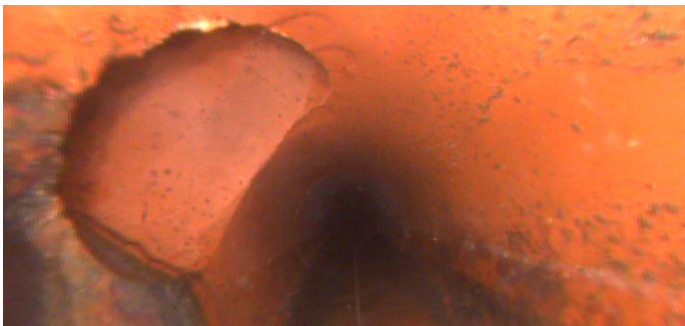
Code: **TF**  
Description: **Tap Factory**

Distance (ft): **112.2**  
Structural Grade: **0**  
O&M Grade: **0**  
Clock Start/From: **2**  
Clock To:  
1st Value: **4.000**  
2nd Value:  
Value Percent:  
Continuous Index:  
Within 8" of Joint:  
Remarks:

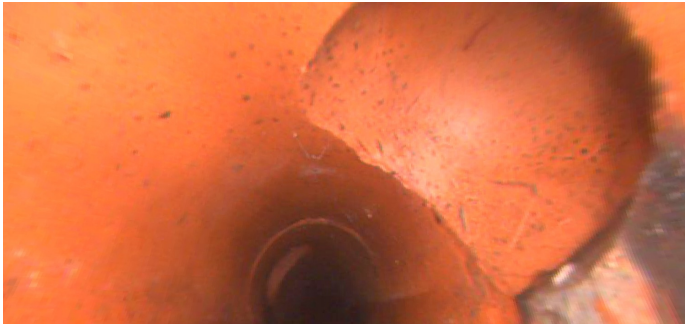
Code: **TF**  
Description: **Tap Factory**

Distance (ft): **114.1**  
Structural Grade: **0**  
O&M Grade: **0**  
Clock Start/From: **10**  
Clock To:  
1st Value: **4.000**  
2nd Value:  
Value Percent:  
Continuous Index:  
Within 8" of Joint:  
Remarks:

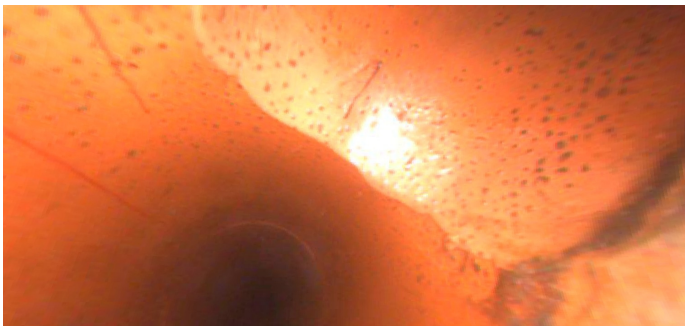
Code: **TF**  
Description: **Tap Factory**

Distance (ft): **186.7**  
Structural Grade: **0**  
O&M Grade: **0**  
Clock Start/From: **10**  
Clock To:  
1st Value: **4.000**  
2nd Value:  
Value Percent:  
Continuous Index:  
Within 8" of Joint:  
Remarks:

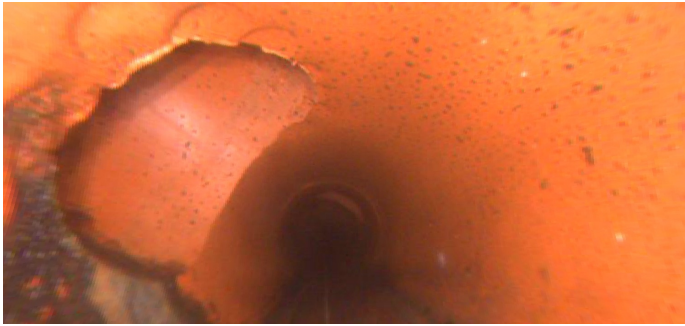
Code: **TF**  
Description: **Tap Factory**

Distance (ft): **189.1**  
Structural Grade: **0**  
O&M Grade: **0**  
Clock Start/From: **2**  
Clock To:  
1st Value: **4.000**  
2nd Value:  
Value Percent:  
Continuous Index:  
Within 8" of Joint:  
Remarks:

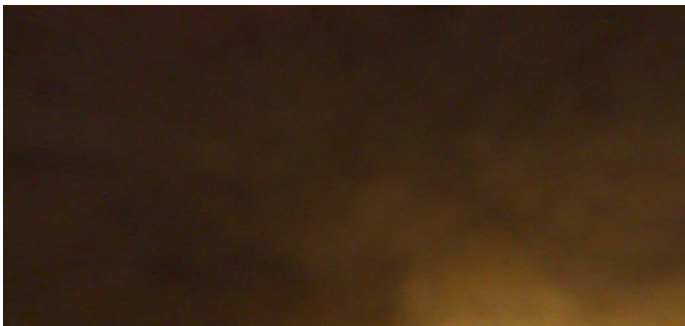
Code: **MSA**  
Description: **Abandoned Survey**

Distance (ft): **192.8**  
Structural Grade: **0**  
O&M Grade: **0**  
Clock Start/From:  
Clock To:  
1st Value:  
2nd Value:  
Value Percent:  
Continuous Index:  
Within 8" of Joint: **NO**  
Remarks: **MCU, CANNOT DISTINGUISH IF DSMH REACHED**
