Profile/Photo Observation Report

Date:	10/03/2018	Weather:		Coding:	PACP 6.0
Pipe Length (ft):	199.1	Owner:	NA	Pre Clean:	Not Known
P.O.#:		Surveyor:	Justin Gonzales	PSR:	P-903-014-015
Customer:		Clean Date:	01/01/1900	Shape:	C

Street:	Shelby St.	Flow Control:	Not Controlled
City:	Hobart, IN	Year Renewed:	
Location:	Light Highway	Tape/Media #:	
Purpose:	Routine Assessment	Dia/Height:	8"
Use:	Sanitary	Material:	VCP
Drain Area:	NA	Lining:	
Category:	NA		
Comment:

Location Details:		Direction of Survey:	Downstream
US MH:	M-903-015	DS MH:	M-903-014
		Total Length Surveyed (ft):	192.8

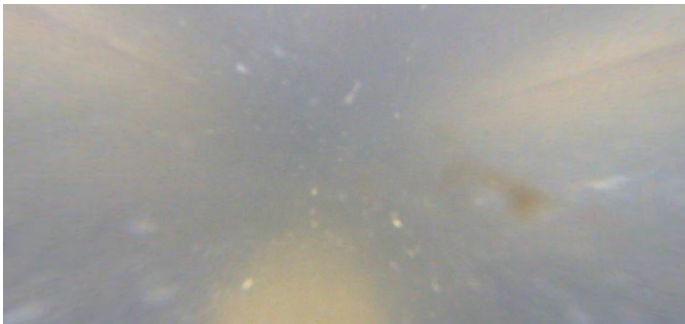
Code:	MCU
Description:	Camera Underwater

Distance (ft):	1.8
Structural Grade:	0
O&M Grade:	4
Clock Start/From:	
Clock To:	
1st Value:	
2nd Value:	
Value Percent:	
Continuous Index:	S01
Within 8" of Joint:	NO
Remarks:

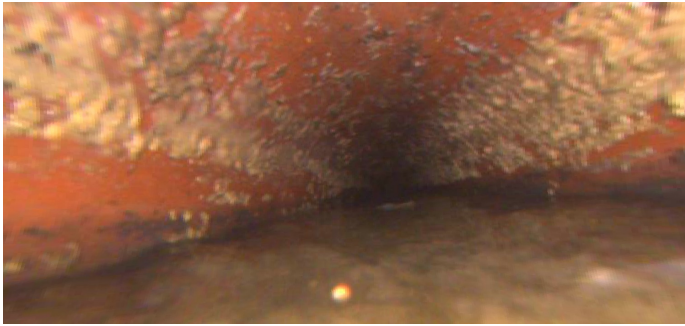
Code: **MCU**
Description: **Camera Underwater**

Distance (ft): **35.4**
Structural Grade: **0**
O&M Grade: **4**
Clock Start/From:
Clock To:
1st Value:
2nd Value:
Value Percent:
Continuous Index: **F01**
Within 8" of Joint: **NO**
Remarks:

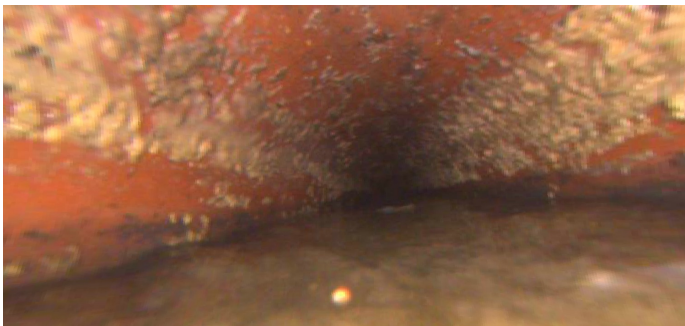
Code: **DAGS**
Description: **Deposits Attached Grease**

Distance (ft): **35.4**
Structural Grade: **0**
O&M Grade: **2**
Clock Start/From: **7**
Clock To: **5**
1st Value:
2nd Value:
Value Percent: **5.000**
Continuous Index: **S02**
Within 8" of Joint: **YES**
Remarks: **WANDER**

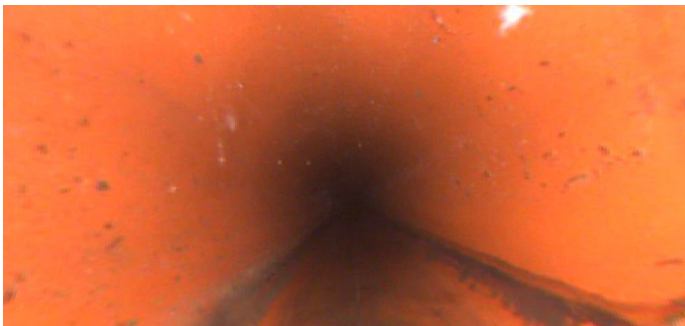
Code: **DAGS**
Description: **Deposits Attached Grease**

Distance (ft): **72.3**
Structural Grade: **0**
O&M Grade: **2**
Clock Start/From: **7**
Clock To: **5**
1st Value:
2nd Value:
Value Percent: **5.000**
Continuous Index: **F02**
Within 8" of Joint: **YES**
Remarks: **WANDER**

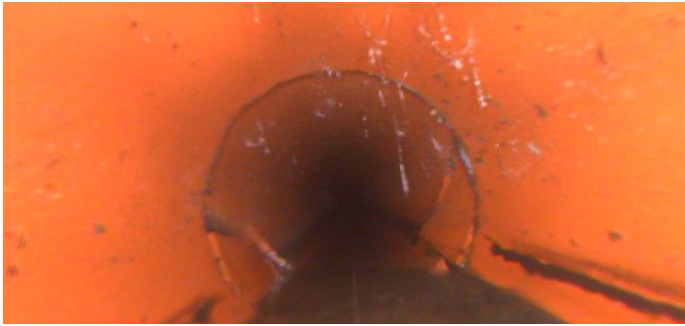
Code: **FM**
Description: **Fracture Multiple**

Distance (ft): **73.1**
Structural Grade: **4**
O&M Grade: **0**
Clock Start/From: **7**
Clock To: **5**
1st Value:
2nd Value:
Value Percent:
Continuous Index:
Within 8" of Joint: **YES**
Remarks:
