Profile/Photo Observation Report

Date:	10/03/2018	Weather:		Coding:	PACP 6.0
Pipe Length (ft):	198.6	Owner:	NA	Pre Clean:	Not Known
P.O.#:		Surveyor:	Justin Gonzales	PSR:	P-903-015-016
Customer:		Clean Date:	01/01/1900	Shape:	C

Street:	E RAND ST	Flow Control:	Not Controlled
City:	Hobart, IN	Year Renewed:	
Location:	Light Highway	Tape/Media #:	
Purpose:	Routine Assessment	Dia/Height:	12"
Use:	Sanitary	Material:	VCP
Drain Area:	NA	Lining:	
Category:	NA		
Comment:

Location Details:		Direction of Survey:	Downstream
US MH:	M-903-015	DS MH:	M-903-016
		Total Length Surveyed (ft):	190.6

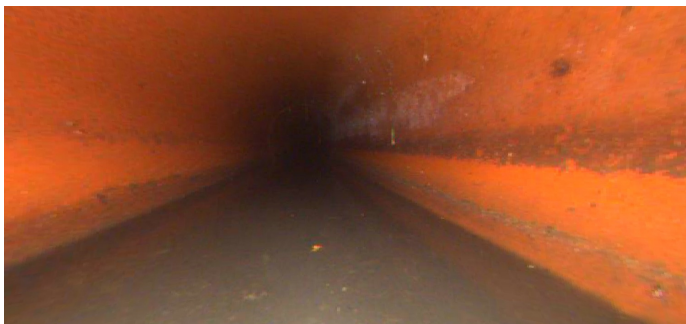
Code: **AMH**
Description: **Manhole**

Distance (ft): **.0**
Structural Grade: **0**
O&M Grade: **0**
Clock Start/From:
Clock To:
1st Value:
2nd Value:
Value Percent:
Continuous Index:
Within 8" of Joint: **NO**
Remarks: **M-903-015**

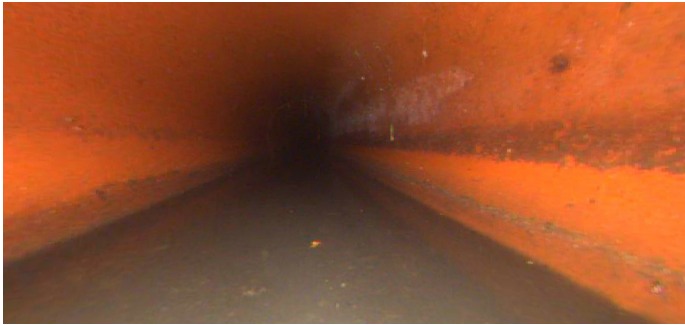
Code:	MWL
Description:	Water Level

Distance (ft):	.0
Structural Grade:	0
O&M Grade:	0
Clock Start/From:	
Clock To:	
1st Value:	
2nd Value:	
Value Percent:	15.000
Continuous Index:	
Within 8" of Joint:	NO
Remarks:

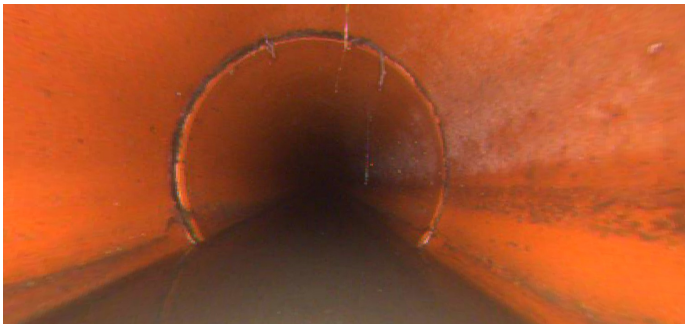
Code:	RFJ
Description:	Roots Fine Joint

Distance (ft):	4.2
Structural Grade:	0
O&M Grade:	1
Clock Start/From:	7
Clock To:	2
1st Value:	
2nd Value:	
Value Percent:	
Continuous Index:	
Within 8" of Joint:	YES
Remarks:

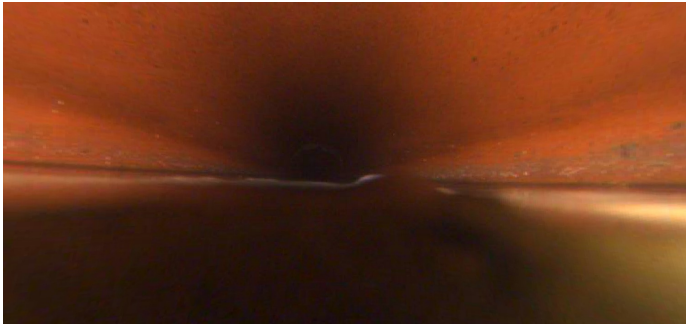
Code: **MWLS**
Description: **Water Level Sag**

Distance (ft): **21.7**
Structural Grade: **3**
O&M Grade: **3**
Clock Start/From:
Clock To:
1st Value:
2nd Value:
Value Percent: **40.000**
Continuous Index:
Within 8" of Joint: **NO**
Remarks:

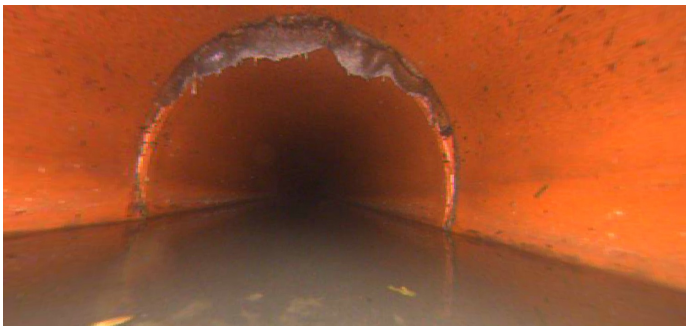
Code: **ISSR**
Description: **Intruding Sealing Ring**

Distance (ft): **26.0**
Structural Grade: **0**
O&M Grade: **2**
Clock Start/From: **10**
Clock To: **2**
1st Value:
2nd Value:
Value Percent: **5.000**
Continuous Index:
Within 8" of Joint: **NO**
Remarks:

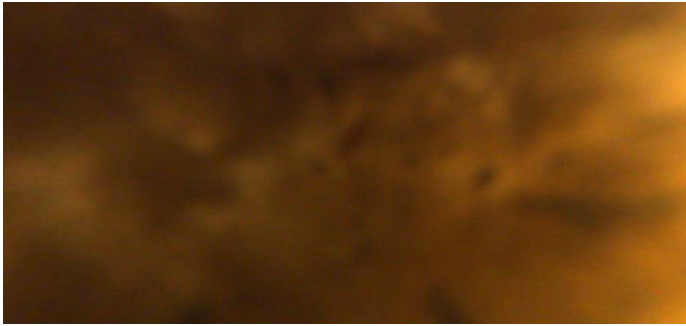
Code: **MCU**
Description: **Camera Underwater**

Distance (ft): **32.0**
Structural Grade: **0**
O&M Grade: **4**
Clock Start/From:
Clock To:
1st Value:
2nd Value:
Value Percent:
Continuous Index:
Within 8" of Joint: **NO**
Remarks:

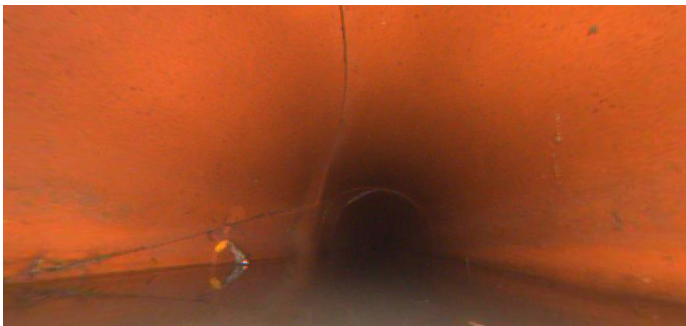
Code: **FM**
Description: **Fracture Multiple**

Distance (ft): **35.0**
Structural Grade: **4**
O&M Grade: **0**
Clock Start/From: **7**
Clock To: **12**
1st Value:
2nd Value:
Value Percent:
Continuous Index:
Within 8" of Joint: **YES**
Remarks:

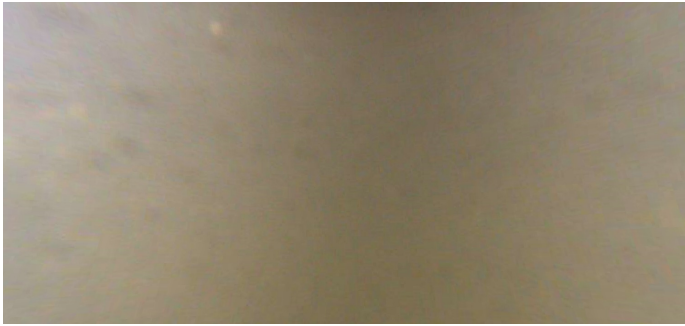
Code: **MCU**
Description: **Camera Underwater**

Distance (ft): **48.3**
Structural Grade: **0**
O&M Grade: **4**
Clock Start/From:
Clock To:
1st Value:
2nd Value:
Value Percent:
Continuous Index: **S01**
Within 8" of Joint: **NO**
Remarks:

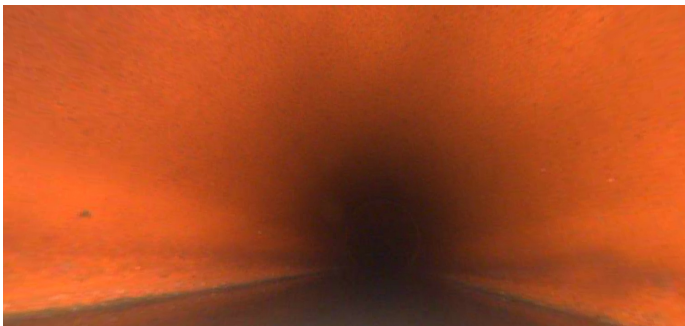
Code: **MCU**
Description: **Camera Underwater**

Distance (ft): **61.4**
Structural Grade: **0**
O&M Grade: **4**
Clock Start/From:
Clock To:
1st Value:
2nd Value:
Value Percent:
Continuous Index: **F01**
Within 8" of Joint: **NO**
Remarks:

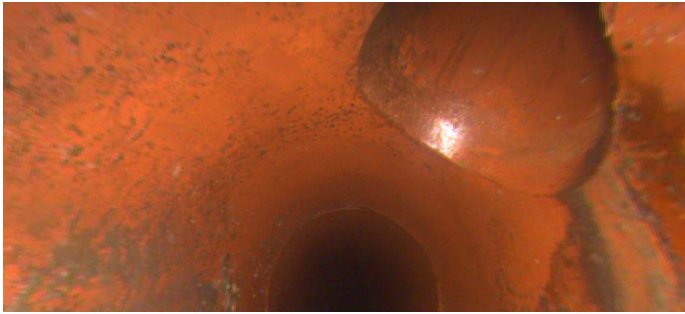
Code: **TF**
Description: **Tap Factory**

Distance (ft): **92.9**
Structural Grade: **0**
O&M Grade: **0**
Clock Start/From: **2**
Clock To:
1st Value: **4.000**
2nd Value:
Value Percent:
Continuous Index:
Within 8" of Joint:
Remarks:

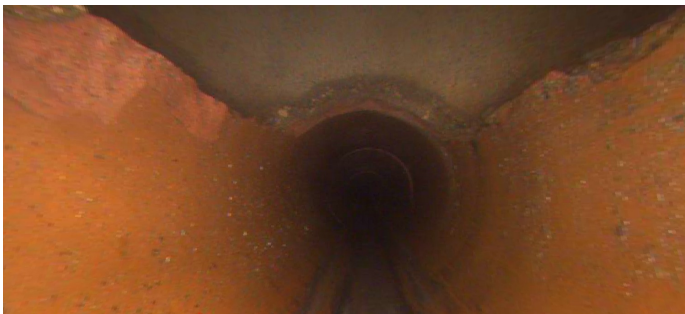
Code: **AMH**
Description: **Manhole**

Distance (ft): **190.6**
Structural Grade: **0**
O&M Grade: **0**
Clock Start/From:
Clock To:
1st Value:
2nd Value:
Value Percent:
Continuous Index:
Within 8" of Joint: **NO**
Remarks: **M-903-016**
