Profile/Photo Observation Report

Street:	Rand St.	Flow Control:	Not Controlled
City:	Hobart, IN	Year Renewed:	
Location:	Light Highway	Tape/Media #:	
Purpose:	Routine Assessment	Dia/Height:	12"
Use:	Sanitary	Material:	VCP
Drain Area:	NA	Lining:	
Category:	NA		
Comment:

Location Details:		Direction of Survey:	Downstream
US MH:	M-903-015	DS MH:	M-903-016
		Total Length Surveyed (ft):	190.6

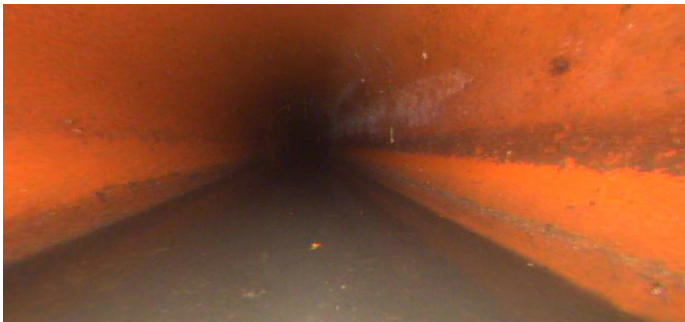
Code: **AMH**
Description: **Manhole**

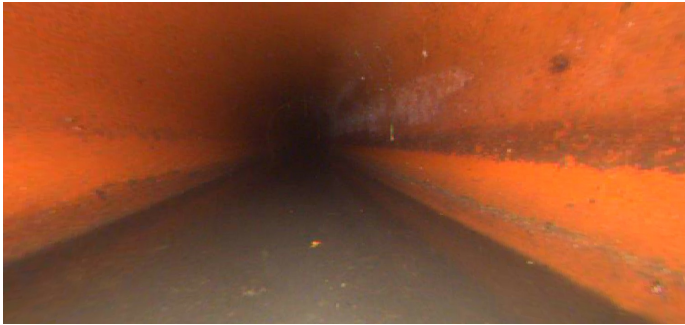
Code:	MWL
Description:	Water Level

Distance (ft):	.0
Structural Grade:	0
O&M Grade:	0
Clock Start/From:	
Clock To:	
1st Value:	
2nd Value:	
Value Percent:	15.000
Continuous Index:	
Within 8" of Joint:	NO
Remarks:

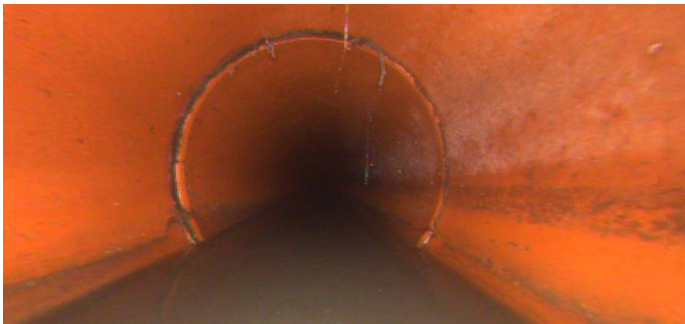
Code:	RFJ
Description:	Roots Fine Joint

Distance (ft):	4.2
Structural Grade:	0
O&M Grade:	1
Clock Start/From:	7
Clock To:	2
1st Value:	
2nd Value:	
Value Percent:	
Continuous Index:	
Within 8" of Joint:	YES
Remarks:

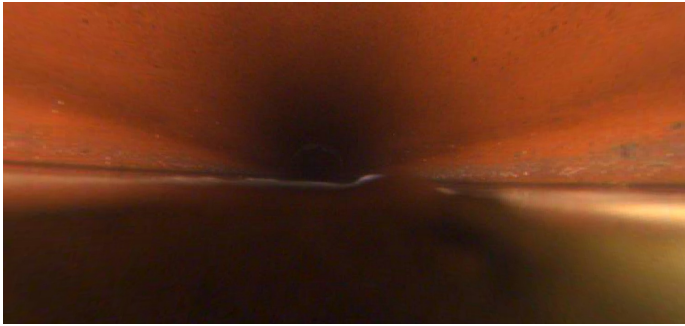
Code: **MWLS**
Description: **Water Level Sag**

Distance (ft): **21.7**
Structural Grade: **3**
O&M Grade: **3**
Clock Start/From:
Clock To:
1st Value:
2nd Value:
Value Percent: **40.000**
Continuous Index:
Within 8" of Joint: **NO**
Remarks:

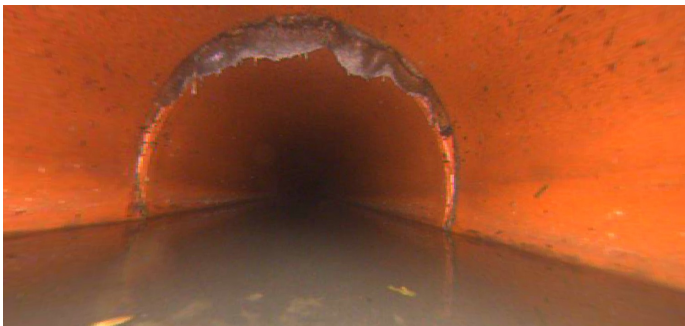
Code: **ISSR**
Description: **Intruding Sealing Ring**

Distance (ft): **26.0**
Structural Grade: **0**
O&M Grade: **2**
Clock Start/From: **10**
Clock To: **2**
1st Value:
2nd Value:
Value Percent: **5.000**
Continuous Index:
Within 8" of Joint: **NO**
Remarks:

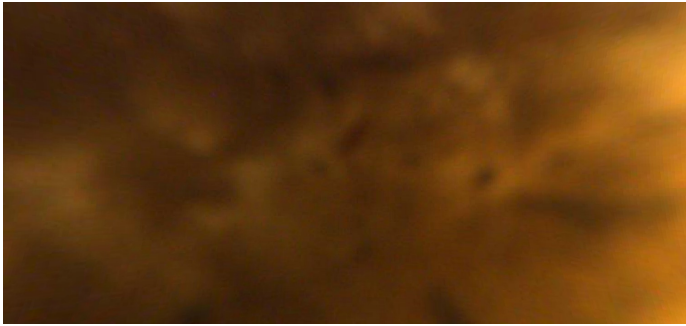
Code: **MCU**
Description: **Camera Underwater**

Distance (ft): **32.0**
Structural Grade: **0**
O&M Grade: **4**
Clock Start/From:
Clock To:
1st Value:
2nd Value:
Value Percent:
Continuous Index:
Within 8" of Joint: **NO**
Remarks:

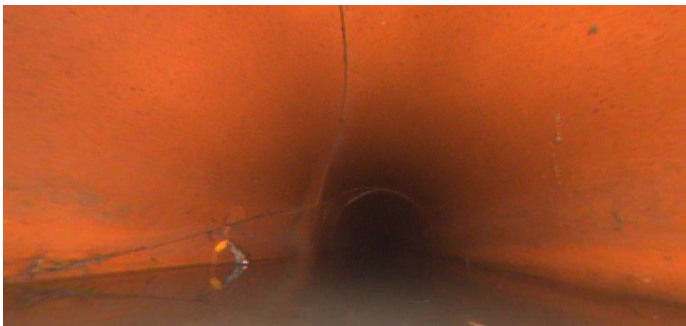
Code: **FM**
Description: **Fracture Multiple**

Distance (ft): **35.0**
Structural Grade: **4**
O&M Grade: **0**
Clock Start/From: **7**
Clock To: **12**
1st Value:
2nd Value:
Value Percent:
Continuous Index:
Within 8" of Joint: **YES**
Remarks:

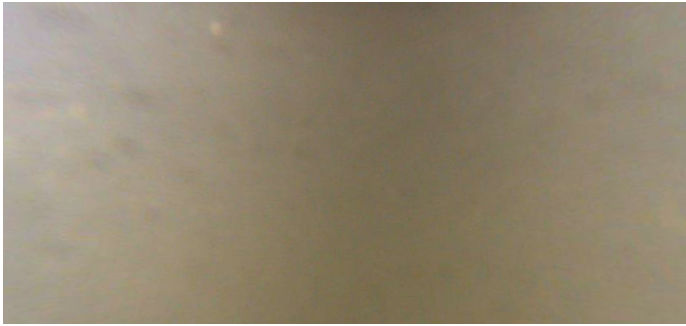
Code: **MCU**
Description: **Camera Underwater**

Distance (ft): **48.3**
Structural Grade: **0**
O&M Grade: **4**
Clock Start/From:
Clock To:
1st Value:
2nd Value:
Value Percent:
Continuous Index: **S01**
Within 8" of Joint: **NO**
Remarks:

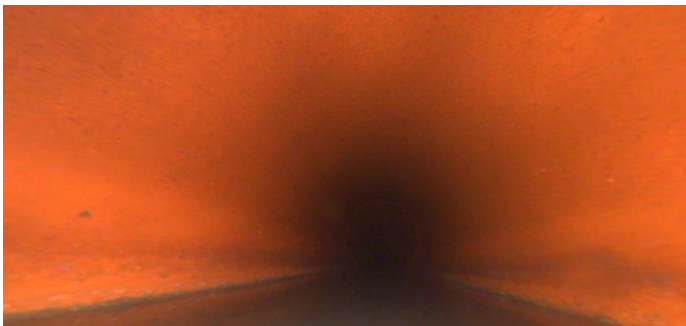
Code: **MCU**
Description: **Camera Underwater**

Distance (ft): **61.4**
Structural Grade: **0**
O&M Grade: **4**
Clock Start/From:
Clock To:
1st Value:
2nd Value:
Value Percent:
Continuous Index: **F01**
Within 8" of Joint: **NO**
Remarks:

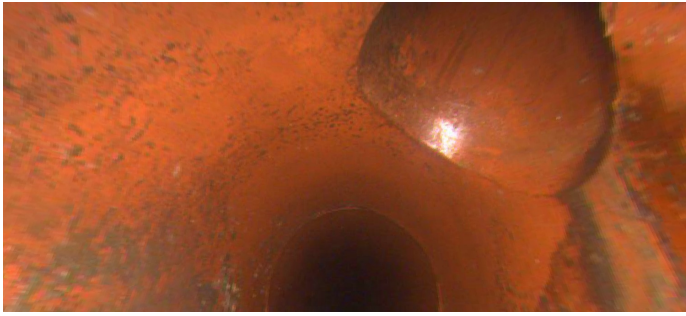
Code: **TF**
Description: **Tap Factory**

Distance (ft): **92.9**
Structural Grade: **0**
O&M Grade: **0**
Clock Start/From: **2**
Clock To:
1st Value: **4.000**
2nd Value:
Value Percent:
Continuous Index:
Within 8" of Joint:
Remarks:

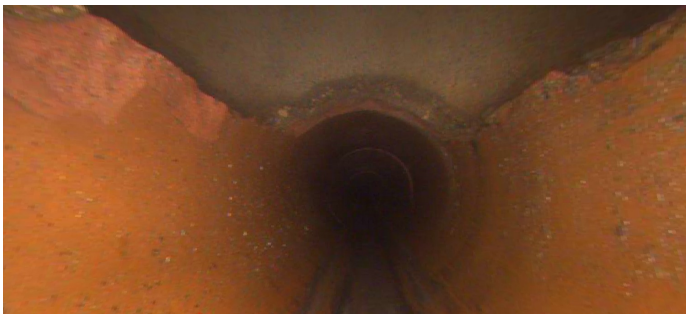
Code: **AMH**
Description: **Manhole**

Distance (ft): **190.6**
Structural Grade: **0**
O&M Grade: **0**
Clock Start/From:
Clock To:
1st Value:
2nd Value:
Value Percent:
Continuous Index:
Within 8" of Joint: **NO**
Remarks: **M-903-016**
