Profile/Photo Observation Report

Date:	04/02/2018	Weather:		Coding:	PACP 6.0
Pipe Length (ft):	162.5	Owner:	NA	Pre Clean:	Not Known
P.O.#:		Surveyor:	Jen Costello	PSR:	P-903-016-017
Customer:		Clean Date:	01/01/1900	Shape:	C

Street:	Rand St.	Flow Control:	Not Controlled
City:	Hobart, IN	Year Renewed:	
Location:	Other	Tape/Media #:	
Purpose:	Not Known	Dia/Height:	12"
Use:	Sanitary	Material:	VCP
Drain Area:	NA	Lining:	
Category:	NA		
Comment:

Location Details:		Direction of Survey:	Upstream
US MH:	M-903-016	DS MH:	M-903-017
		Total Length Surveyed (ft):	47.0

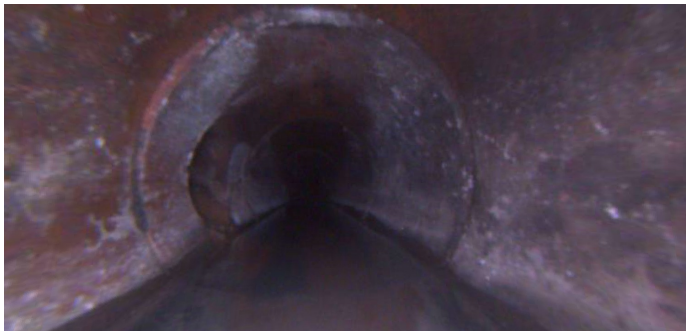
Code: **AMH**
Description: **Manhole**

Distance (ft): **.0**
Structural Grade: **0**
O&M Grade: **0**
Clock Start/From:
Clock To:
1st Value:
2nd Value:
Value Percent:
Continuous Index:
Within 8" of Joint: **NO**
Remarks: **M-903-017**

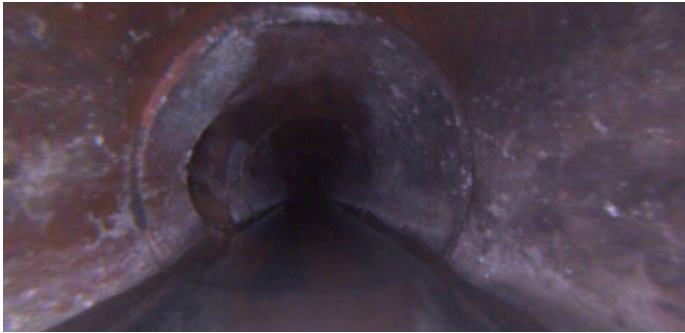
Code:	MWL
Description:	Water Level

Distance (ft):	.0
Structural Grade:	0
O&M Grade:	0
Clock Start/From:	
Clock To:	
1st Value:	
2nd Value:	
Value Percent:	20.000
Continuous Index:	
Within 8" of Joint:	NO
Remarks:

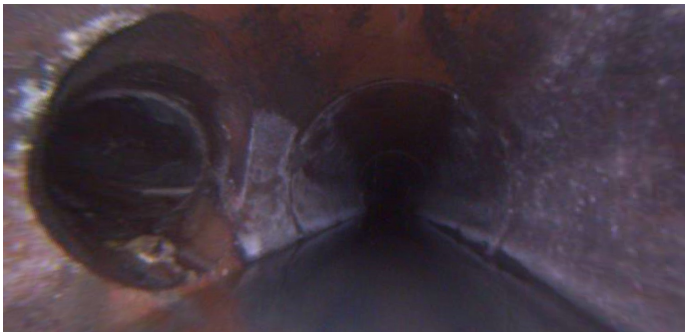
Code:	TF
Description:	Tap Factory

Distance (ft):	1.6
Structural Grade:	0
O&M Grade:	0
Clock Start/From:	9
Clock To:	
1st Value:	4.000
2nd Value:	
Value Percent:	
Continuous Index:	
Within 8" of Joint:	
Remarks:

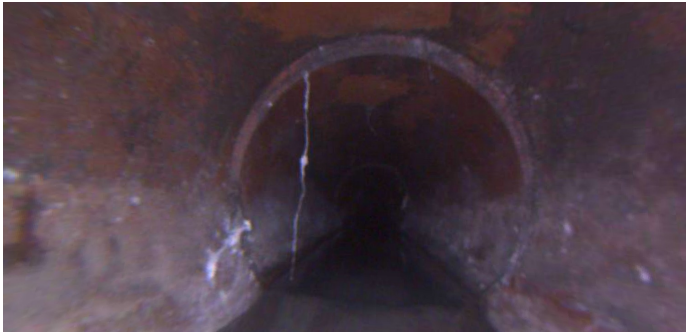
Code: **RFJ**
Description: **Roots Fine Joint**

Distance (ft): **5.1**
Structural Grade: **0**
O&M Grade: **1**
Clock Start/From: **11**
Clock To:
1st Value:
2nd Value:
Value Percent:
Continuous Index:
Within 8" of Joint: **YES**
Remarks:

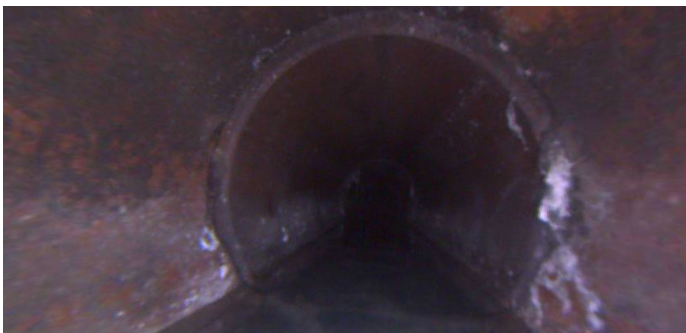
Code: **RFJ**
Description: **Roots Fine Joint**

Distance (ft): **8.3**
Structural Grade: **0**
O&M Grade: **1**
Clock Start/From: **2**
Clock To: **4**
1st Value:
2nd Value:
Value Percent:
Continuous Index:
Within 8" of Joint: **YES**
Remarks:

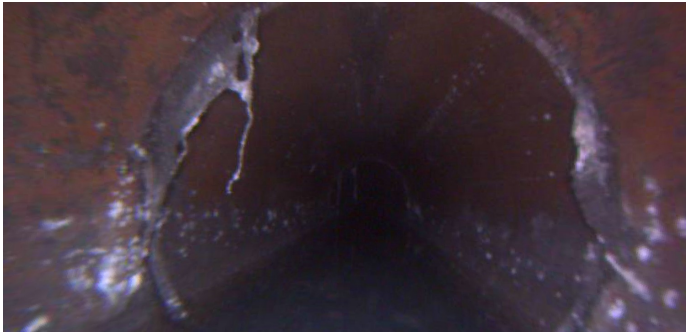
Code: **RFJ**
Description: **Roots Fine Joint**

Distance (ft): **11.5**
Structural Grade: **0**
O&M Grade: **1**
Clock Start/From: **8**
Clock To: **4**
1st Value:
2nd Value:
Value Percent:
Continuous Index: **S01**
Within 8" of Joint: **YES**
Remarks:

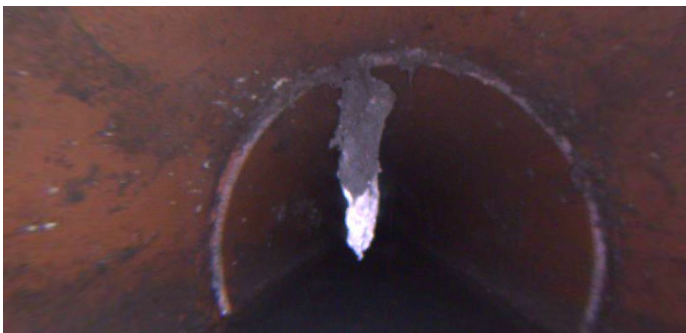
Code: **DAR**
Description: **Deposits Attached Ragging**

Distance (ft): **29.4**
Structural Grade: **0**
O&M Grade: **2**
Clock Start/From: **12**
Clock To:
1st Value:
2nd Value:
Value Percent: **10.000**
Continuous Index:
Within 8" of Joint: **YES**
Remarks:

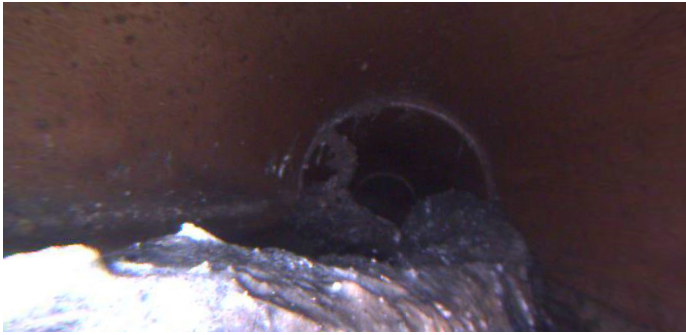
Code: **OBZ**
Description: **Obstacle Other**

Distance (ft): **47.0**
Structural Grade: **0**
O&M Grade: **5**
Clock Start/From: **3**
Clock To: **9**
1st Value:
2nd Value:
Value Percent: **40.000**
Continuous Index:
Within 8" of Joint: **NO**
Remarks: **MISC**

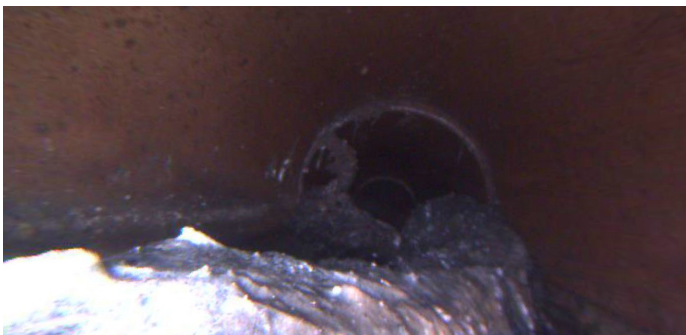
Code: **RFJ**
Description: **Roots Fine Joint**

Distance (ft): **47.0**
Structural Grade: **0**
O&M Grade: **1**
Clock Start/From: **8**
Clock To: **4**
1st Value:
2nd Value:
Value Percent:
Continuous Index: **F01**
Within 8" of Joint: **YES**
Remarks:

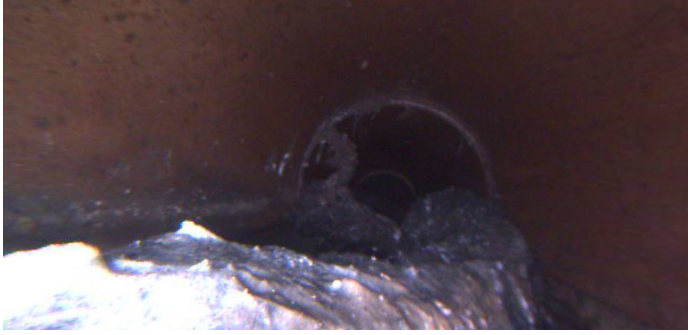
Code:	MSA
Description:	Abandoned Survey
Distance (ft):	47.0
Structural Grade:	0
O&M Grade:	0
Clock Start/From:	
Clock To:	
1st Value:	
2nd Value:	
Value Percent:	
Continuous Index:	
Within 8" of Joint:	NO
Remarks:	MISC
