## Profile/Photo Observation Report

Street:	<b>E RAND ST</b>	Flow Control:	<b>Not Controlled</b>
City:	<b>Hobart, IN</b>	Year Renewed:	
Location:	<b>Other</b>	Tape/Media #:	
Purpose:	<b>Not Known</b>	Dia/Height:	<b>12"</b>
Use:	<b>Sanitary</b>	Material:	<b>VCP</b>
Drain Area:	<b>NA</b>	Lining:	
Category:	<b>NA</b>		
Comment:

Location Details:		Direction of Survey:	<b>Downstream</b>
US MH:	<b>M-903-017</b>	DS MH:	<b>M-903-202</b>
		Total Length Surveyed (ft):	<b>163.9</b>

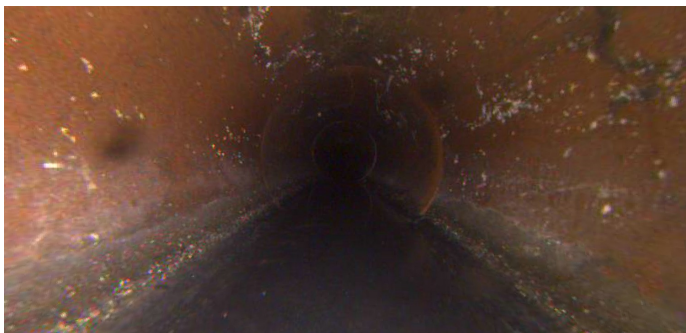
Code: **AMH**  
Description: **Manhole**

Distance (ft): **.0**  
Structural Grade: **0**  
O&M Grade: **0**  
Clock Start/From:  
Clock To:  
1st Value:  
2nd Value:  
Value Percent:  
Continuous Index:  
Within 8" of Joint: **NO**  
Remarks: **M-903-017**

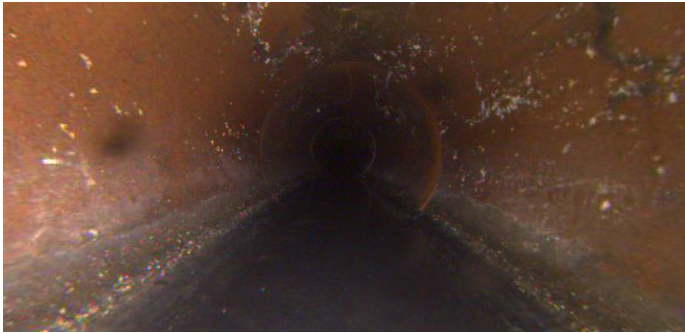
Code:	<b>MWL</b>
Description:	<b>Water Level</b>

Distance (ft):	<b>.0</b>
Structural Grade:	<b>0</b>
O&M Grade:	<b>0</b>
Clock Start/From:	
Clock To:	
1st Value:	
2nd Value:	
Value Percent:	<b>5.000</b>
Continuous Index:	
Within 8" of Joint:	<b>NO</b>
Remarks:

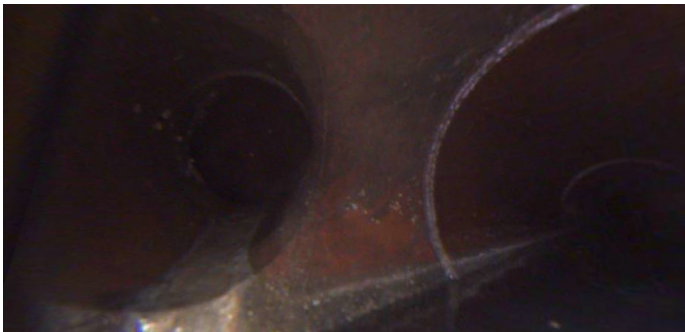
Code:	<b>TFA</b>
Description:	<b>Tap Factory Active</b>

Distance (ft):	<b>48.0</b>
Structural Grade:	<b>0</b>
O&M Grade:	<b>0</b>
Clock Start/From:	<b>3</b>
Clock To:	
1st Value:	<b>4.000</b>
2nd Value:	
Value Percent:	
Continuous Index:	
Within 8" of Joint:	
Remarks:

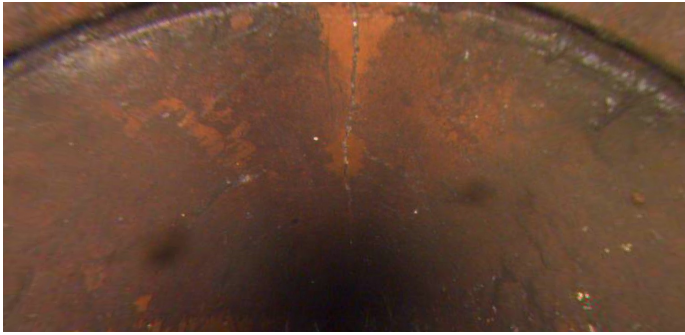
Code: **FL**  
Description: **Fracture Longitudinal**

Distance (ft): **55.9**  
Structural Grade: **3**  
O&M Grade: **0**  
Clock Start/From: **12**  
Clock To:  
1st Value:  
2nd Value:  
Value Percent:  
Continuous Index:  
Within 8" of Joint: **YES**  
Remarks:

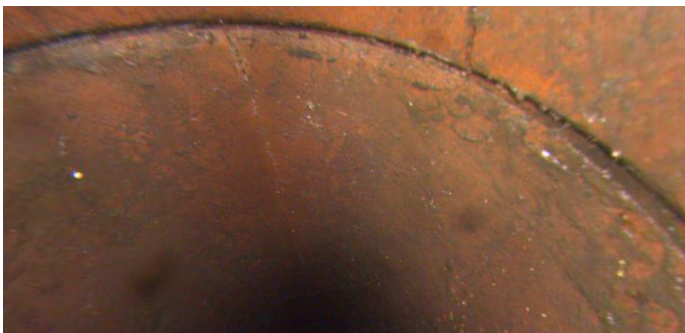
Code: **FM**  
Description: **Fracture Multiple**

Distance (ft): **58.8**  
Structural Grade: **4**  
O&M Grade: **0**  
Clock Start/From: **12**  
Clock To: **1**  
1st Value:  
2nd Value:  
Value Percent:  
Continuous Index:  
Within 8" of Joint: **YES**  
Remarks:

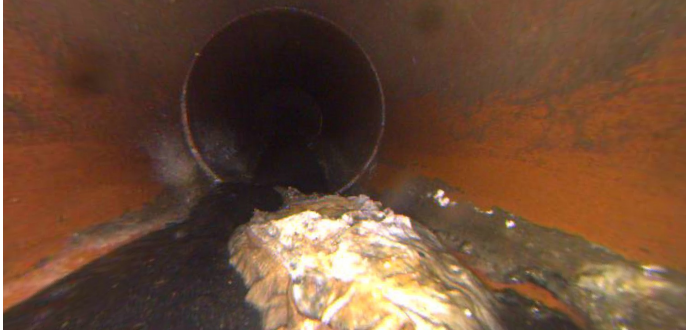
Code: **OBZ**  
Description: **Obstacle Other**

Distance (ft): **111.2**  
Structural Grade: **0**  
O&M Grade: **2**  
Clock Start/From: **5**  
Clock To: **6**  
1st Value:  
2nd Value:  
Value Percent: **10.000**  
Continuous Index:  
Within 8" of Joint: **NO**  
Remarks: **MISC**

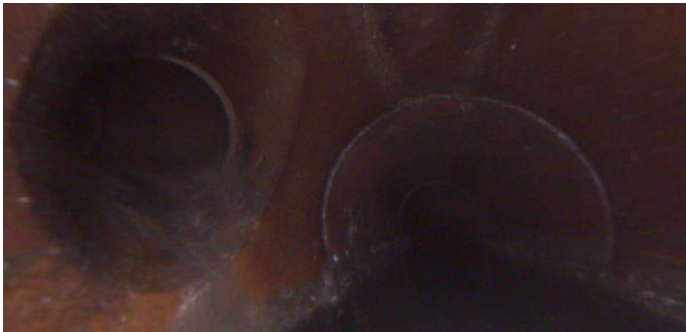
Code: **TF**  
Description: **Tap Factory**

Distance (ft): **137.8**  
Structural Grade: **0**  
O&M Grade: **0**  
Clock Start/From: **3**  
Clock To:  
1st Value: **4.000**  
2nd Value:  
Value Percent:  
Continuous Index:  
Within 8" of Joint:  
Remarks:

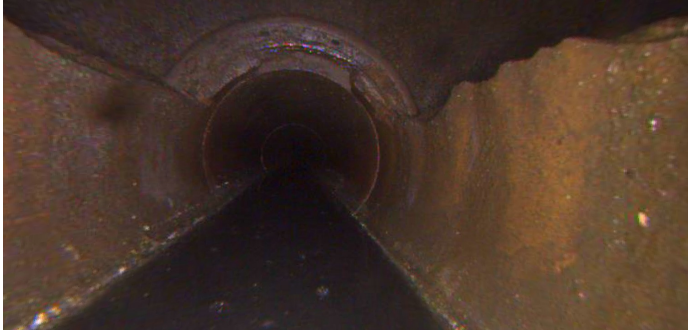
Code:	<b>AMH</b>
Description:	<b>Manhole</b>
Distance (ft):	<b>163.9</b>
Structural Grade:	<b>0</b>
O&M Grade:	<b>0</b>
Clock Start/From:	
Clock To:	
1st Value:	
2nd Value:	
Value Percent:	
Continuous Index:	
Within 8" of Joint:	<b>NO</b>
Remarks:	<b>M-903-202</b>
