Profile/Photo Observation Report

Street:	Rand St.	Flow Control:	Not Controlled
City:	Hobart, IN	Year Renewed:	
Location:	Other	Tape/Media #:	
Purpose:	Not Known	Dia/Height:	12"
Use:	Sanitary	Material:	VCP
Drain Area:	NA	Lining:	
Category:	NA		
Comment:

Location Details:		Direction of Survey:	Downstream
US MH:	M-903-017	DS MH:	M-903-202
		Total Length Surveyed (ft):	163.9

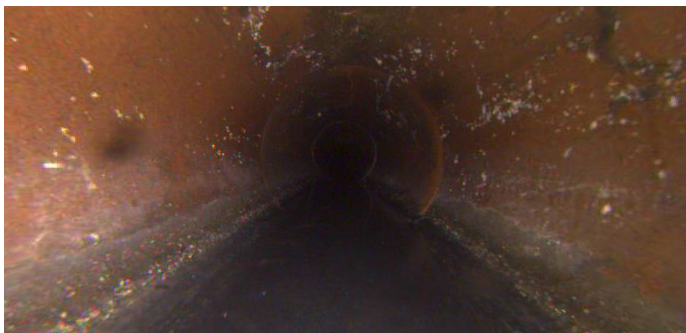
Code: **AMH**
Description: **Manhole**

Distance (ft): **.0**
Structural Grade: **0**
O&M Grade: **0**
Clock Start/From:
Clock To:
1st Value:
2nd Value:
Value Percent:
Continuous Index:
Within 8" of Joint: **NO**
Remarks: **M-903-017**

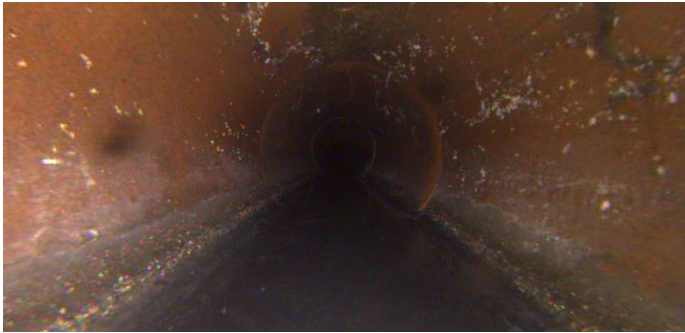
Code:	MWL
Description:	Water Level

Distance (ft):	.0
Structural Grade:	0
O&M Grade:	0
Clock Start/From:	
Clock To:	
1st Value:	
2nd Value:	
Value Percent:	5.000
Continuous Index:	
Within 8" of Joint:	NO
Remarks:

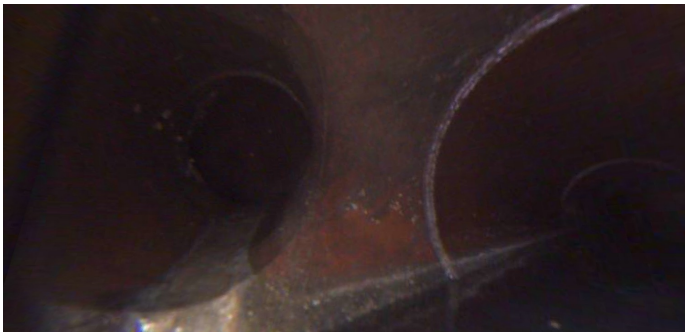
Code:	TFA
Description:	Tap Factory Active

Distance (ft):	48.0
Structural Grade:	0
O&M Grade:	0
Clock Start/From:	3
Clock To:	
1st Value:	4.000
2nd Value:	
Value Percent:	
Continuous Index:	
Within 8" of Joint:	
Remarks:

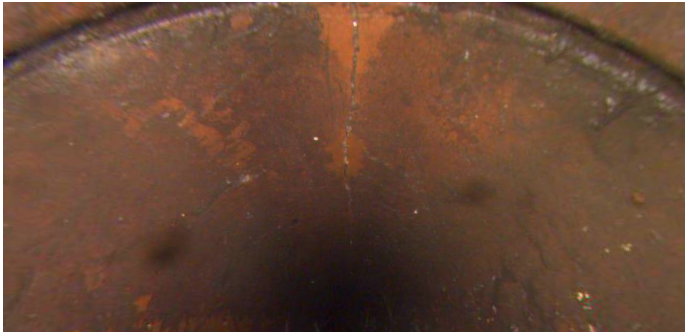
Code: **FL**
Description: **Fracture Longitudinal**

Distance (ft): **55.9**
Structural Grade: **3**
O&M Grade: **0**
Clock Start/From: **12**
Clock To:
1st Value:
2nd Value:
Value Percent:
Continuous Index:
Within 8" of Joint: **YES**
Remarks:

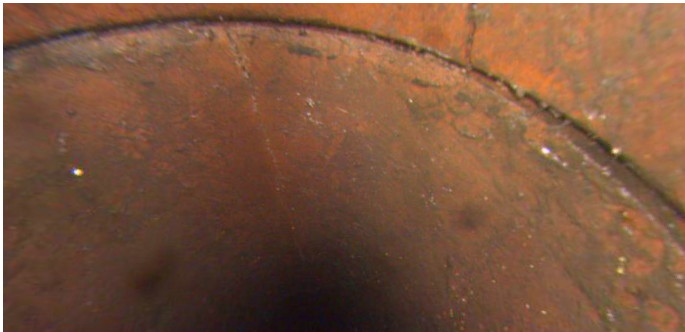
Code: **FM**
Description: **Fracture Multiple**

Distance (ft): **58.8**
Structural Grade: **4**
O&M Grade: **0**
Clock Start/From: **12**
Clock To: **1**
1st Value:
2nd Value:
Value Percent:
Continuous Index:
Within 8" of Joint: **YES**
Remarks:

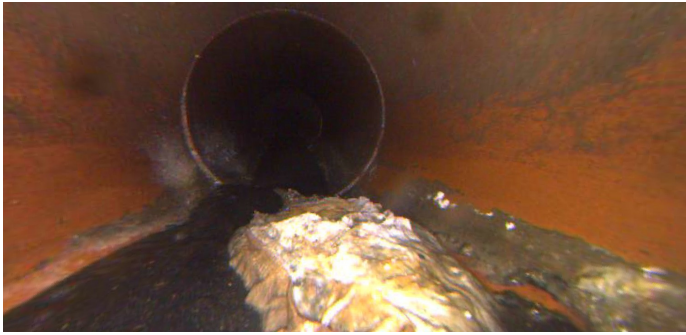
Code: **OBZ**
Description: **Obstacle Other**

Distance (ft): **111.2**
Structural Grade: **0**
O&M Grade: **2**
Clock Start/From: **5**
Clock To: **6**
1st Value:
2nd Value:
Value Percent: **10.000**
Continuous Index:
Within 8" of Joint: **NO**
Remarks: **MISC**

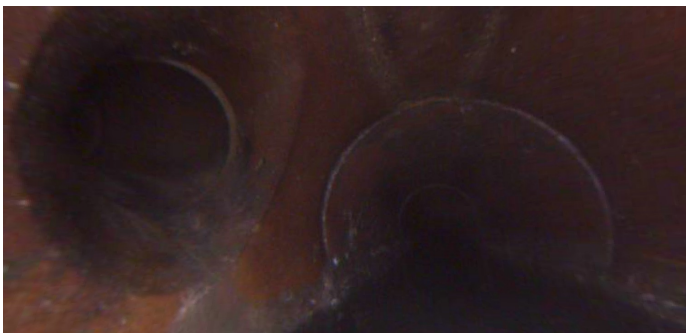
Code: **TF**
Description: **Tap Factory**

Distance (ft): **137.8**
Structural Grade: **0**
O&M Grade: **0**
Clock Start/From: **3**
Clock To:
1st Value: **4.000**
2nd Value:
Value Percent:
Continuous Index:
Within 8" of Joint:
Remarks:

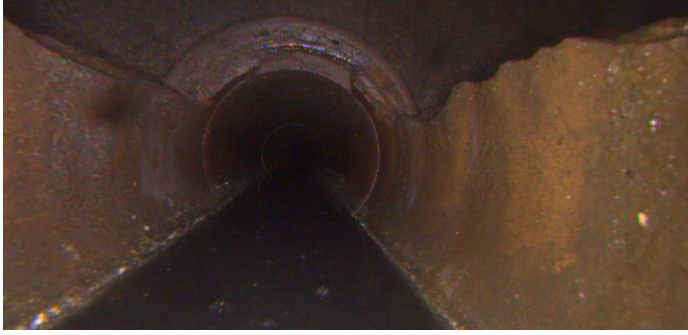
Code:	AMH
Description:	Manhole
Distance (ft):	163.9
Structural Grade:	0
O&M Grade:	0
Clock Start/From:	
Clock To:	
1st Value:	
2nd Value:	
Value Percent:	
Continuous Index:	
Within 8" of Joint:	NO
Remarks:	M-903-202
