Profile/Photo Observation Report

Date:	03/29/2018	Weather:		Coding:	PACP 6.0
Pipe Length (ft):	207.0	Owner:	NA	Pre Clean:	Not Known
P.O.#:		Surveyor:	Jen Costello	PSR:	P-903-019-018
Customer:		Clean Date:	01/01/1900	Shape:	C

Street:	ALLEY BETWEEN N SHELBY ST & BRA	Flow Control:	Not Controlled
City:	Hobart, IN	Year Renewed:	
Location:	Other	Tape/Media #:	
Purpose:	Not Known	Dia/Height:	10"
Use:	Sanitary	Material:	VCP
Drain Area:	NA	Lining:	
Category:	NA		
Comment:

Location Details:		Direction of Survey:	Downstream
US MH:	M-903-018	DS MH:	M-903-019
		Total Length Surveyed (ft):	103.9

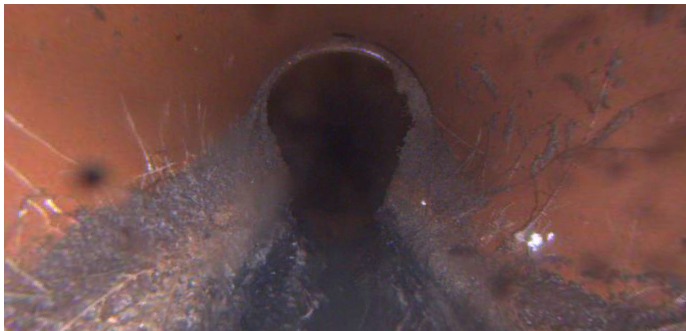
Code: **AMH**
Description: **Manhole**

Distance (ft): **.0**
Structural Grade: **0**
O&M Grade: **0**
Clock Start/From:
Clock To:
1st Value:
2nd Value:
Value Percent:
Continuous Index:
Within 8" of Joint: **NO**
Remarks: **M-903-018**

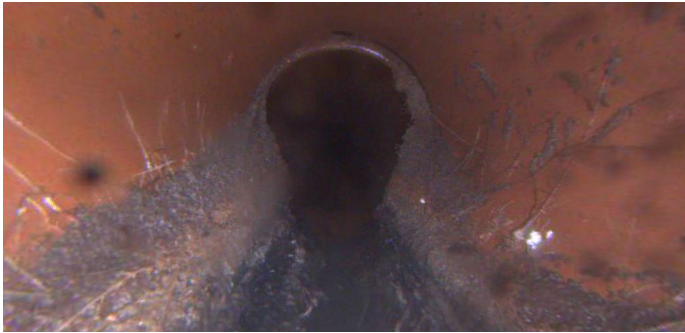
Code:	MWL
Description:	Water Level

Distance (ft):	.0
Structural Grade:	0
O&M Grade:	0
Clock Start/From:	
Clock To:	
1st Value:	
2nd Value:	
Value Percent:	5.000
Continuous Index:	
Within 8" of Joint:	NO
Remarks:

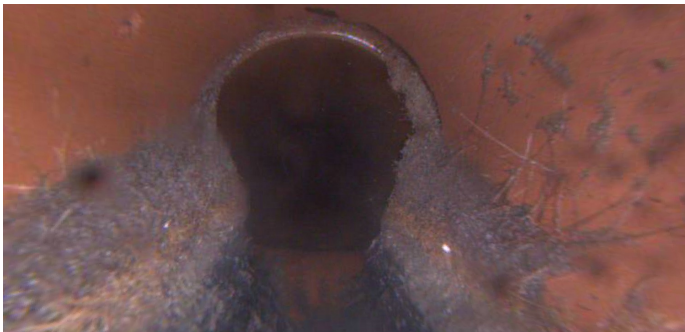
Code:	RMJ
Description:	Roots Medium Joint

Distance (ft):	.7
Structural Grade:	0
O&M Grade:	3
Clock Start/From:	8
Clock To:	4
1st Value:	
2nd Value:	
Value Percent:	20.000
Continuous Index:	
Within 8" of Joint:	YES
Remarks:

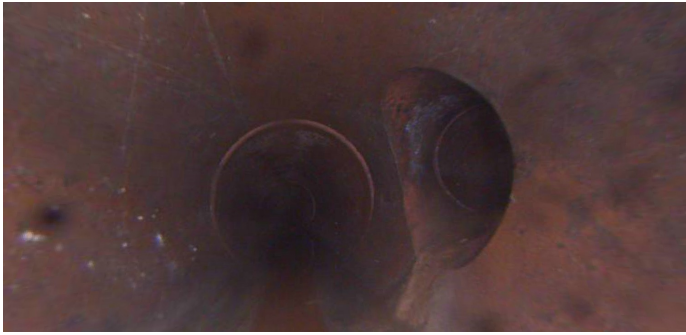
Code: **TFA**
Description: **Tap Factory Active**

Distance (ft): **42.6**
Structural Grade: **0**
O&M Grade: **0**
Clock Start/From: **3**
Clock To:
1st Value: **4.000**
2nd Value:
Value Percent:
Continuous Index:
Within 8" of Joint:
Remarks:

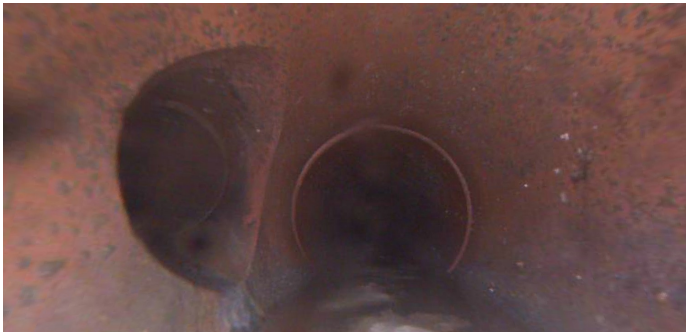
Code: **TF**
Description: **Tap Factory**

Distance (ft): **48.8**
Structural Grade: **0**
O&M Grade: **0**
Clock Start/From: **9**
Clock To:
1st Value: **4.000**
2nd Value:
Value Percent:
Continuous Index:
Within 8" of Joint:
Remarks:

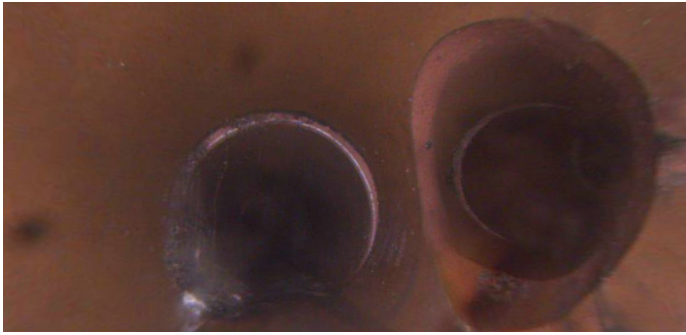
Code: **TF**
Description: **Tap Factory**

Distance (ft): **96.6**
Structural Grade: **0**
O&M Grade: **0**
Clock Start/From: **3**
Clock To:
1st Value: **4.000**
2nd Value:
Value Percent:
Continuous Index:
Within 8" of Joint:
Remarks:

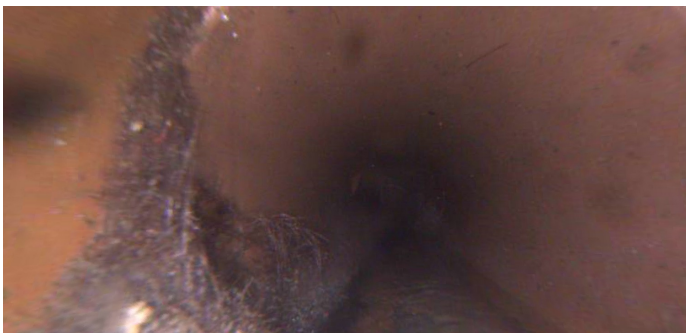
Code: **RMJ**
Description: **Roots Medium Joint**

Distance (ft): **97.5**
Structural Grade: **0**
O&M Grade: **3**
Clock Start/From: **7**
Clock To: **11**
1st Value:
2nd Value:
Value Percent: **10.000**
Continuous Index:
Within 8" of Joint: **YES**
Remarks:

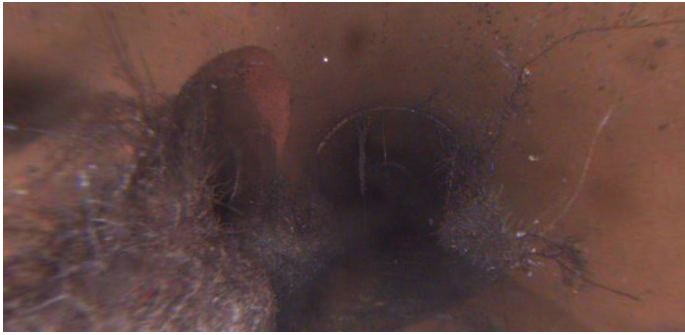
Code: **TFD**
Description: **Tap Factory Defective**

Distance (ft): **99.4**
Structural Grade: **0**
O&M Grade: **2**
Clock Start/From: **9**
Clock To:
1st Value: **4.000**
2nd Value:
Value Percent:
Continuous Index:
Within 8" of Joint:
Remarks: **RML**

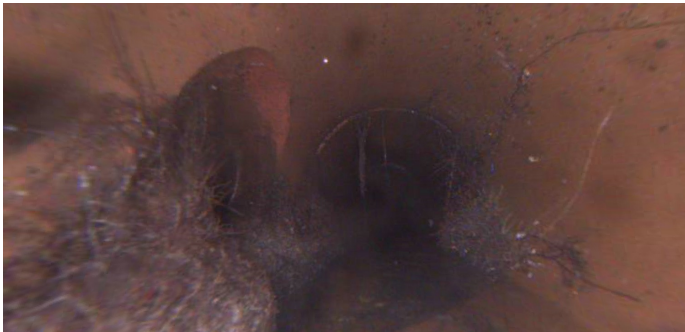
Code: **RML**
Description: **Roots Medium Lateral**

Distance (ft): **99.4**
Structural Grade: **0**
O&M Grade: **3**
Clock Start/From: **7**
Clock To: **9**
1st Value:
2nd Value:
Value Percent: **10.000**
Continuous Index:
Within 8" of Joint: **NO**
Remarks:

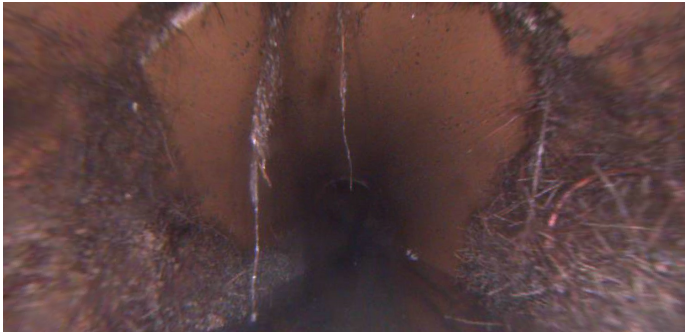
Code: **RMJ**
Description: **Roots Medium Joint**

Distance (ft): **100.4**
Structural Grade: **0**
O&M Grade: **3**
Clock Start/From: **8**
Clock To: **4**
1st Value:
2nd Value:
Value Percent: **20.000**
Continuous Index:
Within 8" of Joint: **YES**
Remarks:

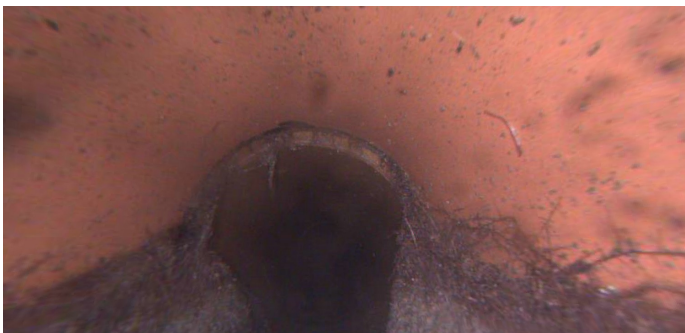
Code: **RMJ**
Description: **Roots Medium Joint**

Distance (ft): **102.9**
Structural Grade: **0**
O&M Grade: **3**
Clock Start/From: **8**
Clock To: **4**
1st Value:
2nd Value:
Value Percent: **20.000**
Continuous Index:
Within 8" of Joint: **YES**
Remarks:

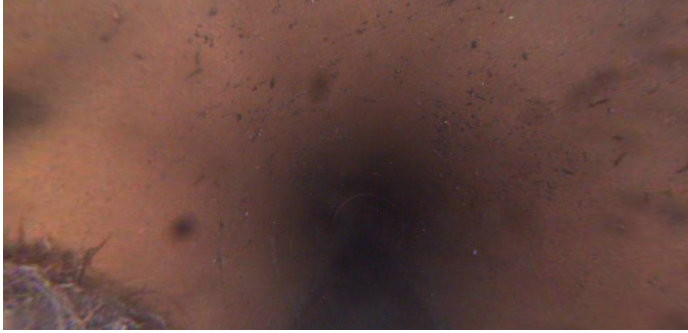
Code:	MSA
Description:	Abandoned Survey
Distance (ft):	103.9
Structural Grade:	0
O&M Grade:	0
Clock Start/From:	
Clock To:	
1st Value:	
2nd Value:	
Value Percent:	
Continuous Index:	
Within 8" of Joint:	NO
Remarks:	ROOTS
